EXPERIMENTAL PROJECTS CONSTRUCTION REPORT AND ANNUAL EVALUATION

3M WET REFLECTIVE CERAMIC ELEMENTS AND POTTERS VISIMAX PLUS: NEW BEAD TECHNOLOGY FOR ADDED RETROREFLECTIVITY IN PAVEMENT MARKINGS

Project Name: Rockvale - Laurel

Experimental Project No. MT-12-12

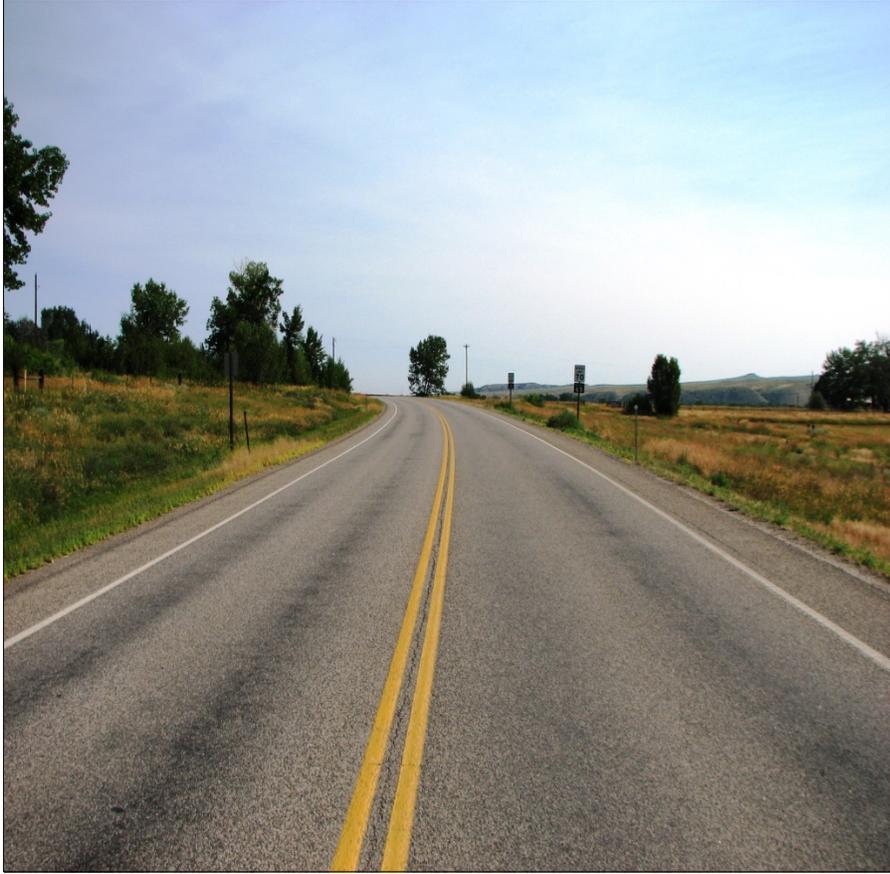
← Representative image taken in July of 2013 prior to new pavement markings application. View north.

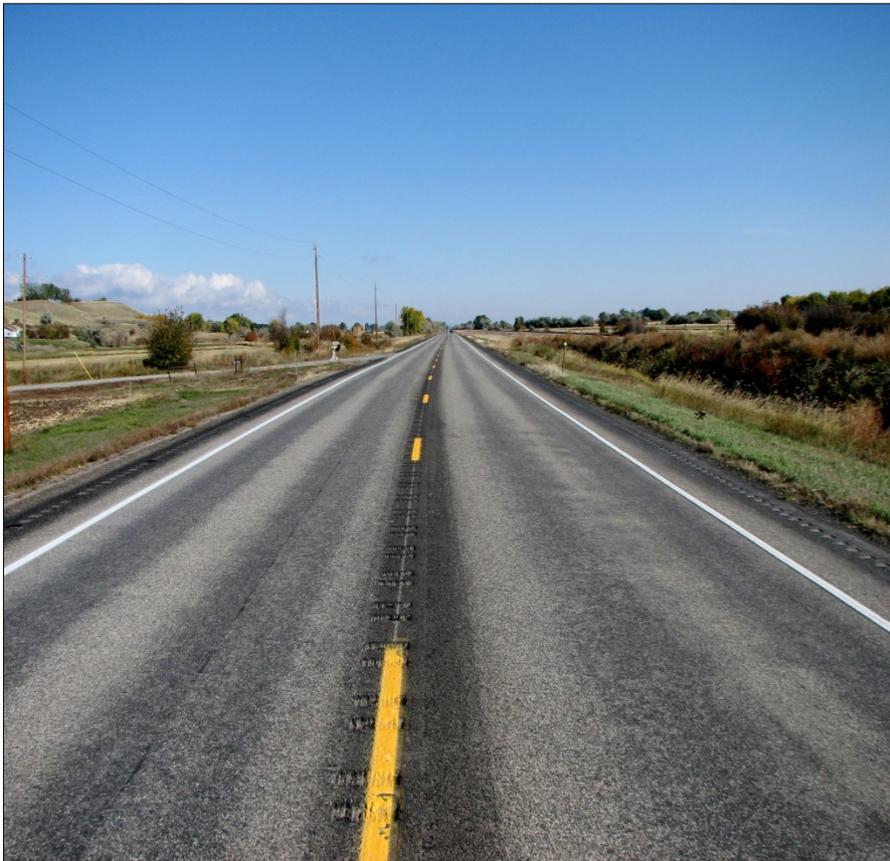
← Representative image taken in September of 2013 after pavement markings application, showing added centerline and shoulder rumble strips. View north.

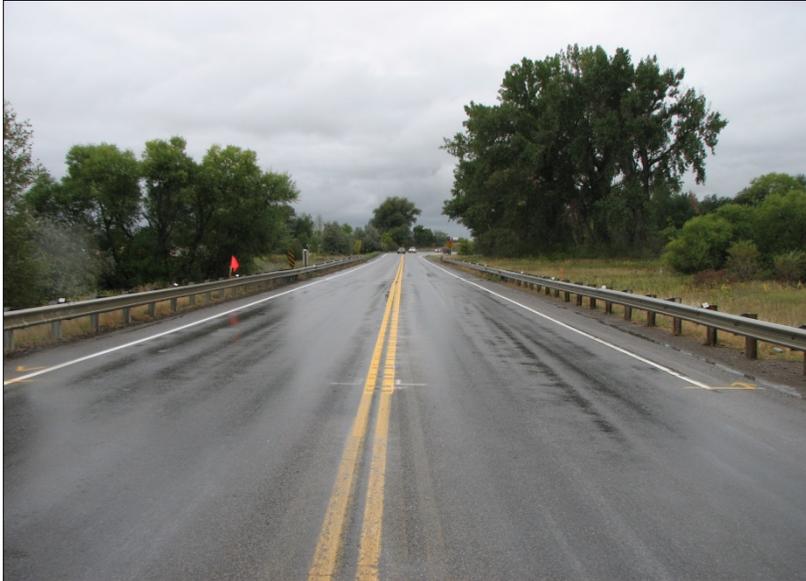
← Beginning of VISIMAX PLUS pavement markings at reference point 53 looking south.

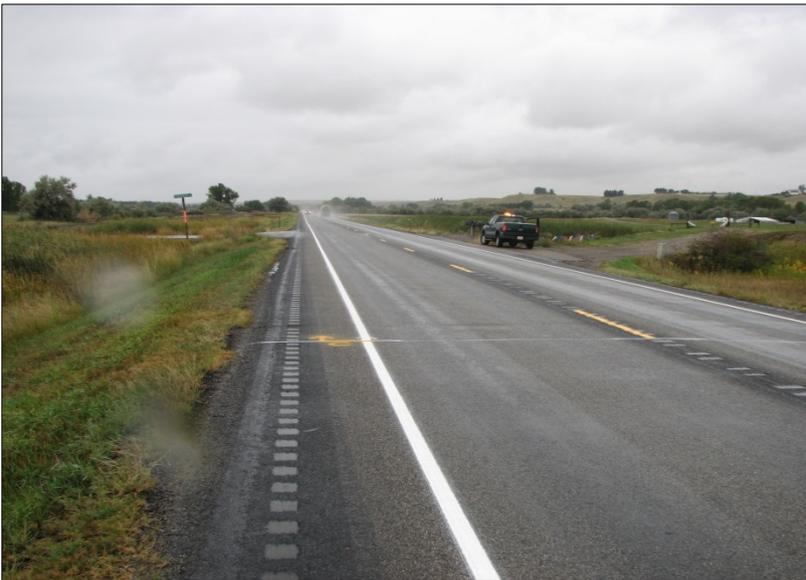
← Beginning of Control (Type 2) pavement markings at reference point 49 looking south.

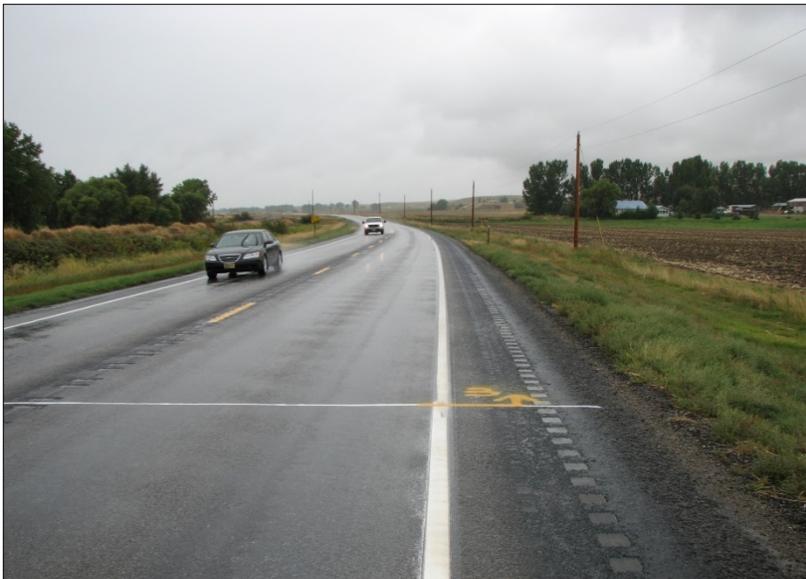
← Beginning of 3M Wet Reflective Element pavement markings at reference point 47 looking south.

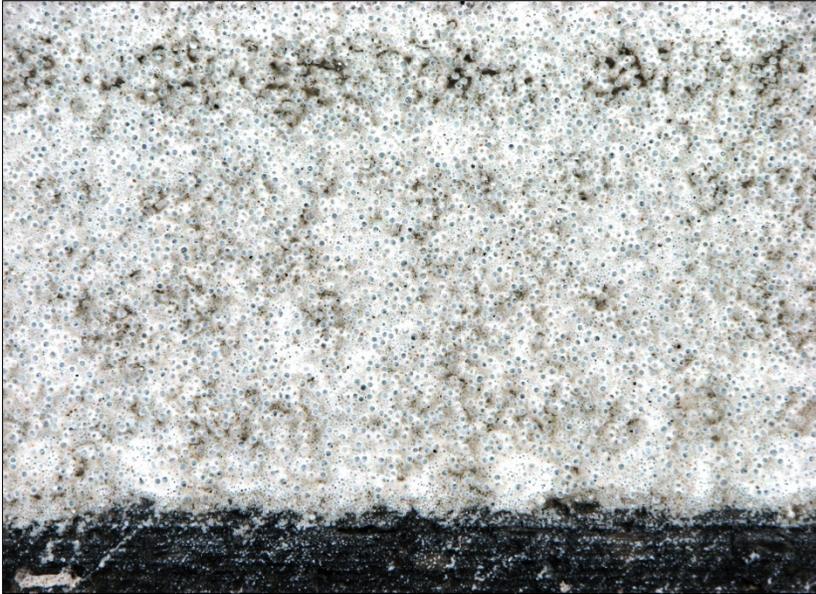
← Close-up of the VISIMAX PLUS white pigmented pavement markings.

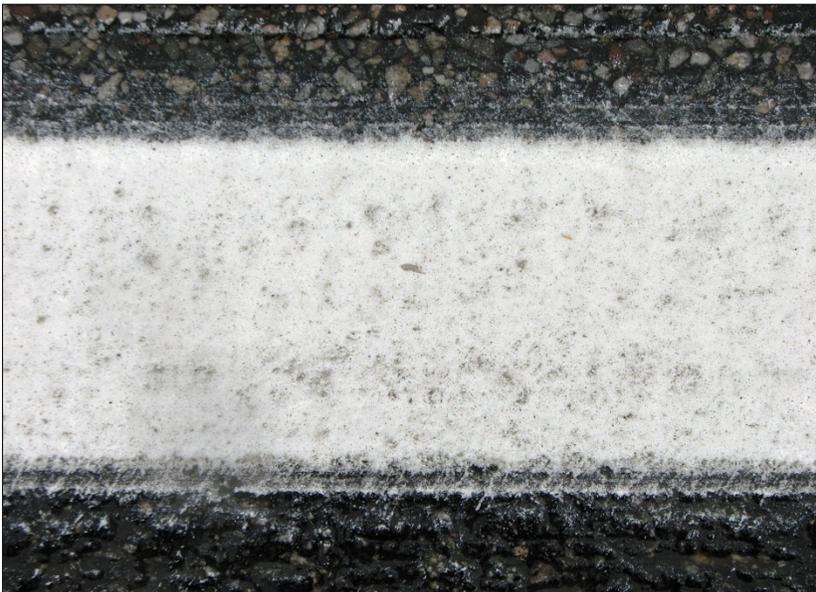
← Close-up of the Control (Type 2) white pigmented pavement markings.

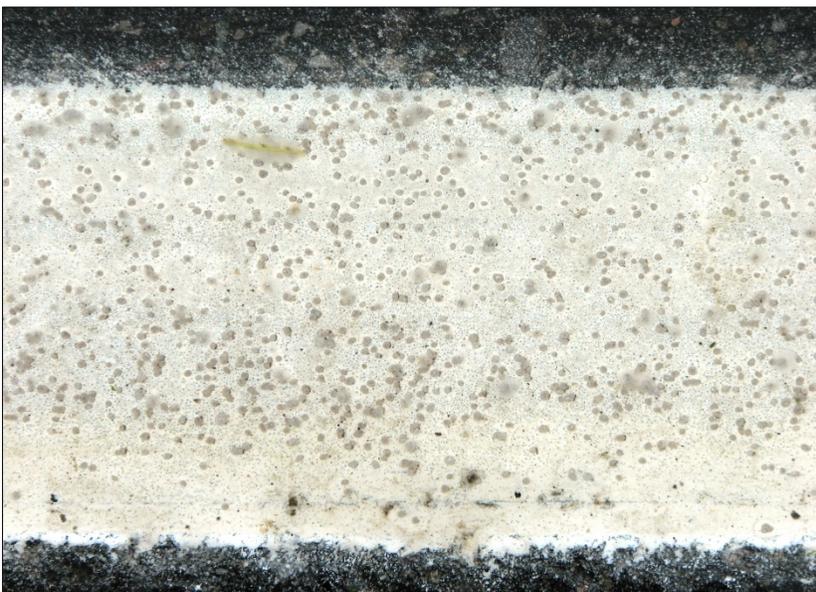
← Close-up of the 3M Wet Reflective Elements white pigmented pavement markings.

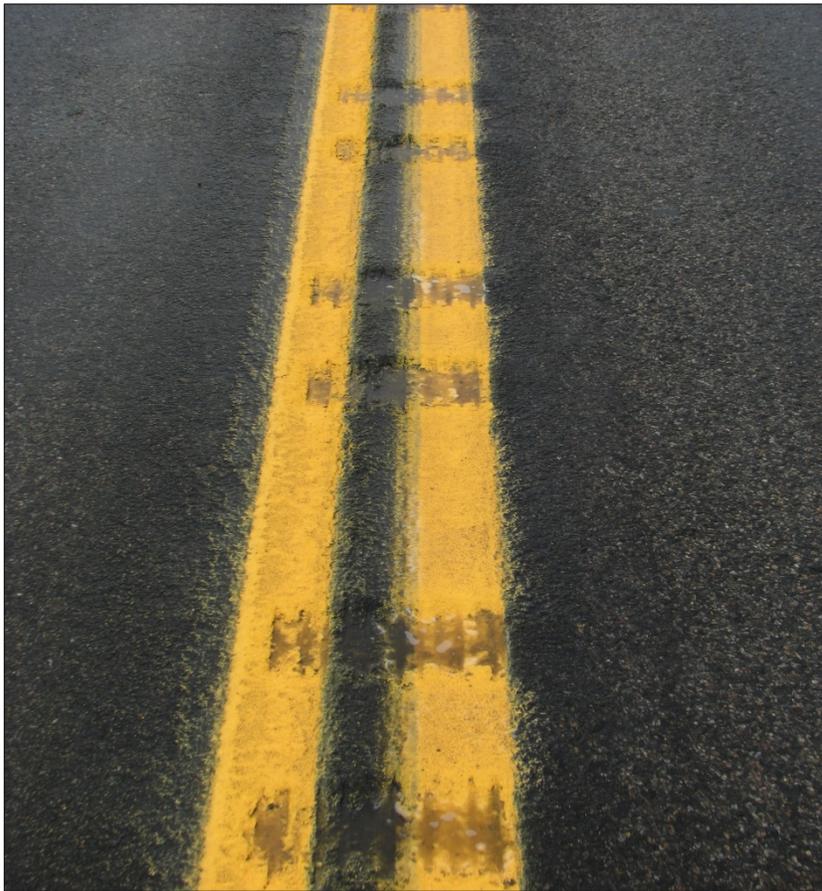
← Representative image of no-passing stripes placed over center-line rumble strips (wet condition).

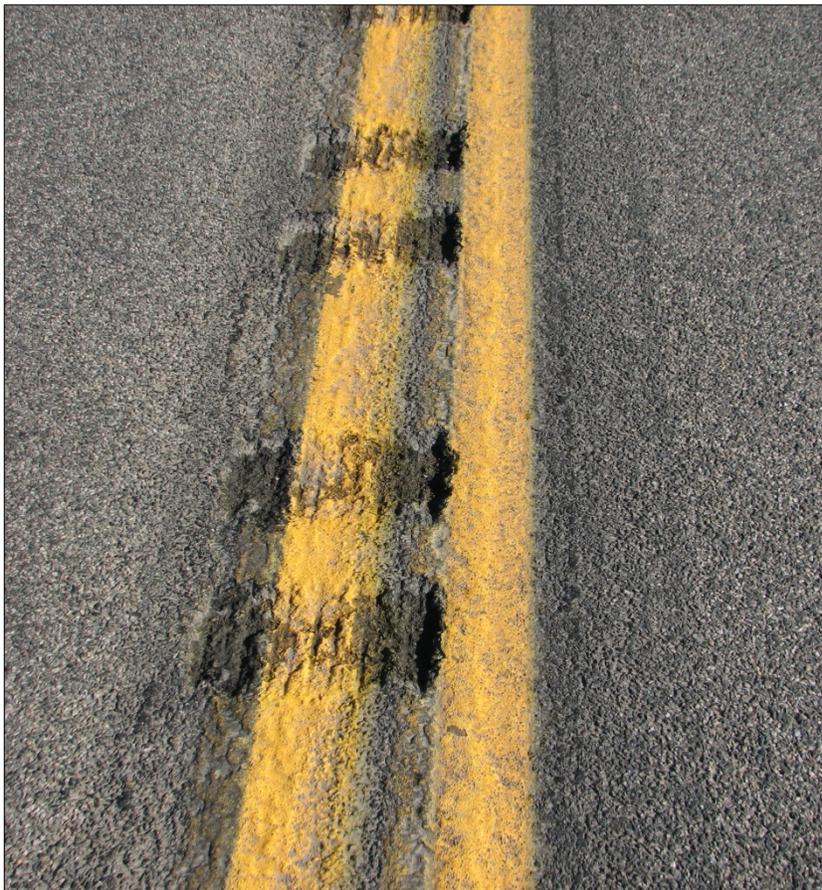
← Representative image (taken in mid-October 2013) of no-passing lane stripes placed over center-line rumble strips (dry condition).

Note that centerline striping did not receive a 60 mil groove treatment.

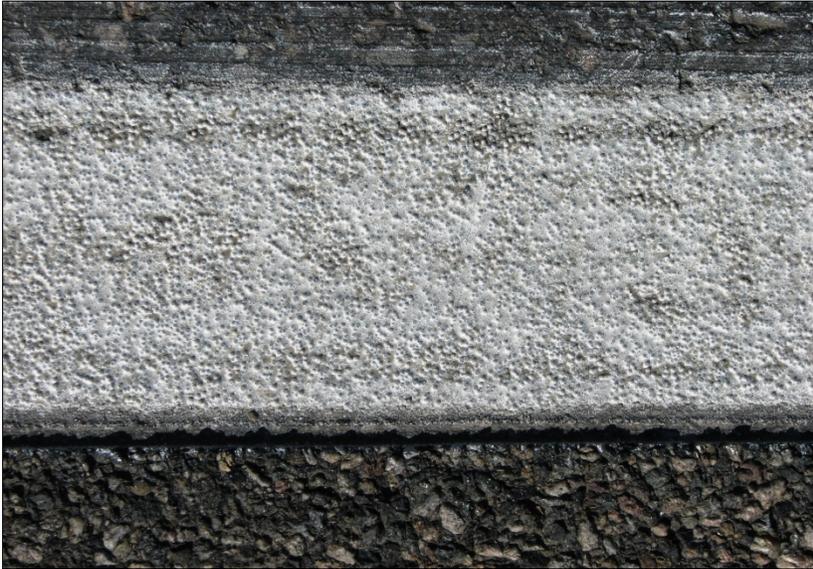
← Close-up of the VISIMAX PLUS white pigmented pavement markings.

Note that (for the most part) the pavement stripe falls well within the parameters of the 60 mil groove; which should aid in the durability of the stripe. This is indicative of all three (3) sections on the project.

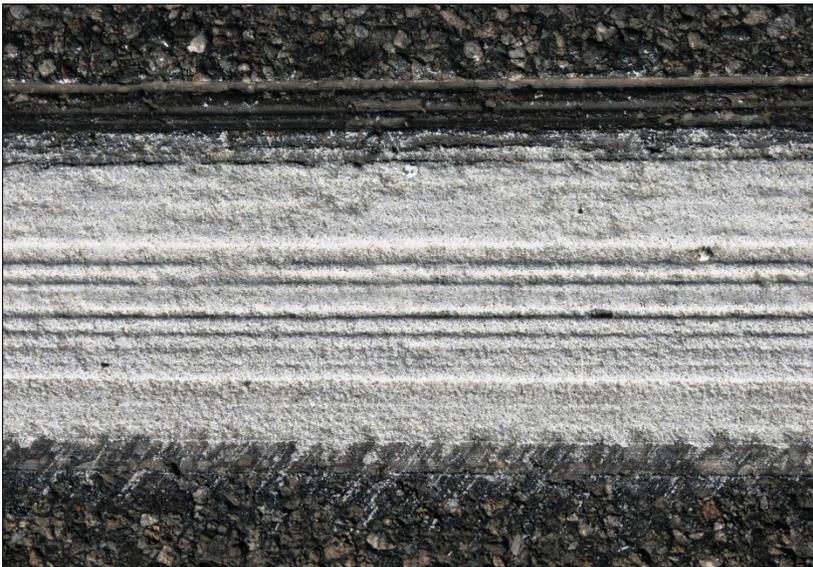
← Close-up of the Control (Type 2) white pigmented pavement markings.

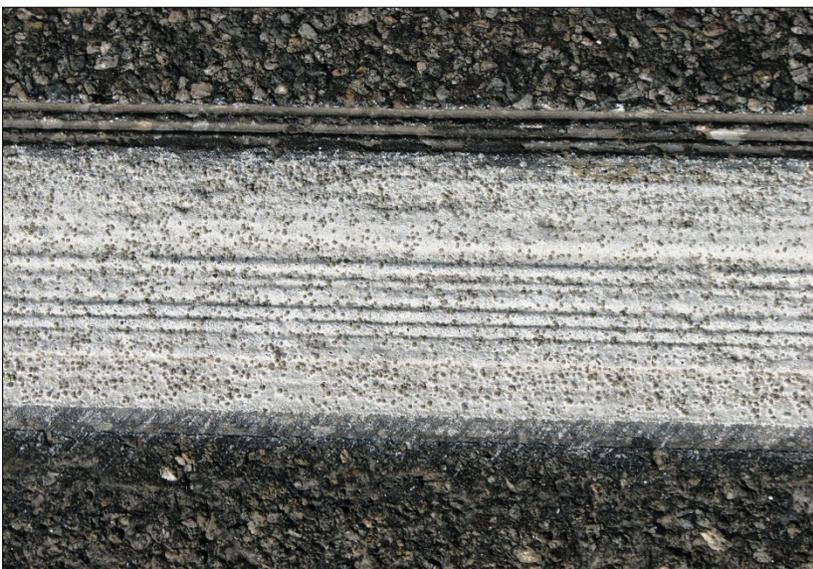
← Close-up of the 3M Wet Reflective Elements white pigmented pavement markings.

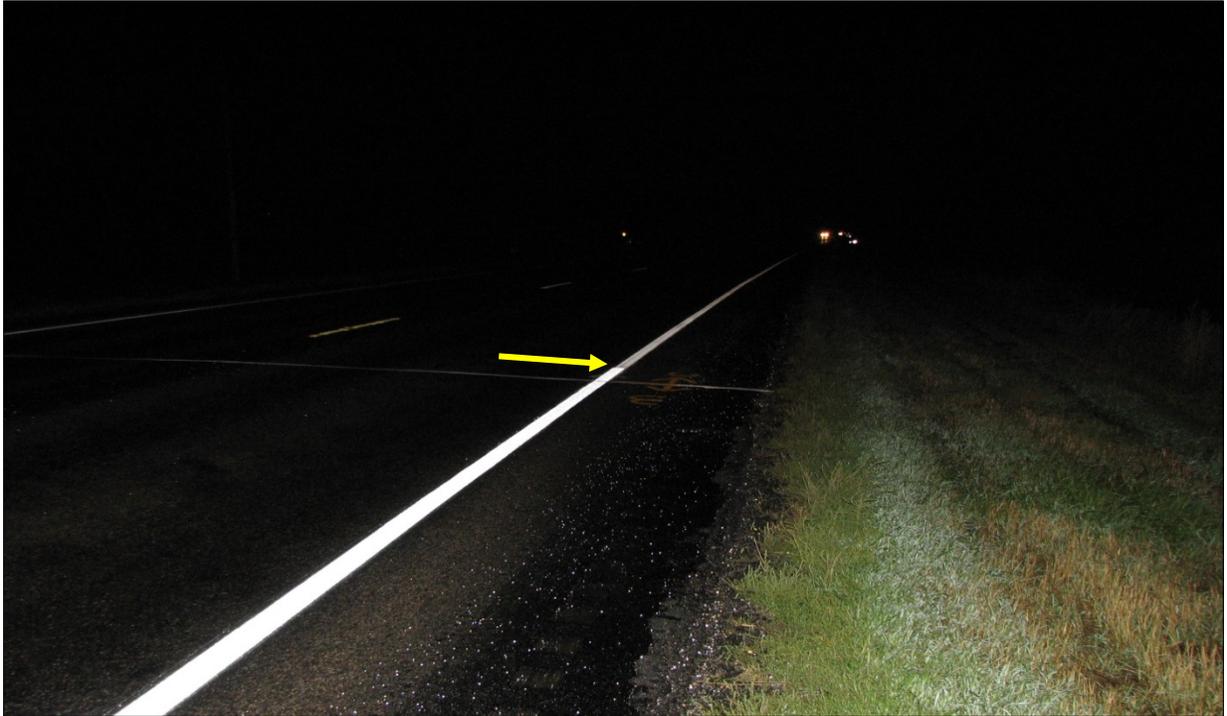
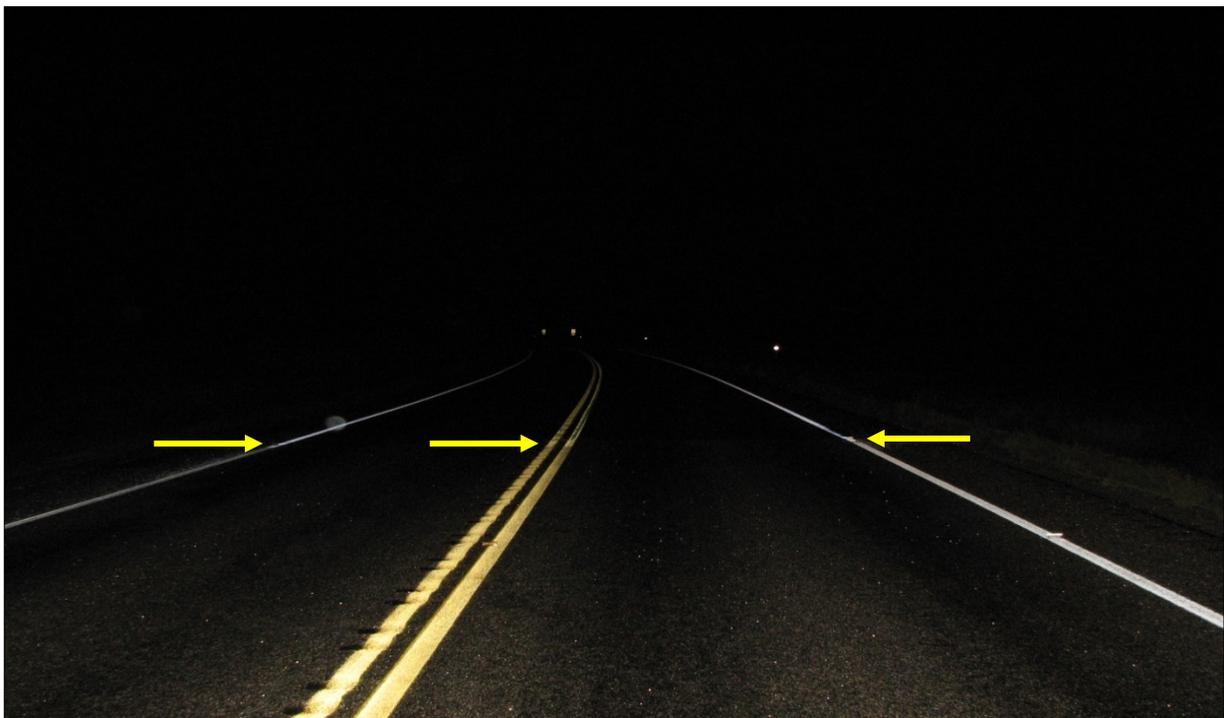
↑ This is the transition of the 3M striping and control section at approximately RP 47 (yellow arrow). It was actively raining at the time. ↓ The image below is the transition of the conventional striping and 3M striping at approximately RP 43.

Although difficult to see in these images; during actual field observation, the difference in luminosity and contrast between the two test sections was apparent as compared to the control in nighttime driving under wet conditions.

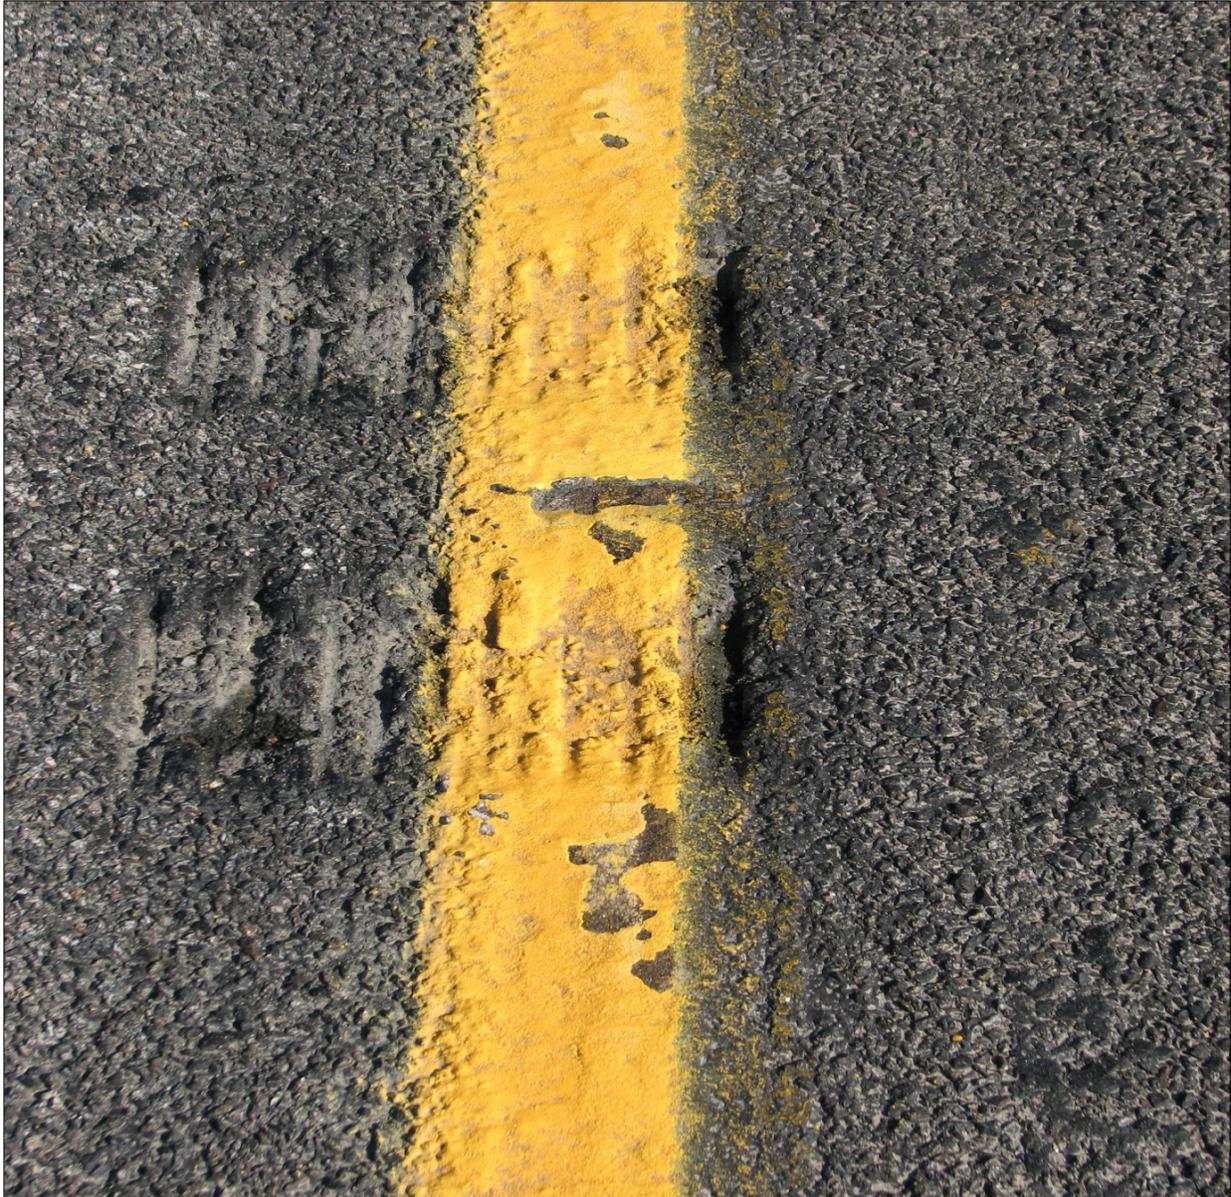
↑ This image taken on October 15, 2013 of the centerline markings is showing distress of debonding of the striping binder to the pavement surface commonly associated with snow plow damage or some other type of metal to binder contact.

District Maintenance staff reported in November they are noticing more of this kind of distress and since it is not in a milled groove is expected to increase over time.

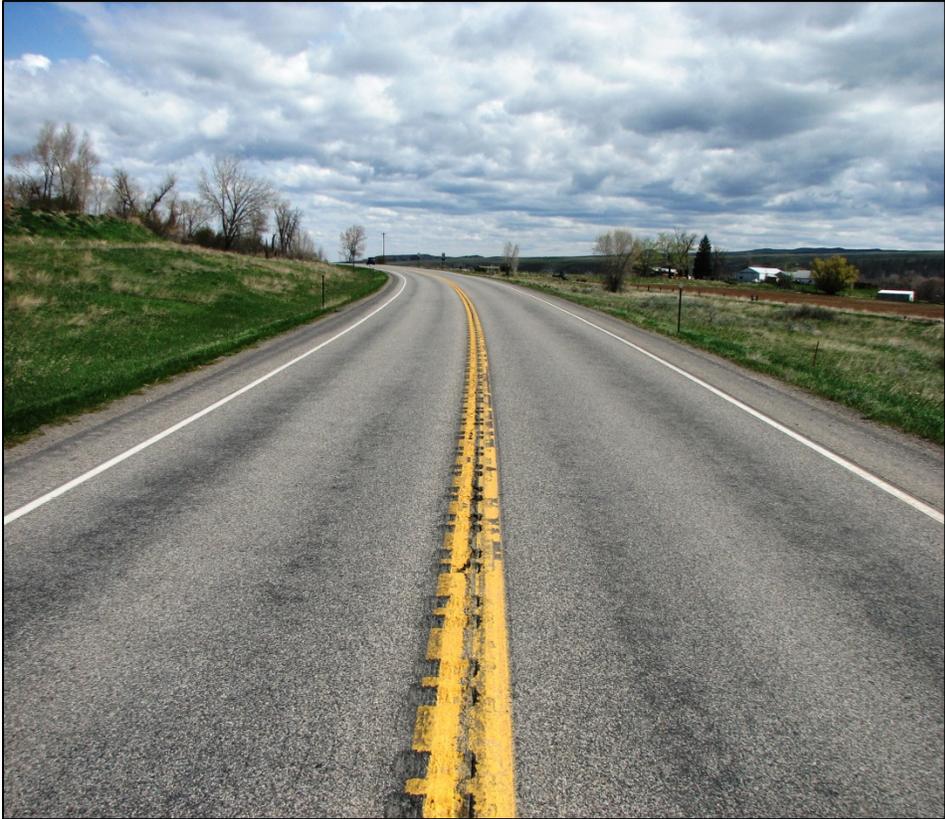
← Beginning of the 3M section at reference point 43; view east.

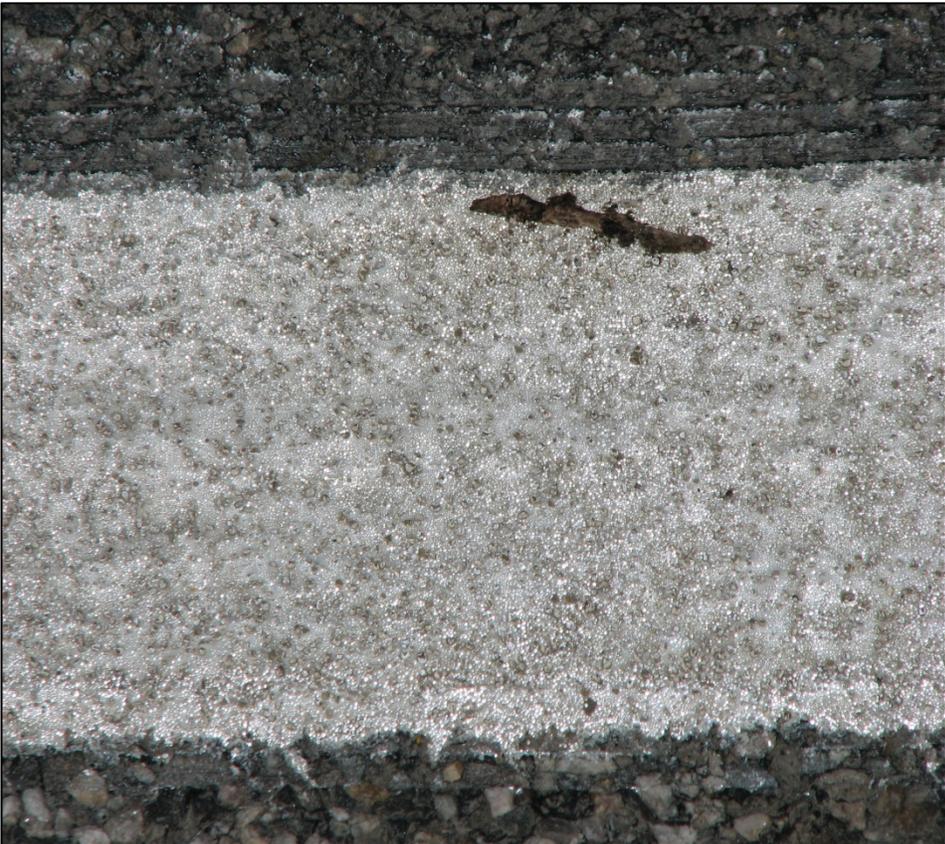
← Close-up of 3M Elements marking.

This image is representative of the overall condition of the stripe on the project.

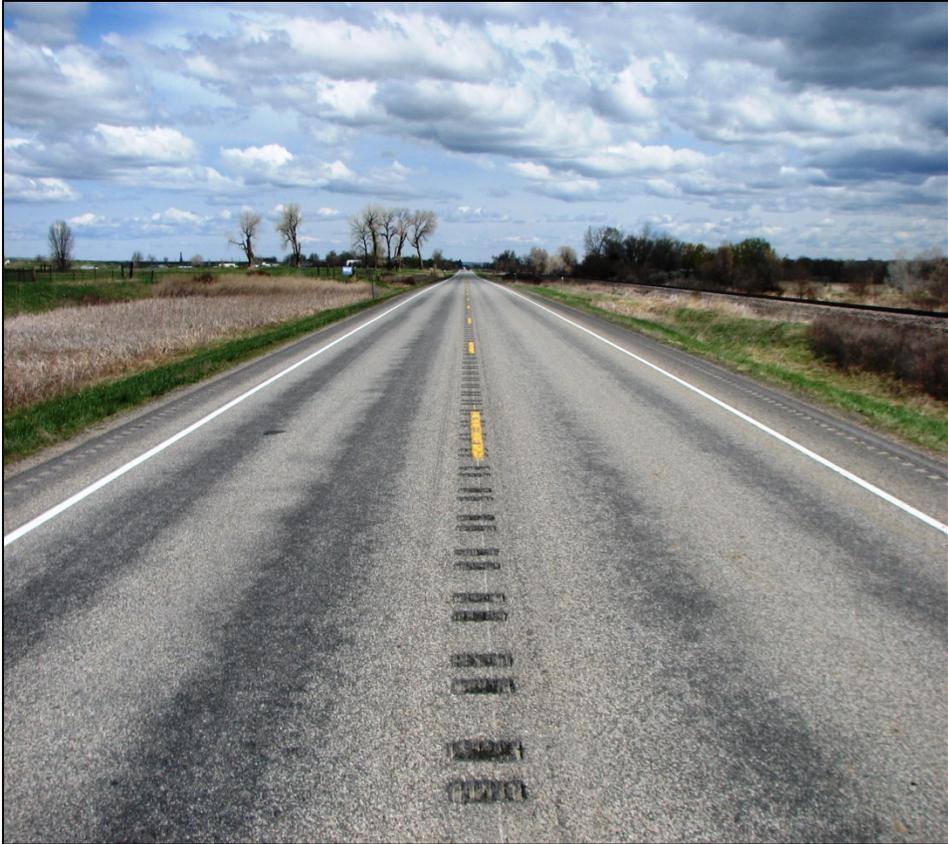
← Beginning of the Visamax section at reference point 49; view east.

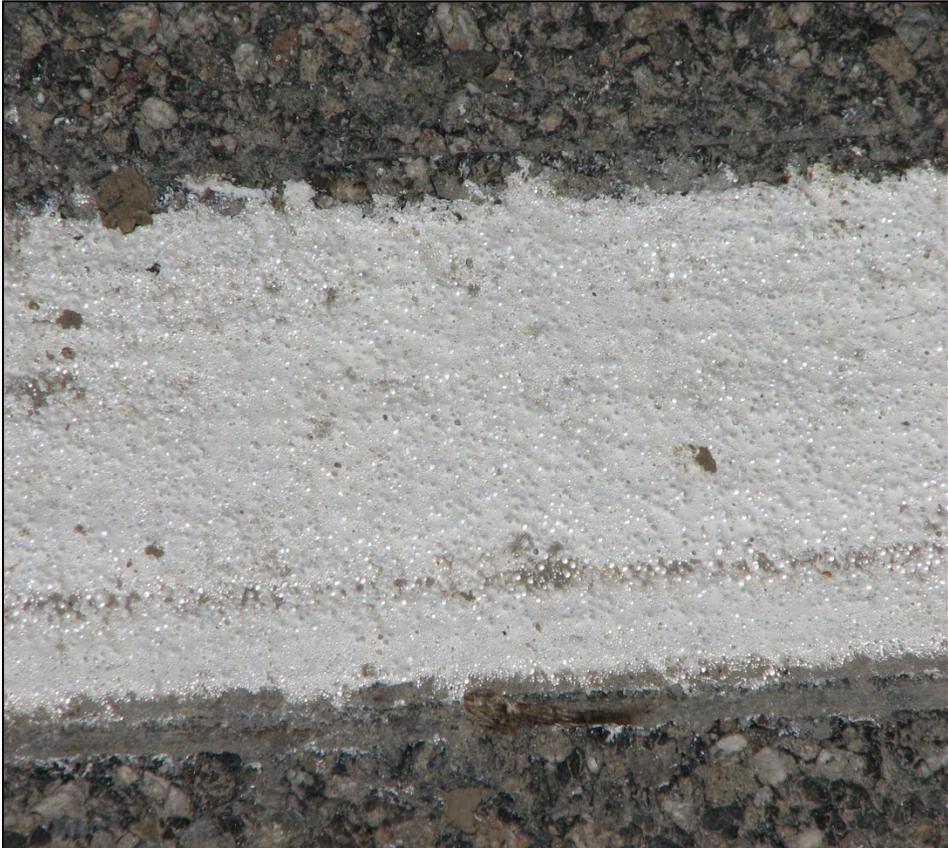
← Close-up of Visamax marking.

This image is representative of the overall condition of the stripe on the project.

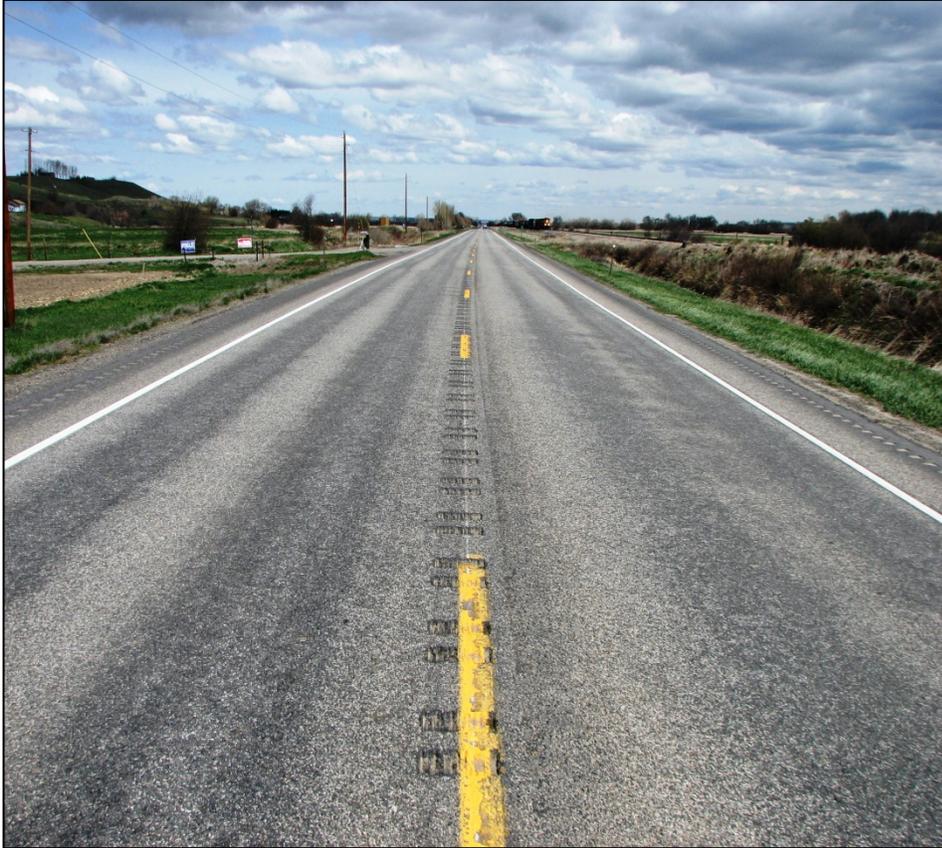
← Beginning of the Type II control section at reference point 47; view east.

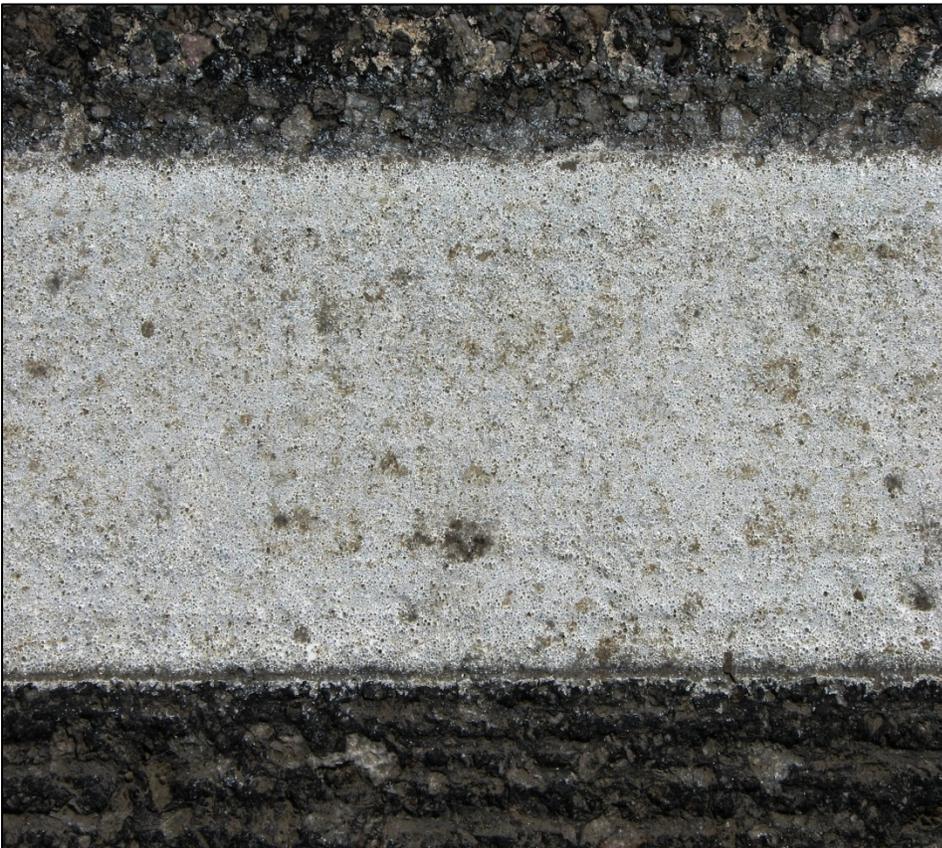
← Close-up of Type II marking.

This image is representative of the overall condition of the stripe on the project.

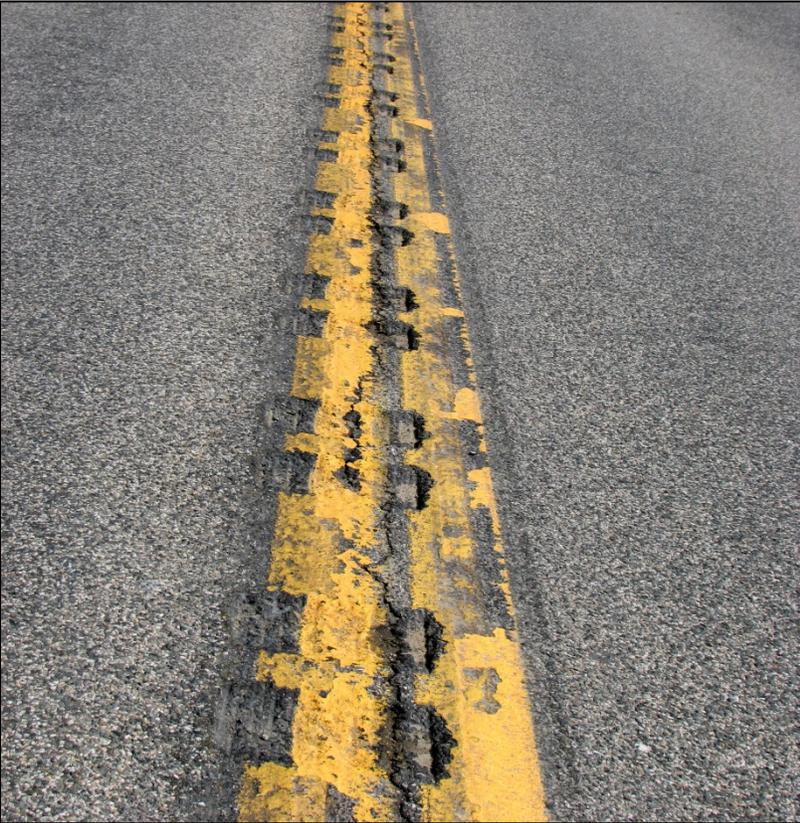
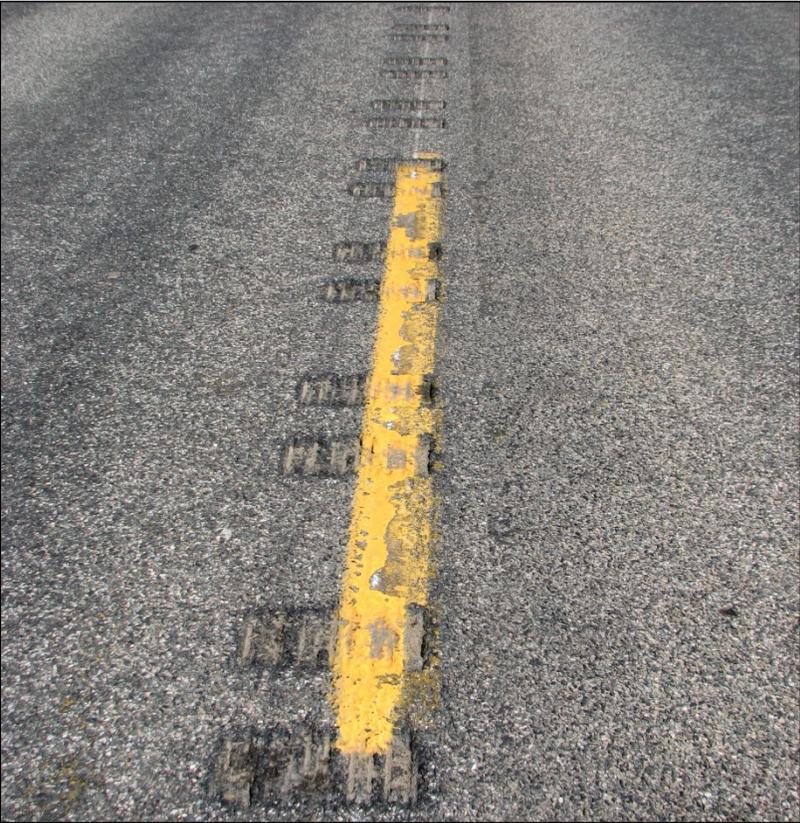
↙↘ Images representative of the general condition of the stripe over rumble strip on the project.

Loss of binder to pavement due to assumed snow plow passes.

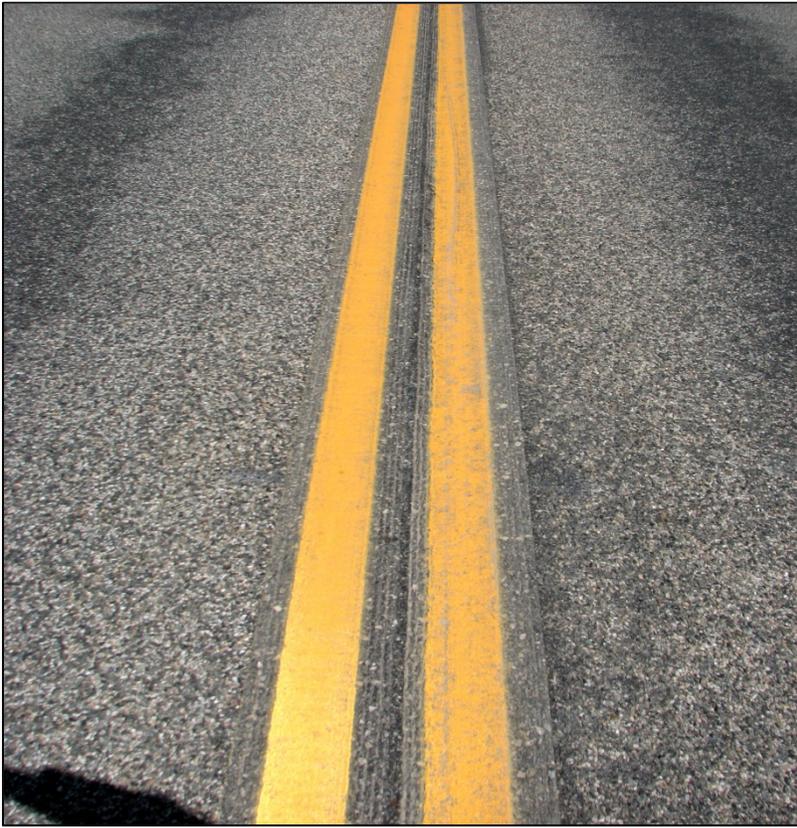
← There was a small linear section of no-passing zone that received a 60 mil grind within the 3M Element section. As seen the stripe is in good condition.

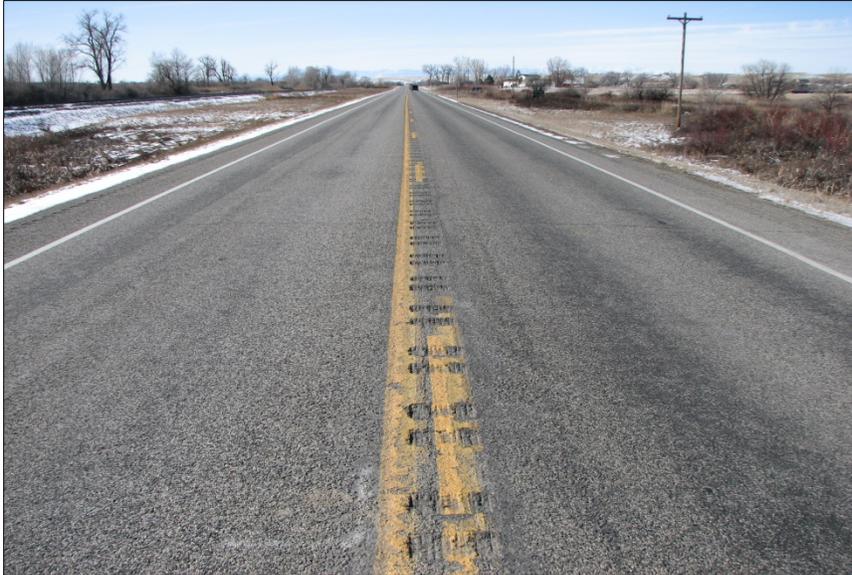
← Overview of 3M Elements section; view west near mile point 47.

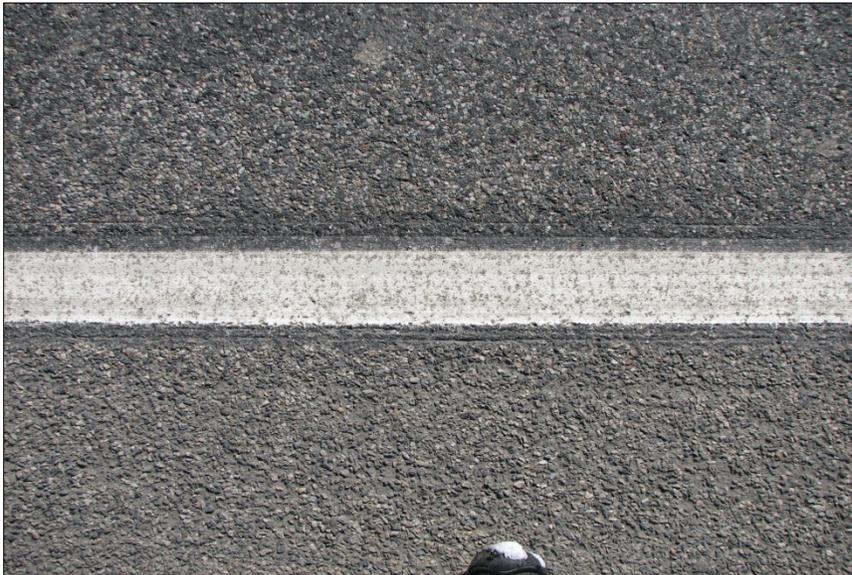
← Close-up of 3M Elements marking.

This image is representative of the overall condition of the stripe on the project.

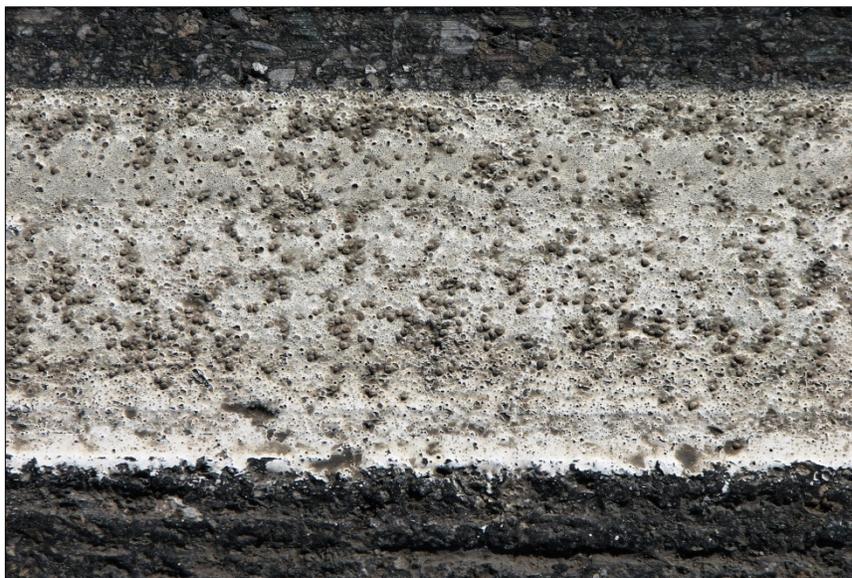
← Additional close-up of 3M Elements marking.

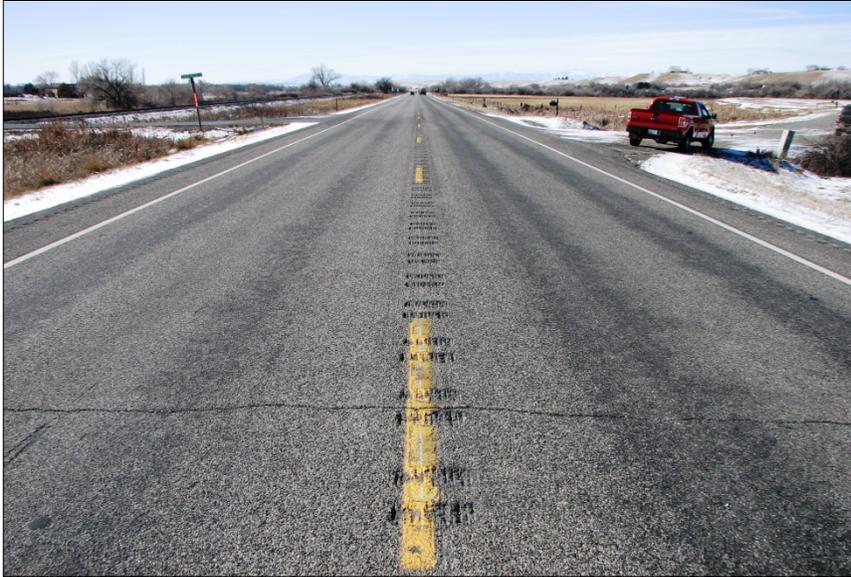
← Overview of Type II Control section; view west near mile point 49.

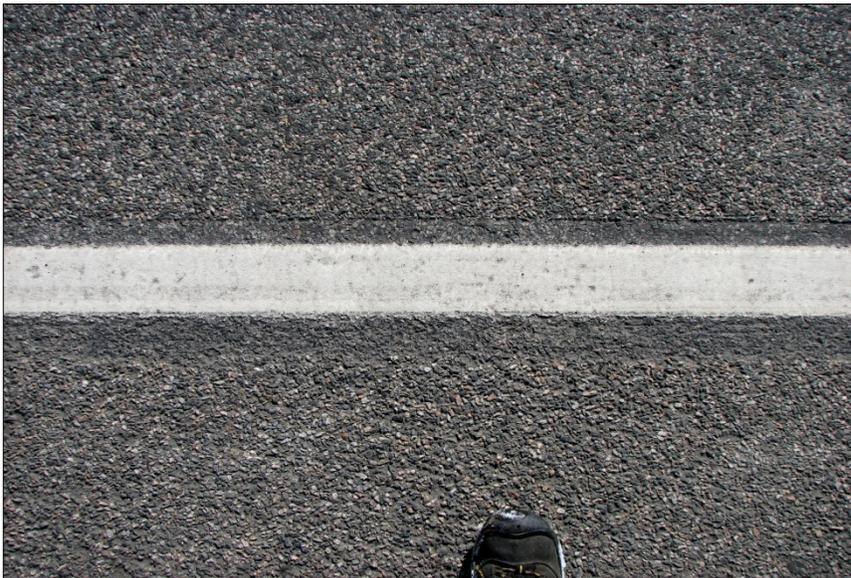
← Close-up of Type II marking.

This image is representative of the overall condition of the stripe on the project.

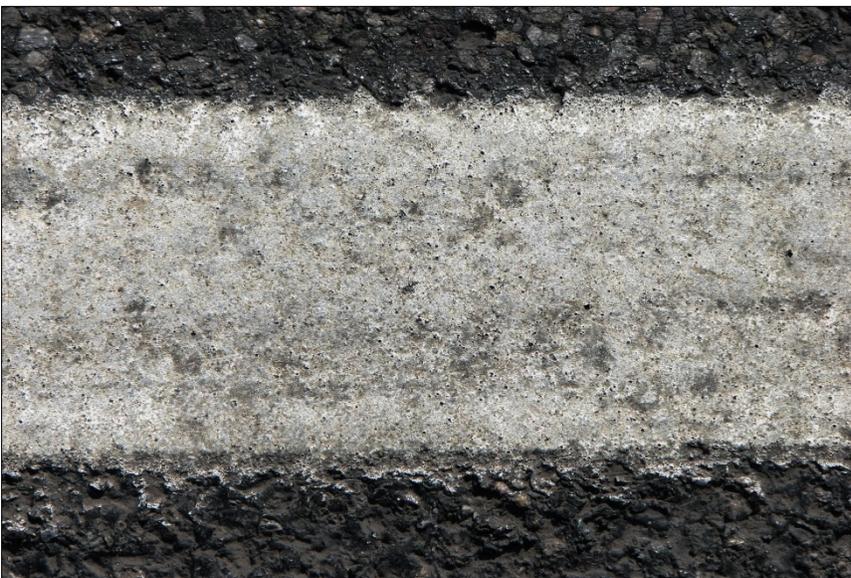
← Additional close-up of Type II marking.

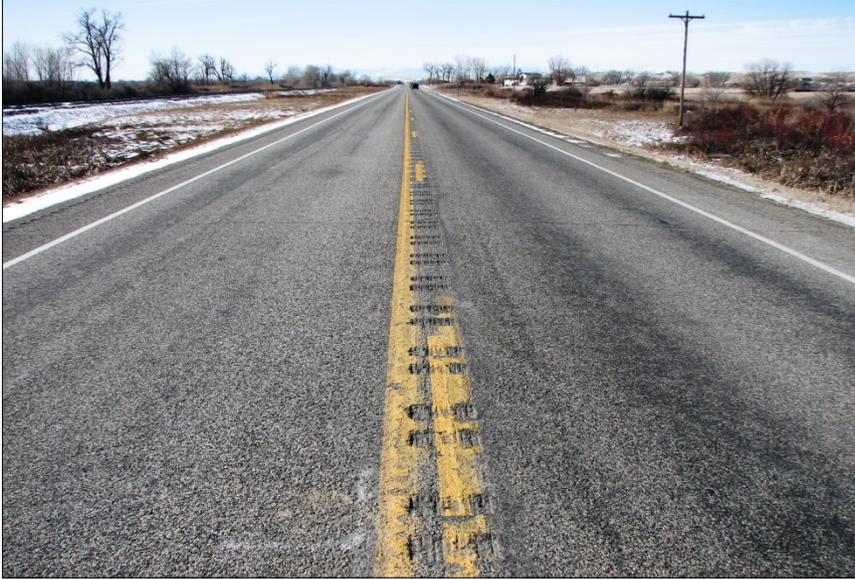
← Overview of VISIMAX PLUS section; view west near mile point 50.

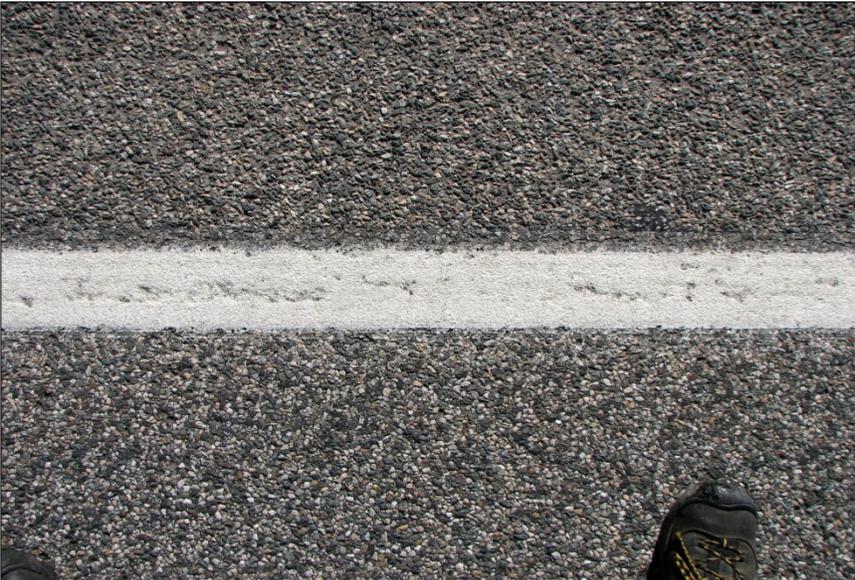
← Close-up of VISIMAX PLUS marking.

This image is representative of the overall condition of the stripe on the project.

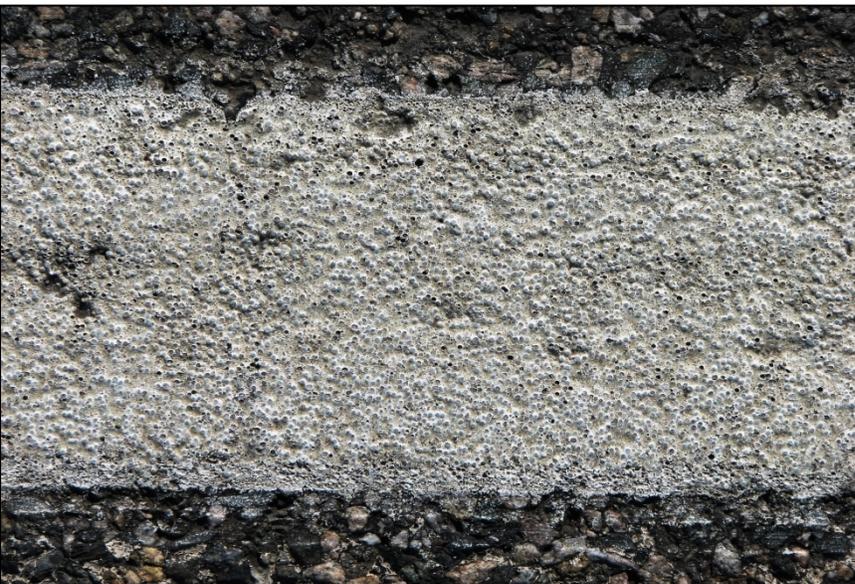
← Additional close-up of VISIMAX PLUS marking.
