EXPERIMENTAL PROJECTS CONSTRUCTION REPORT AND ANNUAL EVALUATION

3M WET REFLECTIVE CERAMIC ELEMENTS AND POTTERS VISIMAX PLUS: NEW BEAD TECHNOLOGY FOR ADDED RETROREFLECTIVITY IN PAVEMENT MARKINGS

Project Name: Rockvale - Laurel

Experimental Project No. MT-12-12

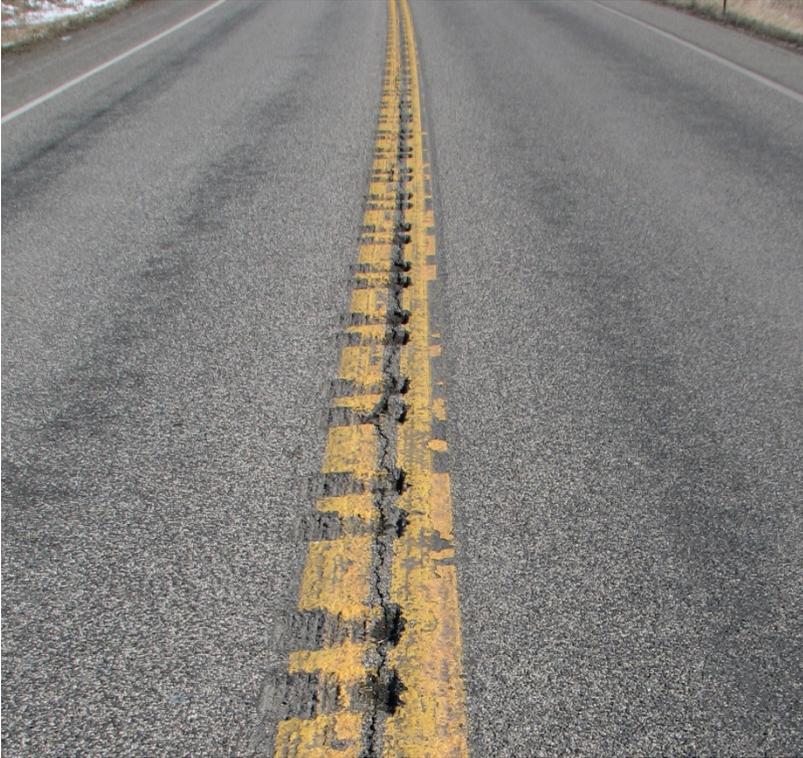
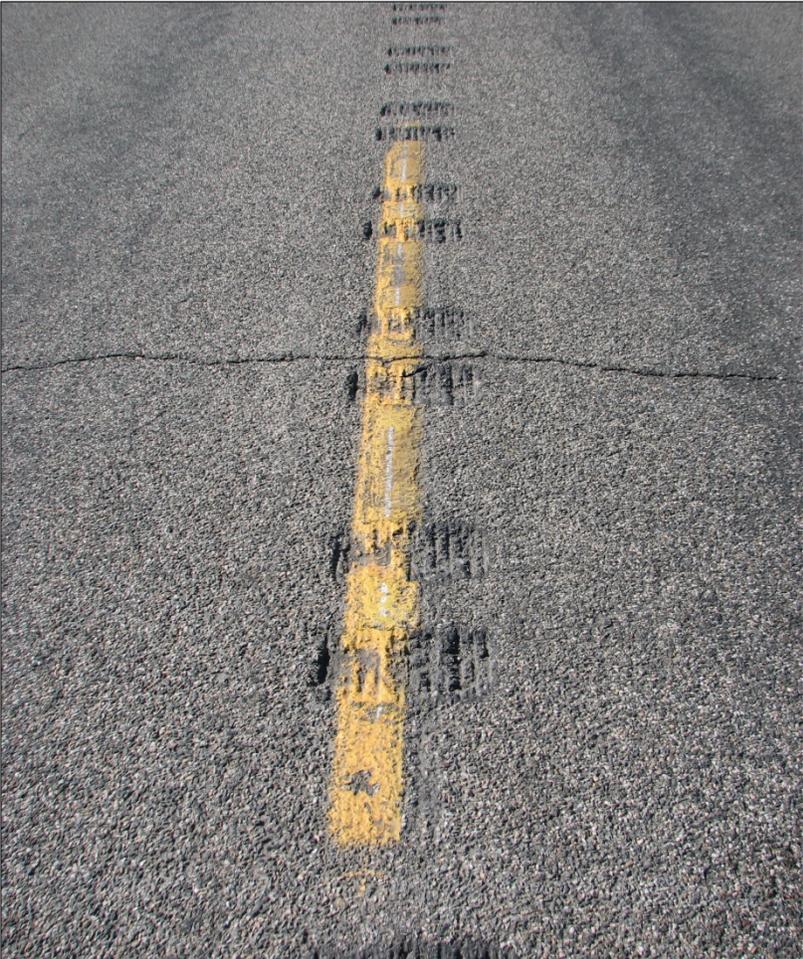
All project test and control sections white lines placed in the 60 mil groove are in good shape with no appreciable visible distress due to environmental factors or from snow plow activities. As predicted the yellow center lines have received distress from snow plows as seen in images contained in this report. Retro readings were conducted in October 2014.

↙↓ Images representative of the general condition of the stripe over rumble strip on the project.
