# MONTANA

## Aviation System Plan - 2009 Update

PAVEMENT CONDITION INDEXES

PREPARED BY  
ROBERT PECCIA & ASSOCIATES  
HELENA, KALISPELL, & BUTTE, MONTANA

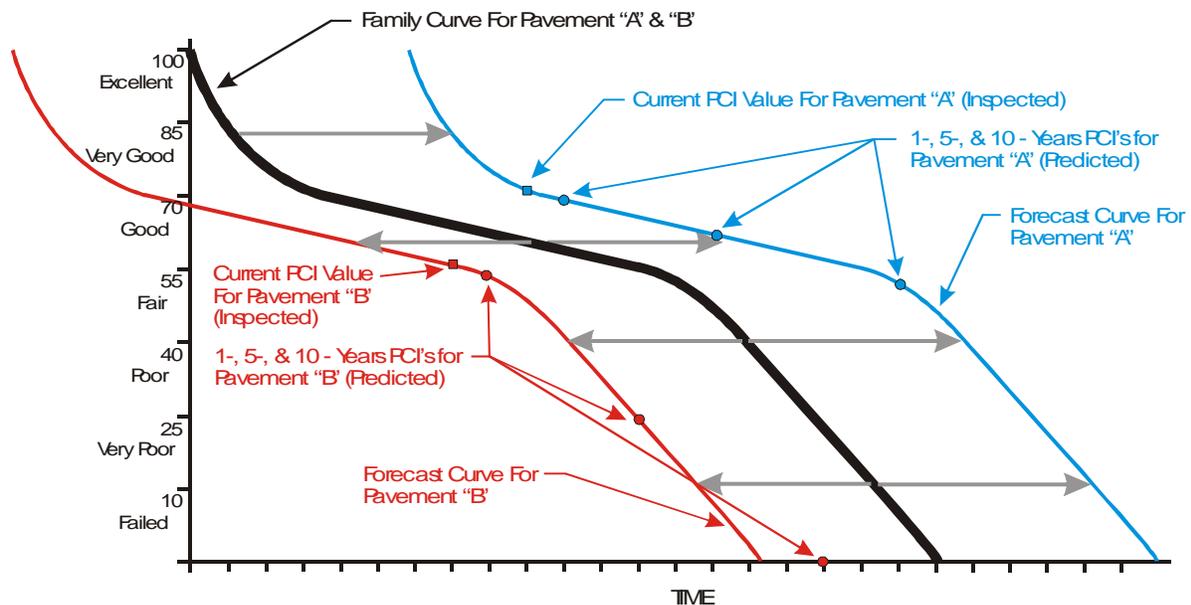
**FIGURE 3.1  
MICROPAVER PCI PREDICTION PROCESS**

Pavement Condition Index values were predicted for one, five, and ten years into the future for all pavements in the database, using the previously discussed pavement families: ACPL, ACAM, ACRML, ACRMU, ACAH, ACRH, STPA, and PCAA. The MicroPAVER software predicts PCI's by taking the last inspected PCI value, finding the corresponding PCI value on the family curve for that pavement, and assuming the particular pavement ages in the same way the family curve declines. Graphically, the family curve is moved *horizontally* until it lies on top of the last inspected PCI-verses-age point, then the family curve is followed forward.

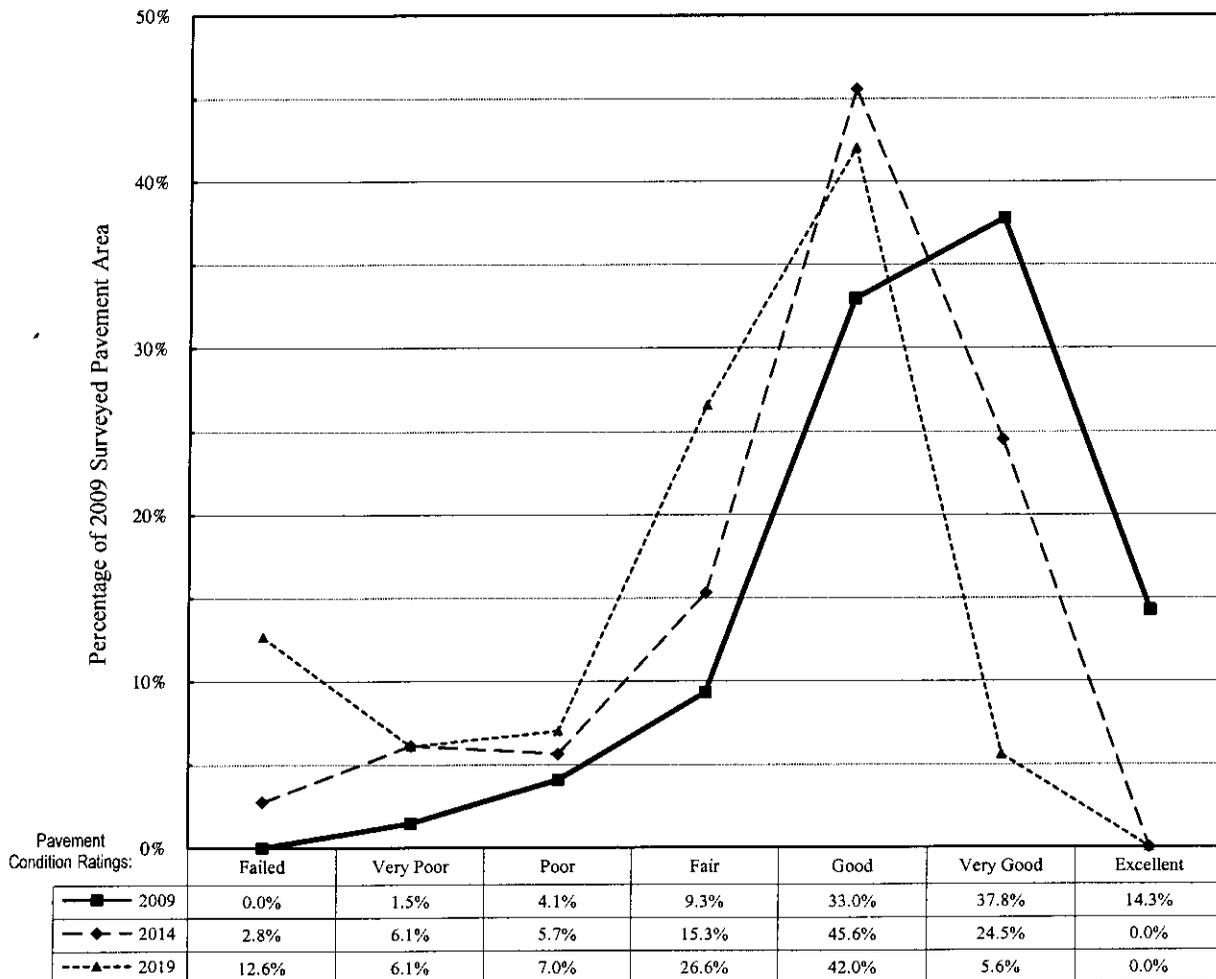
**FIGURE 3.2**  
**SYSTEM-WIDE PAVEMENT CONDITION RATINGS**  
 "No Action" Alternative For Pavements Surveyed in 2009

MicroPAVER uses current PCI values as a starting point on the pavement section’s family curve, then continues down the family curve to project PCI’s in the future. The constrained “best-fit” life cycle curves generated for each family are valid only to the age for which there is survey data, after which they assume a straight-line projection of the curve’s slope (shown with dashed lines on the family curves). An Excel spreadsheet was used to summarize, organize, and enhance the presentation of MicroPAVER-processed information into system-wide pavement condition ratings (Figure 3.2). The Pavement Condition Ratings shown are area-weighted to portray the percentage of 2009-surveyed Montana airport pavement area falling into each rating class. Square footages for each pavement section were accumulated into one of seven Pavement Condition Ratings, based on their inspected or predicted PCI values, and the rating scale shown in Figure 2.2, Step 8. The pavement area in each condition rating was then converted to percentages by dividing by the total 2009-surveyed area. The resulting distribution of Pavement Condition Ratings shown in Figure 3.2 projects a representative aging of all inspected airport pavements given continued maintenance practices, but no major rehabilitation or reconstruction.

The data in Table 3.1 and Figure 3.2 both show unequivocally that if reconstruction programs on Montana airports were suspended or discontinued, airport pavements would degrade to marginal serviceability within about 10 years. While there are many finer points to be gleaned from the graph of system-wide pavement condition ratings (Figure 3.2), splitting the pavement ratings into three groups (below fair, fair, and above fair) will help translate the extensive data set to more comprehensible insights.

Pavements rated as “Fair” are generally in a state of transition on two fronts: surface defects are beginning to be noticeable in both type and frequency, and the expense of reconstruction is becoming more economical than continued preventative maintenance. While surface distresses indicating deterioration of the pavement/base course system are visible, they are subtle enough to not have major effects on ride quality nor are they generating significant foreign object debris (FOD). Studies continue to indicate that reconstruction of “good” to “fair” quality asphalt surfacing is more economical than waiting until major distresses appear. While it may seem counterintuitive to reconstruct good-looking pavement, reconstruction before the gravel base deteriorates is much less expensive. The area of transitional pavements in the absence of reconstruction is projected to escalate from 9% to 15% to 27% in the years 2009, 2014, and 2019, respectively.

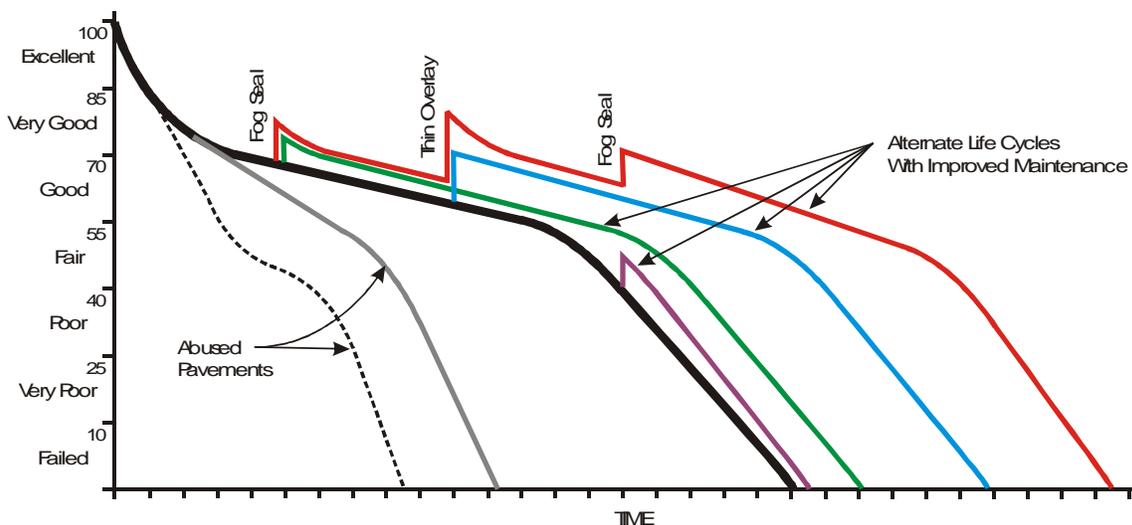
**FIGURE 3.3  
EXTENDED PAVEMENT LIFE CYCLE**

All of the results obtained from this analysis are affected by maintenance practices. In general, improved maintenance raises all points of the curve, produces a “bump up” in quality, and/or extends the “flat” portion of the pavement life cycle, providing a longer usable pavement life before dropping off at the critical condition. Figure 3.3 revisits the pavement life cycle curve from Figure 2.12 showing the benefits of improved maintenance practices. While occasional maintenance extends pavement life, regular preventative maintenance clearly extends the usable life of pavement well beyond its non-maintained expected usable life. Most pavements around the State are already benefitting from recent increases in federal airport funding and improved maintenance policies. Families have more data scatter than previous years, due in large part to new maintenance policies mixed with the old data. Future analyses may be able to quantify these effects by studying maintenance practices more closely along with the PCI evaluations, and redefining pavement families to account for maintenance practices.

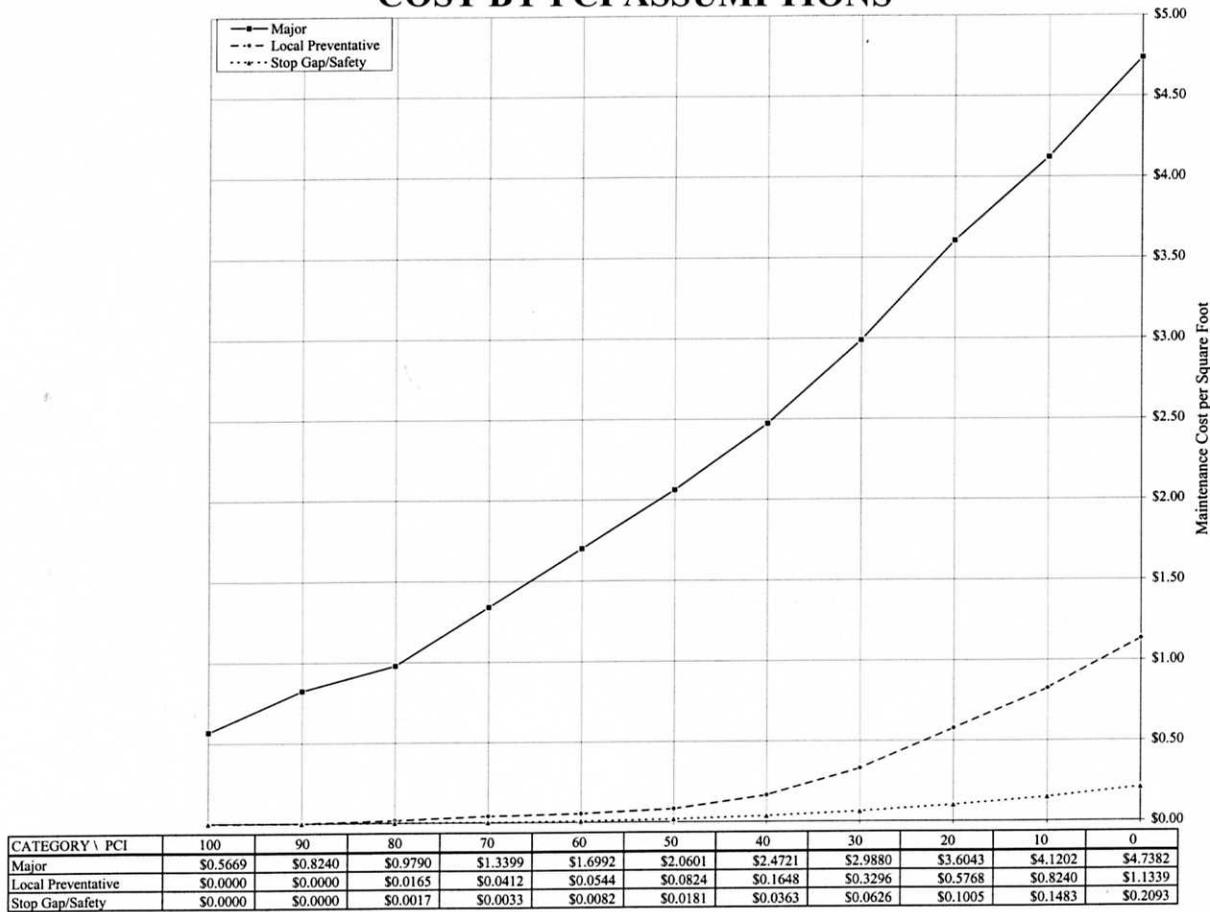
**FIGURE 3.4**  
**COST BY PCI ASSUMPTIONS**

indicate structural failure even above the critical PCI. The “Major Under-Critical” case of Major M&R assumes that the critical PCI was chosen such that reconstruction is a more economical option than continued maintenance once a section has passed below its critical PCI. While it is very rare, structural failure of parts of a section (like a culvert crossing of a runway settling) may produce an unusable pavement with a PCI rating above critical. This “Major Above-Critical” special case can only be treated effectively by reestablishing a sound foundation for the surface layer, hence its inclusion in the Major M&R policy.

The Limited to Budget Report is an hybrid report which makes the best use of detailed inspection data for short-range predictions then switches to a more general, empirically verified long-range scheme. The first year predictions are based on a Consequence Model Report plus Global and Major repair options, while successive years use the same costs (see Figure 3.6) as the Minimum Condition Report. First year predictions of costs for local maintenance and conditions are determined from Localized Safety and Localized Preventative Maintenance Policies (Table 3.5) and their associated cost and consequence tables (Tables 3.6 and 3.7). In succeeding years, both Localized Safety and Preventative Maintenance costs are determined from the Cost by PCI table illustrated in Figure 3.4. Global M&R always takes its costs and consequences from user-defined values irrespective of pavement PCI’s (see Table 3.8). In other words fog seals will have the same cost and useful life regardless of the quality of pavement they’re applied to. Major Rehabilitation costs for all projection years are used from the Cost by PCI table in Figure 3.4.

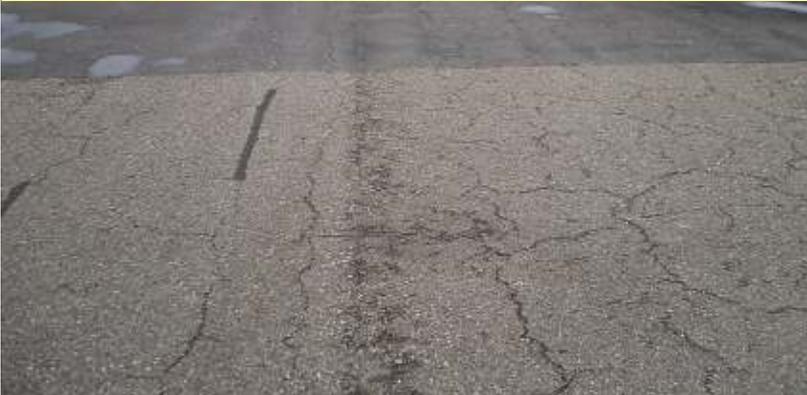
**Light** Fine parallel hairline cracks with few or no interconnecting cracks. No spalling.  
Repair: Do nothing / SurfaceSeal / Overlay

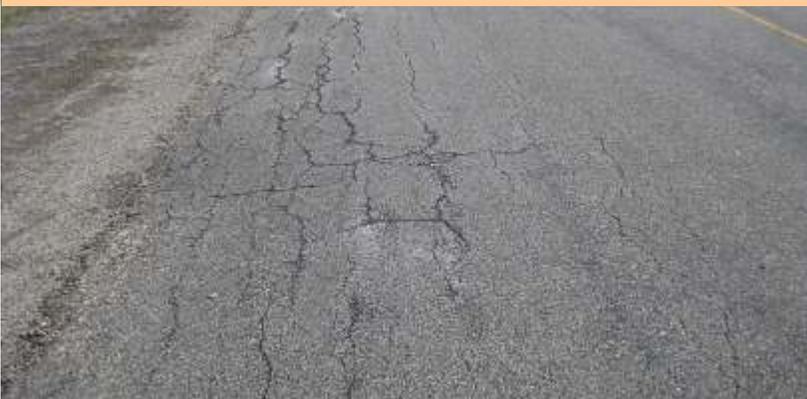
**Medium** Pattern or network of cracks that may be lightly spalled.  
Repair: Partial or full depth patch / Overlay / Reconstruct

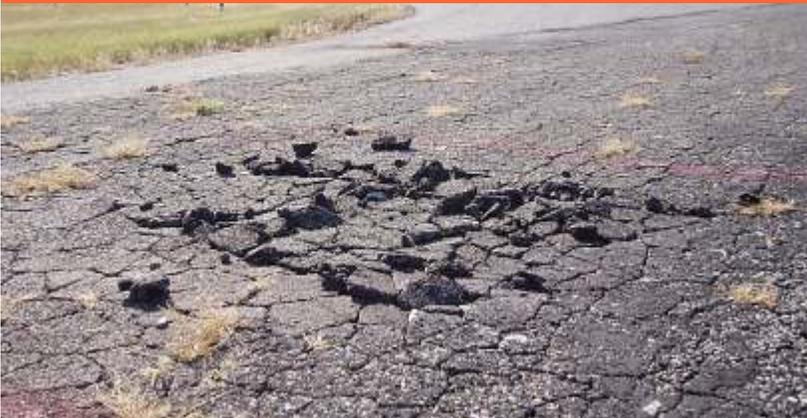
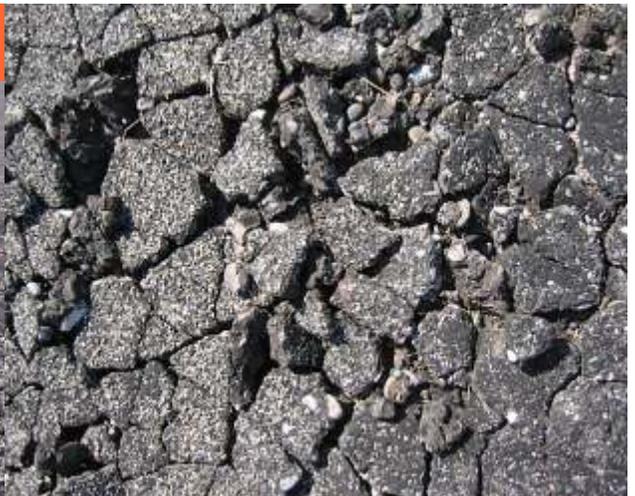
**High** Pattern or network of cracks with well-defined pieces and spalled edges  
Repair: Partial or full depth patch / Overlay / Reconstruct

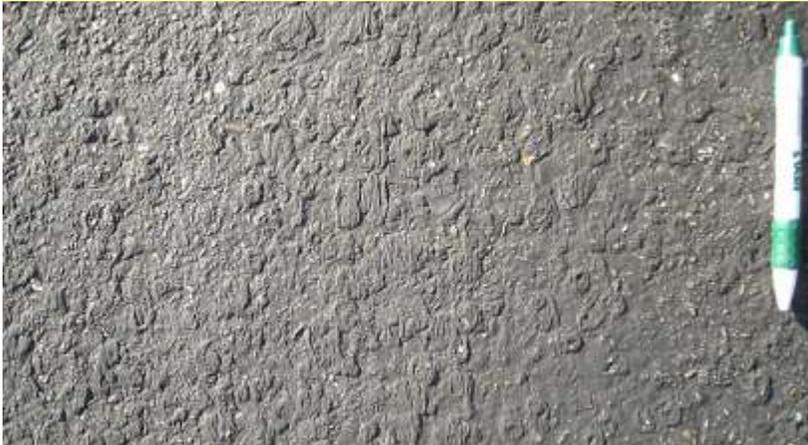
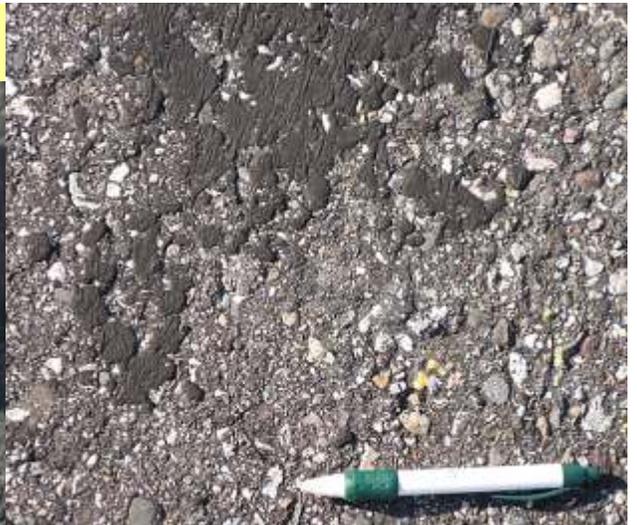
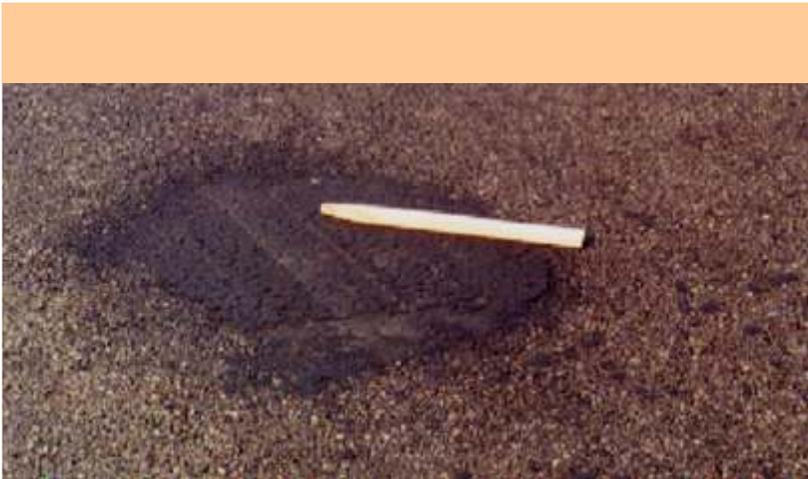
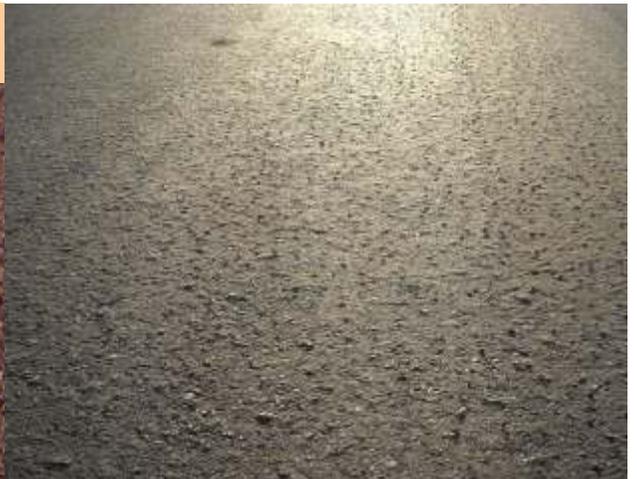
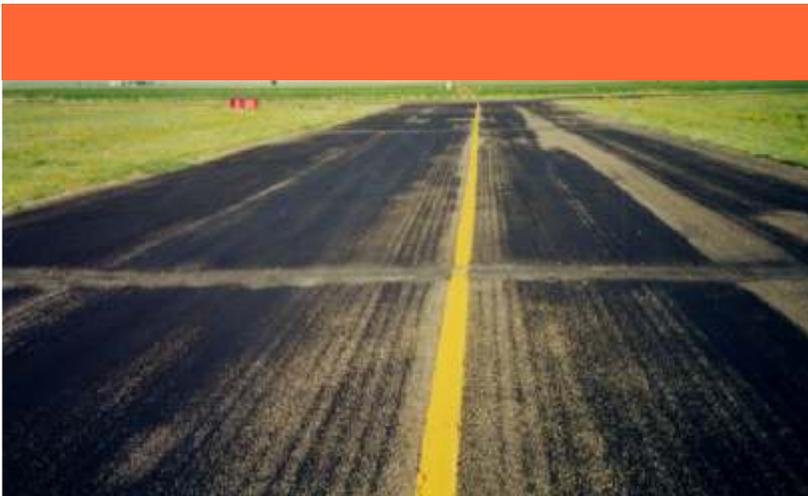
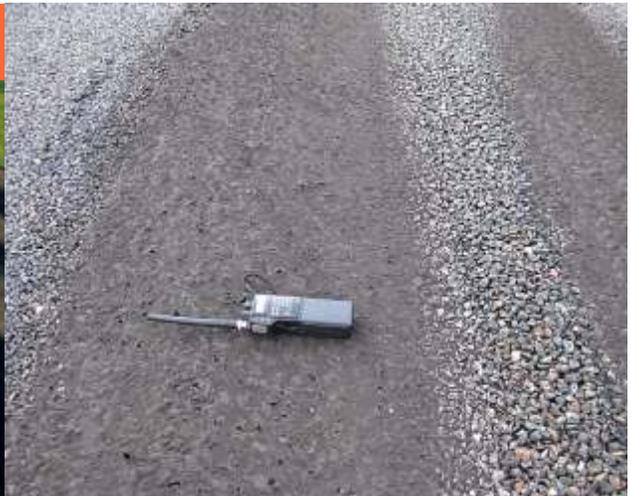
Extensive enough to cause reduced skid resistance.  
Repair: Do Nothing / Heat, Sand & Sweep

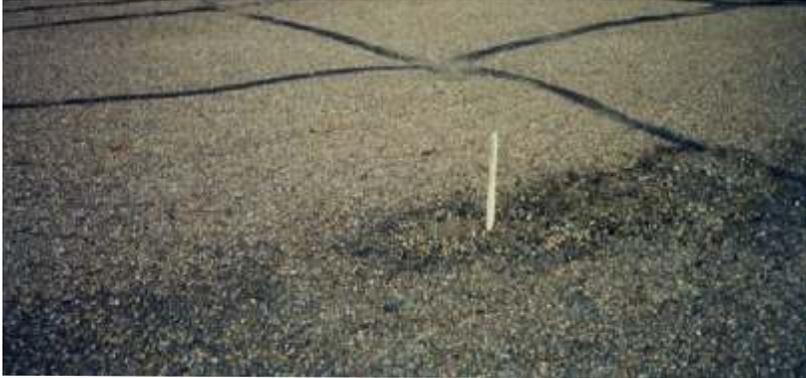
## Light

Non- or only lightly-spalled Blocks with no foreign object damage/debris (FOD) potential. Nonfilled cracks have ¼ inch or less mean width and filled cracks have filler in satisfactory condition. Repair: Do nothing / Apply rejuvenator

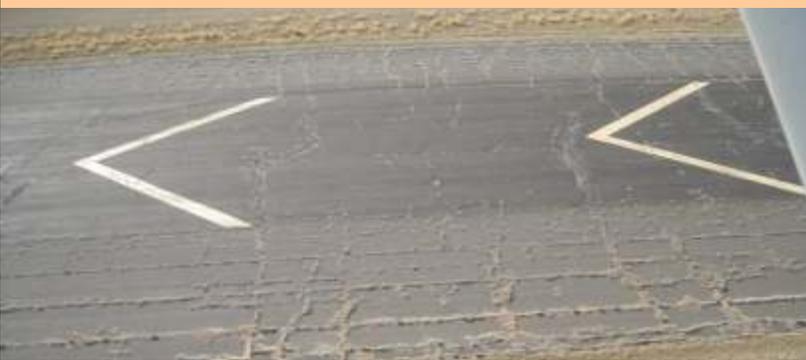
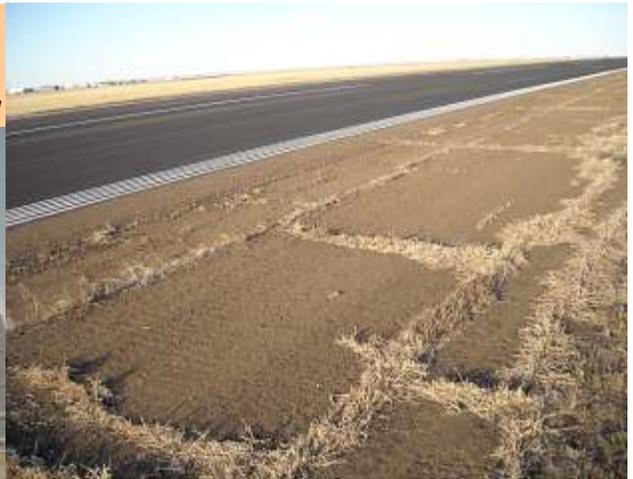
## Medium

\* filled or nonfilled cracks that are moderately spalled  
\* nonfilled cracks with mean width greater than approximately ¼ inch  
\* filled medium cracks with failed sealant  
Repair: Seal cracks / Apply rejuvenator / Recycle surface / Heater scarify & overlay

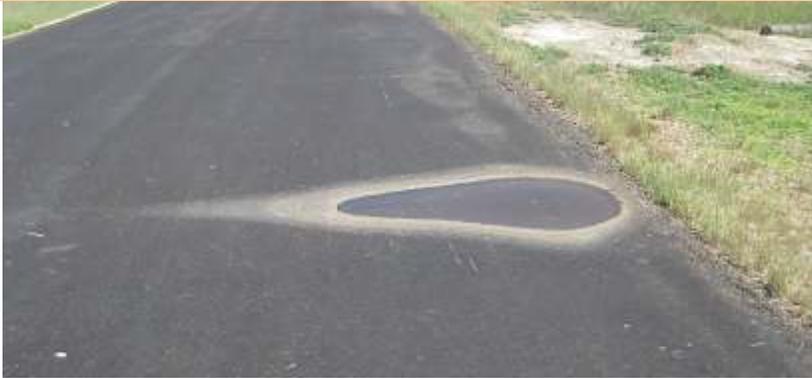
**Medium** Mean Depth: Runways/Taxiways: >1/2-1 inch  
Apron: >1-2 inches  
Repair: Partial or full depth patch.

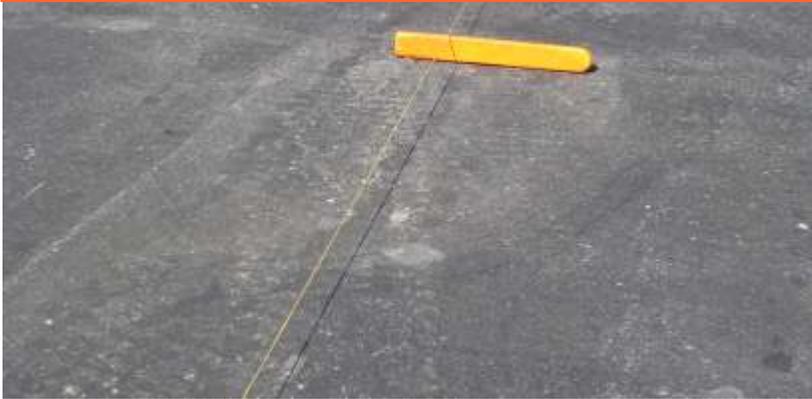
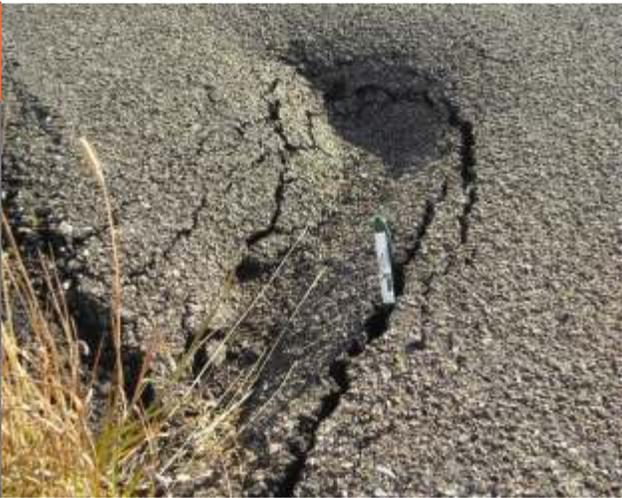
**High** Mean Depth: Runways/Taxiways: >1 inch  
Apron: >2 inches  
Repair: Partial or full depth patch

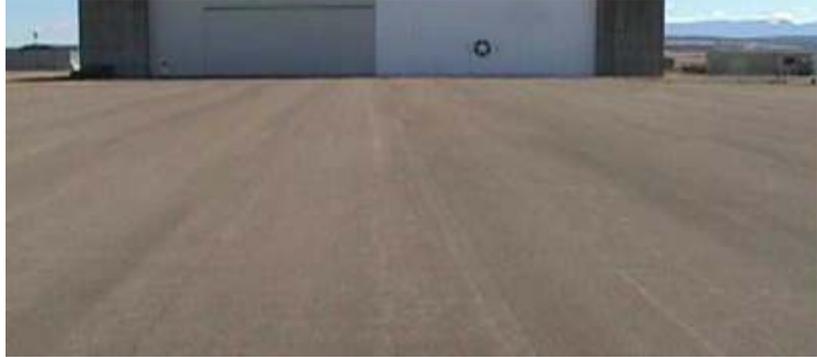
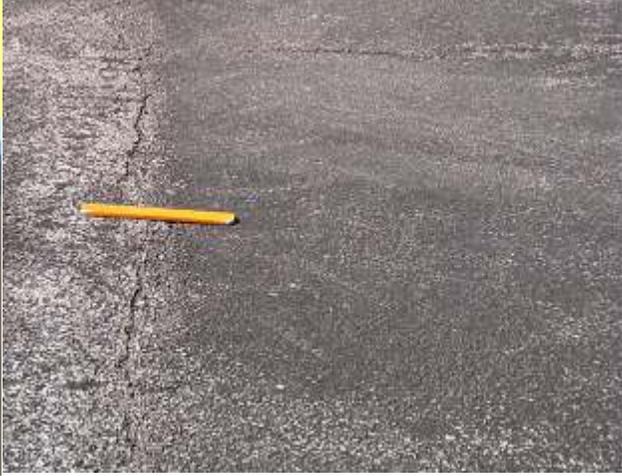
- Filled or nonfilled cracks have light or no spalling.
- Nonfilled cracks have a mean width of ¼ inch or less.
- Filled cracks are of any width, but with filler material in satisfactory condition.

Repair: Do nothing / Seal cracks over 1/8 inch

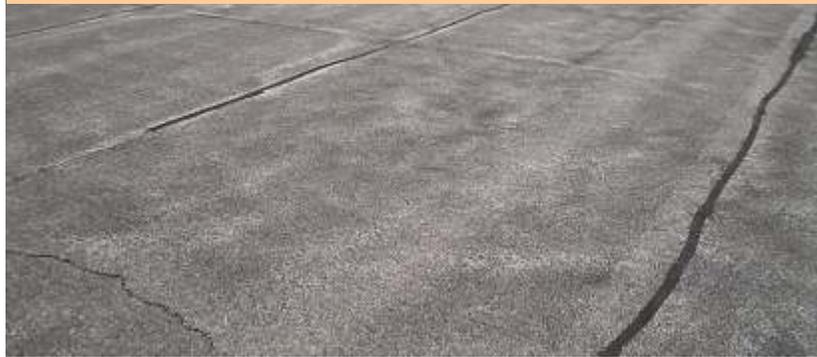
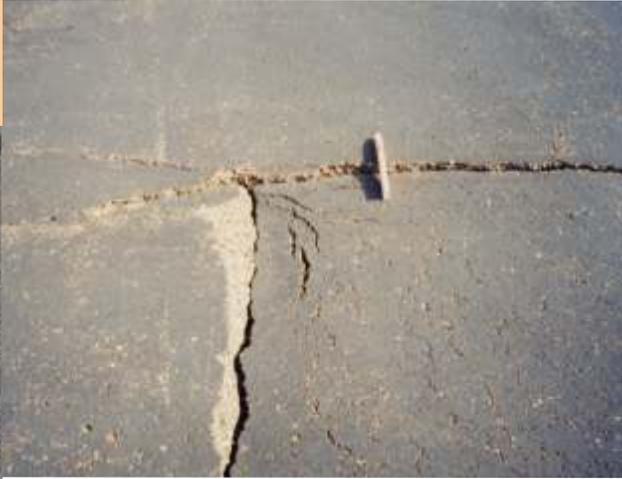
**Medium**

- Filled or nonfilled cracks are moderately spalled.
- Filled cracks are not spalled or are only lightly spalled but with failed filler.
- Nonfilled cracks have mean crack width greater than ¼ inch with light/no spalling.

Repair: Seal cracks / Partial depth patch

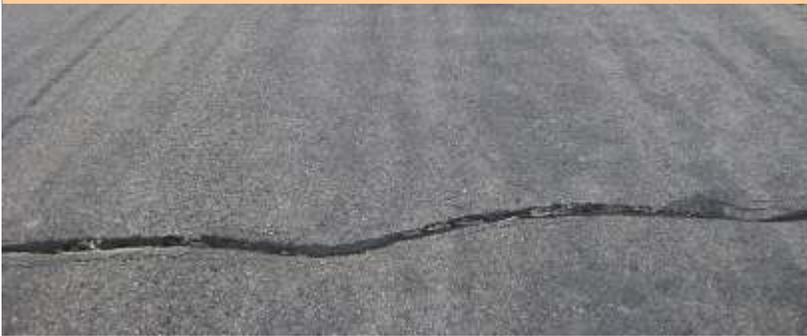
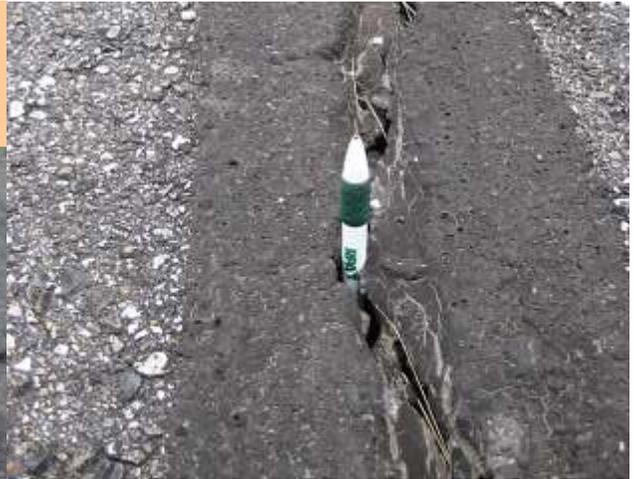
## Medium

- Nonfilled cracks have mean crack width greater than 1/4 inch possibly with light spalling.
  - Filled or non filled cracks are moderately spalled (some FOD potential).
  - Filled cracks have failed sealant with possible light spalling.
- Repair: Seal cracks

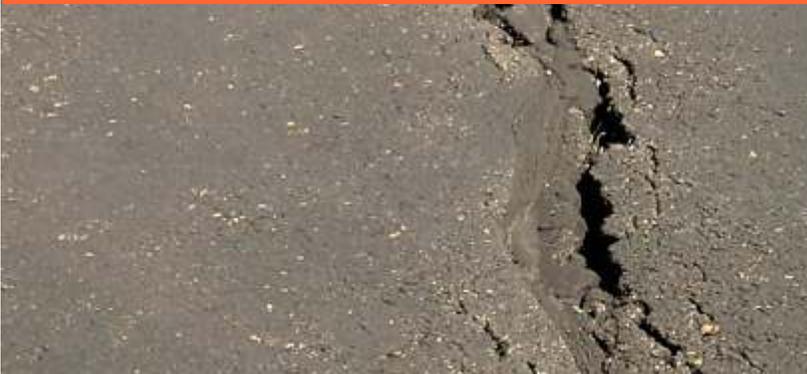
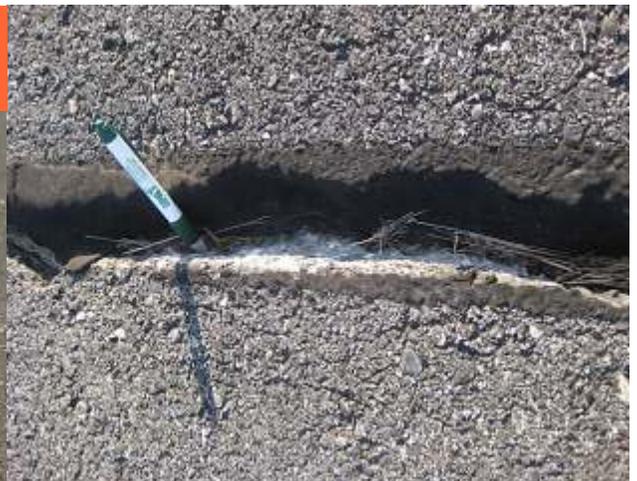
## High

- Cracks are severely spalled, causing definite FOD potential. They're usually greater than 1 inch wide.
- Repair: Seal cracks; Partial depth patch

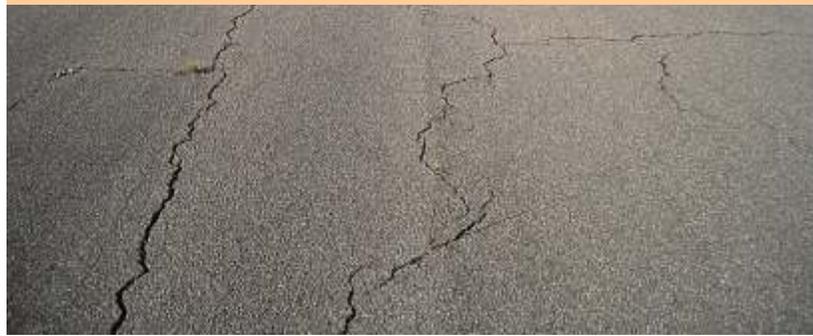
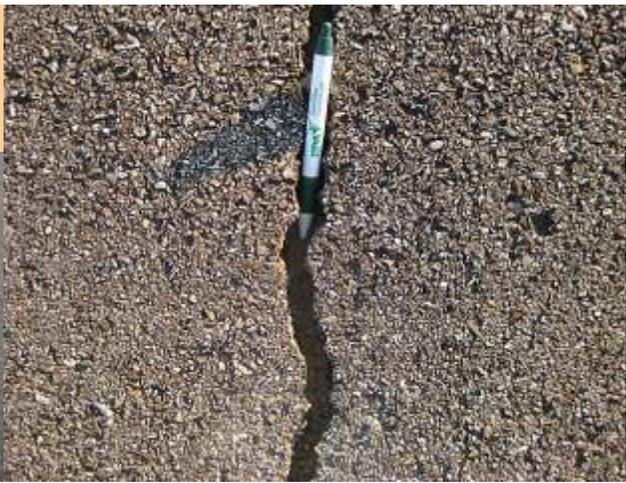
**Medium**

- Nonfilled cracks have mean crack width greater than 1/4 inch possibly with light spalling.
- Filled or non filled cracks are moderately spalled (some FOD potential).
- Filled cracks have failed sealant with possible light spalling.

Repair: Seal cracks

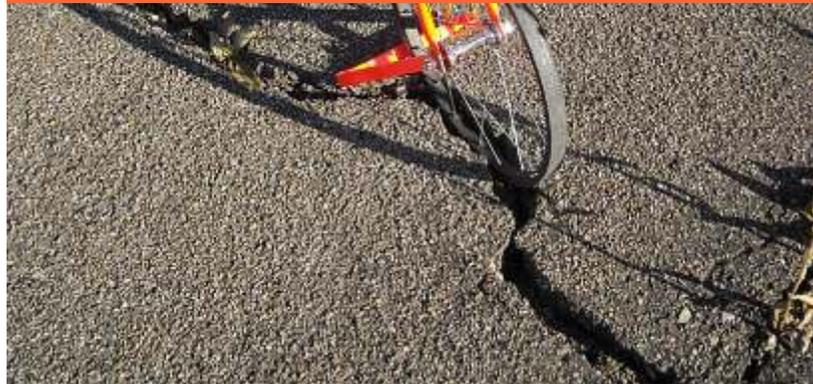
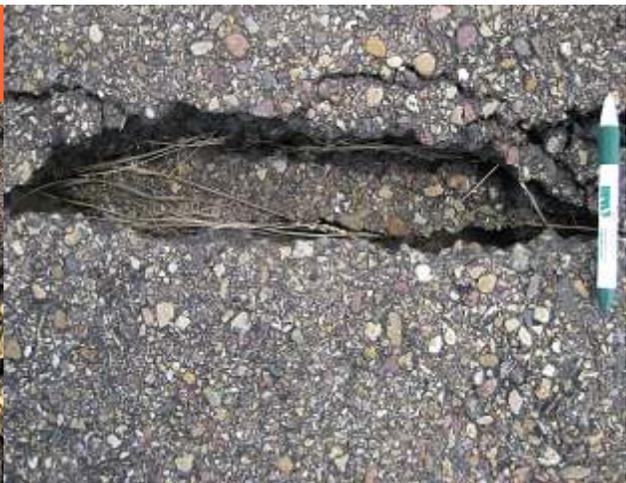
**High**

Cracks are severely spalled, causing definite FOD potential. They're usually greater than 1 inch wide.

Repair: Seal cracks; Partial depth patch

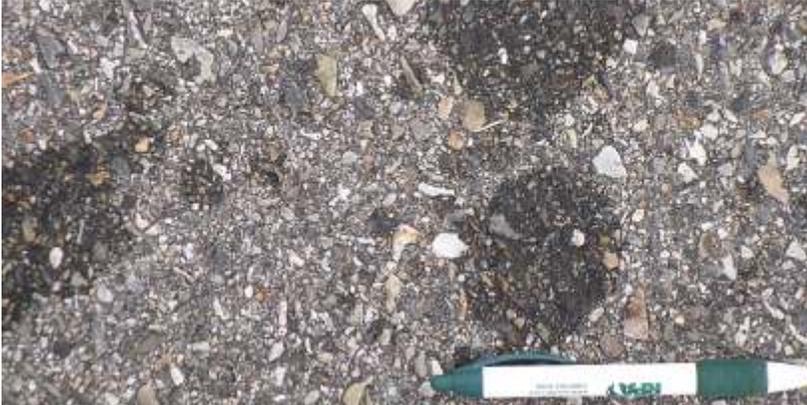
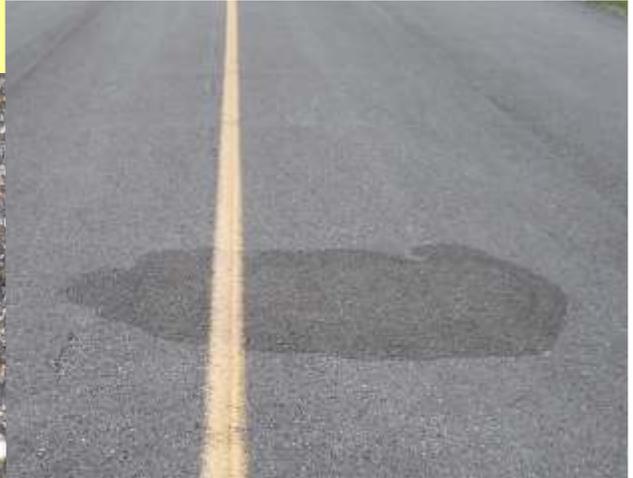
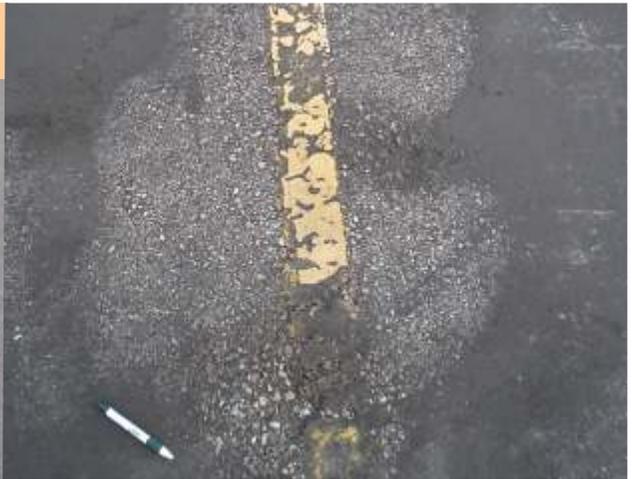
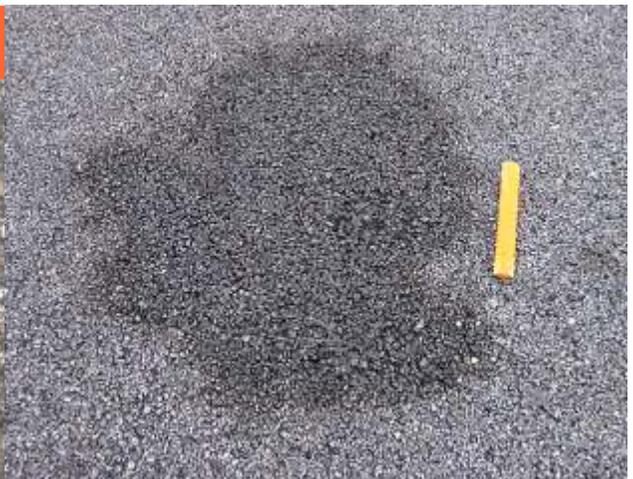
spillage exists  
Repair: Do nothing / Partial or full depth patch

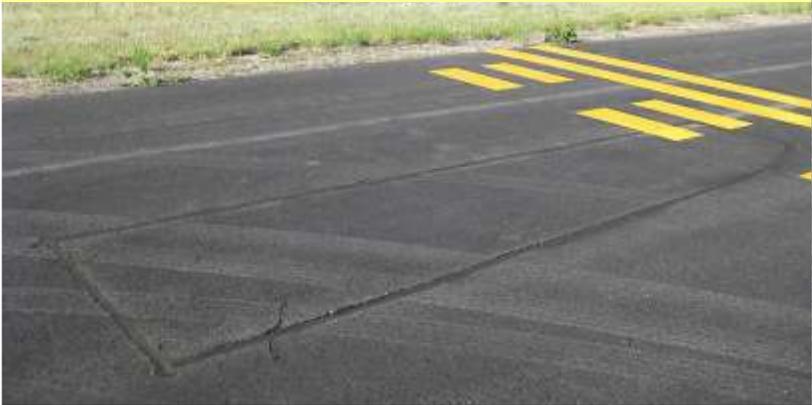
**Light** Patch is in good condition and is performing satisfactorily.  
Repair: Do nothing

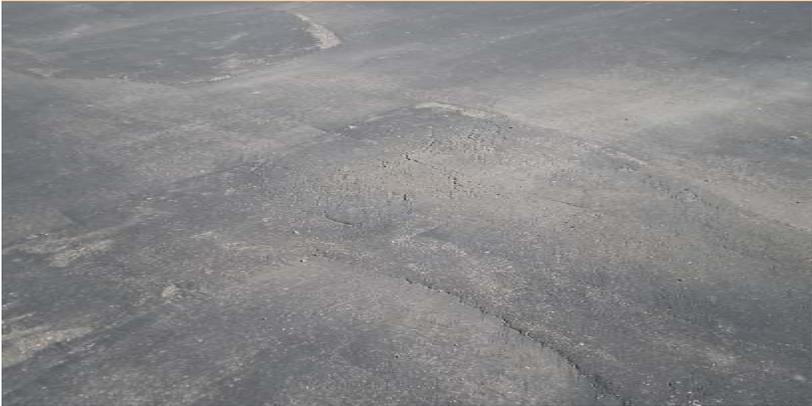
**Medium** Patch and/or patch joint has deteriorated and/or affects riding quality.  
Repair: Seal cracks/Repair distress in patch/Replace patch

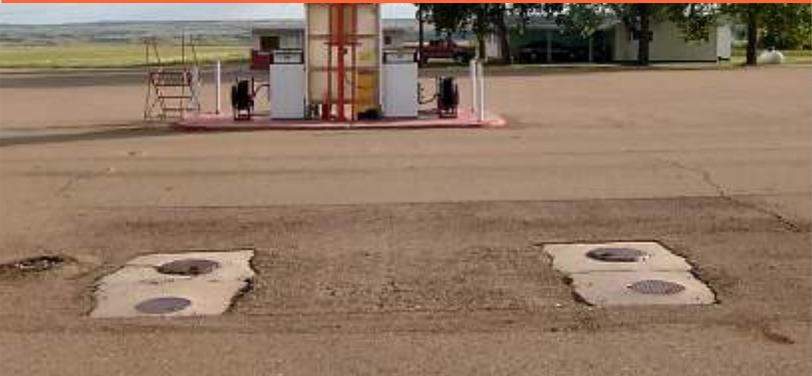
**High** Patch and/or patch joint has badly deteriorated resulting in high FOD potential and poor ride quality.  
Repair: Replace patch

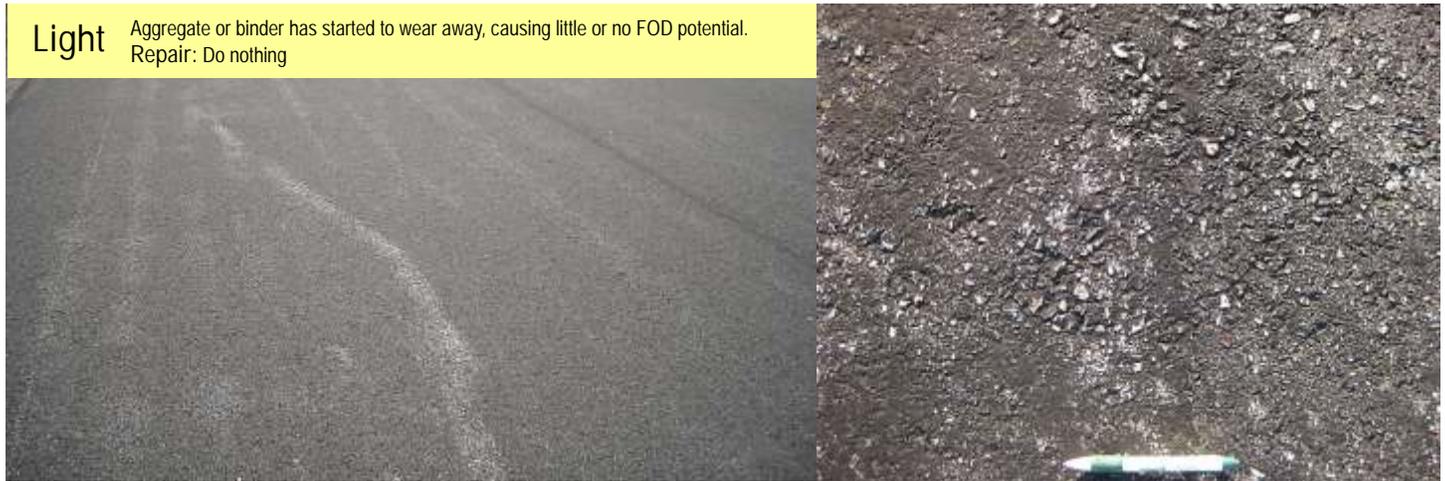
**Light** Aggregate or binder has started to wear away, causing little or no FOD potential.  
Repair: Do nothing

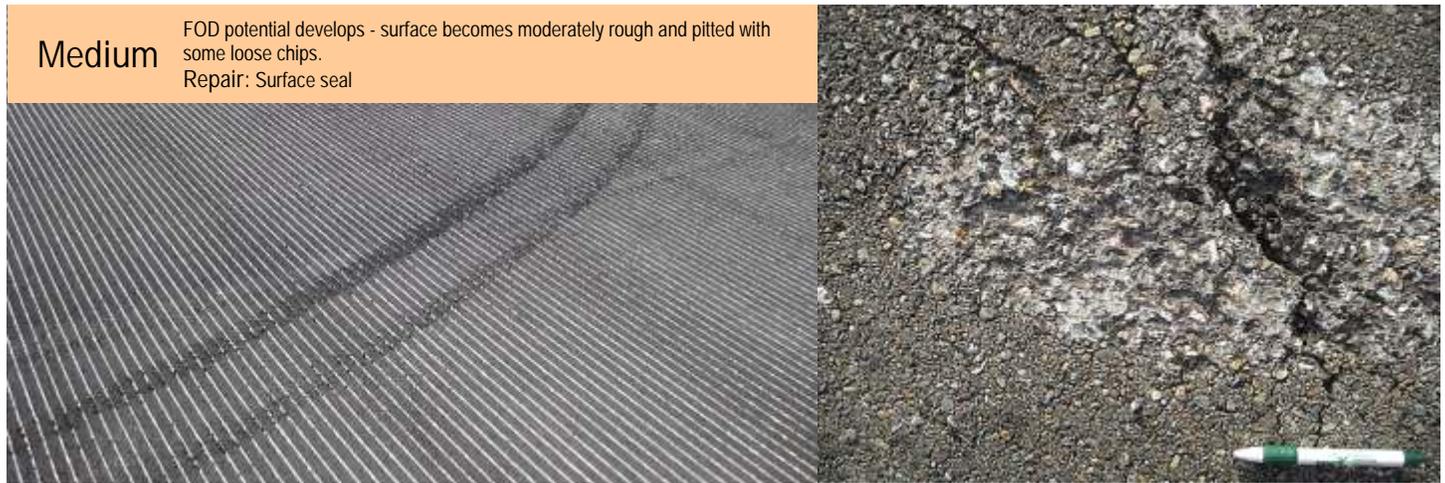
**Medium** FOD potential develops - surface becomes moderately rough and pitted with some loose chips.  
Repair: Surface seal

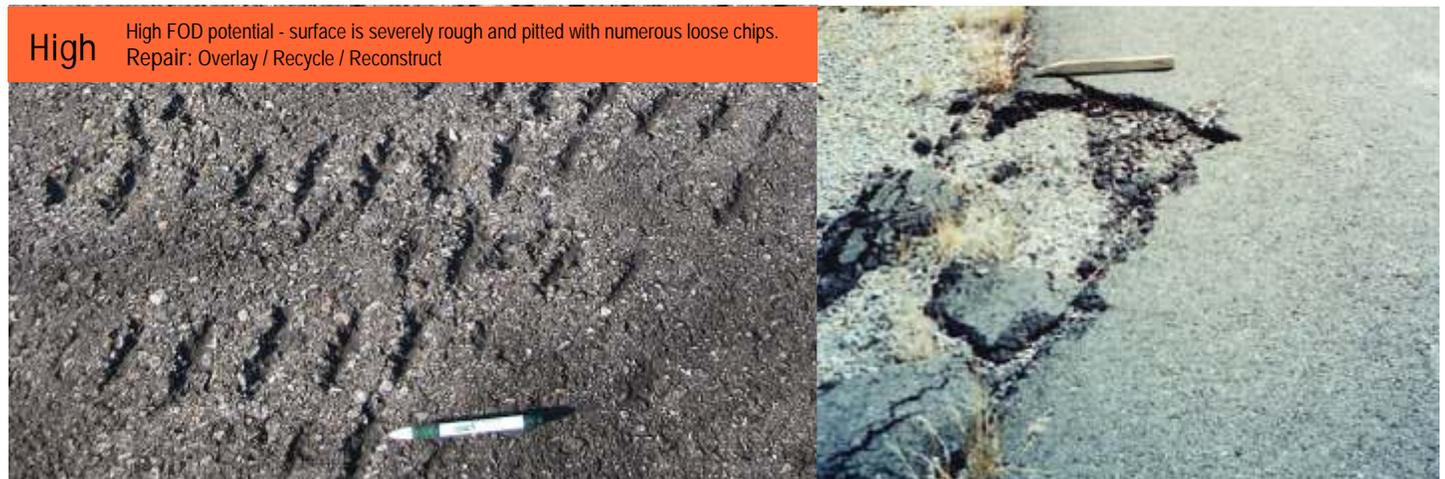
**High** High FOD potential - surface is severely rough and pitted with numerous loose chips.  
Repair: Overlay / Recycle / Reconstruct

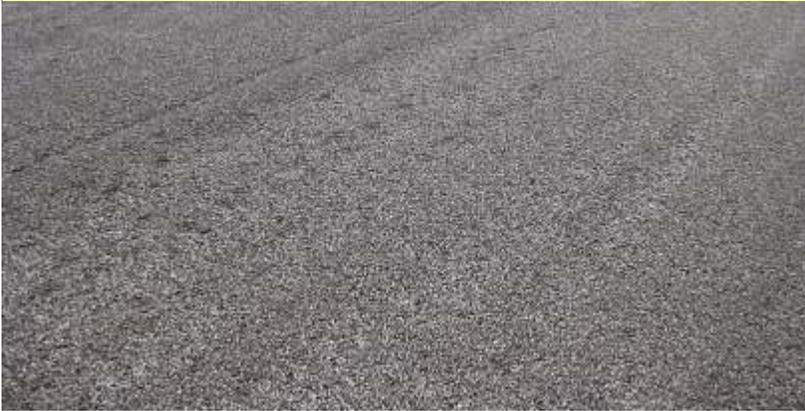
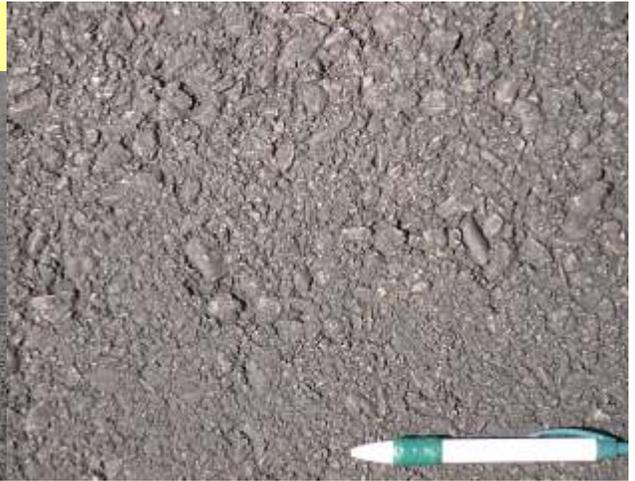
**Light** Aggregate or binder has started to wear away, causing little or no FOD potential.  
Repair: Do nothing / Surface seal

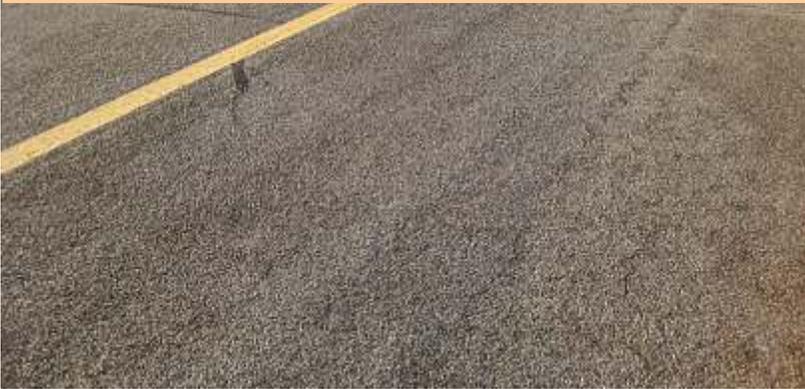
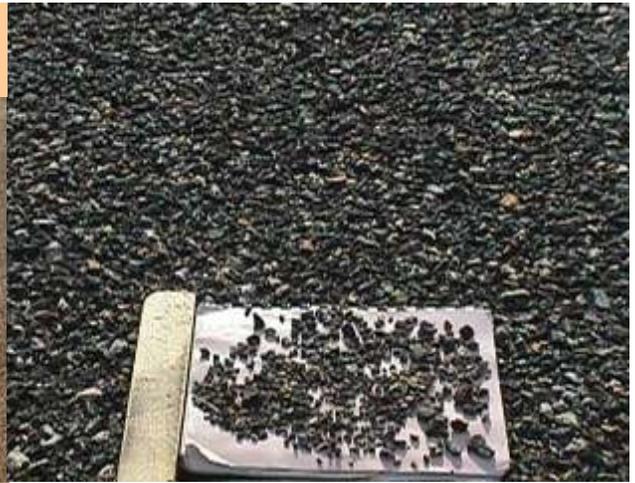
**Medium** FOD potential develops - surface becomes moderately rough and pitted with some loose chips.  
Repair: Surface seal

**Description:** Wearing away of the pavement surface including dislodging of aggregate particles and loss of asphalt or tar binder.

**Causes:** Use (including especially plow scrapes, touchdowns, braking and turning) and/or ultraviolet exposure that oxidizes & hardens the asphalt binder.

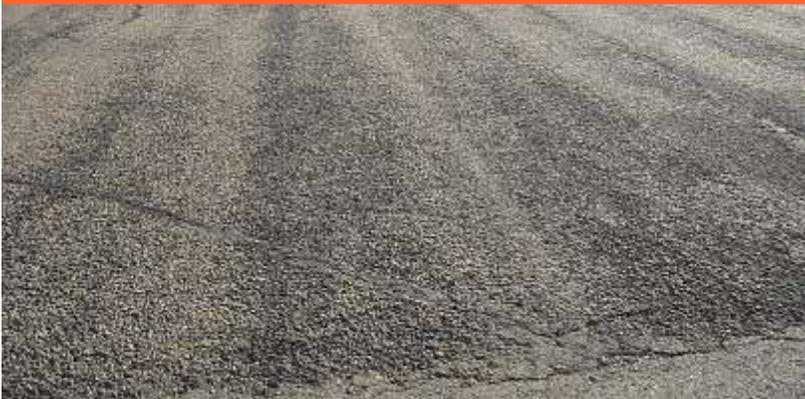
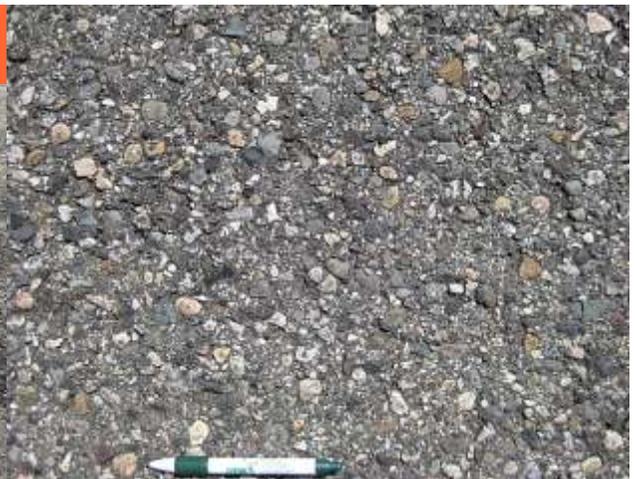
**High** High FOD potential - surface is severely rough and pitted with numerous loose chips.  
Repair: Overlay / Recycle / Reconstruct

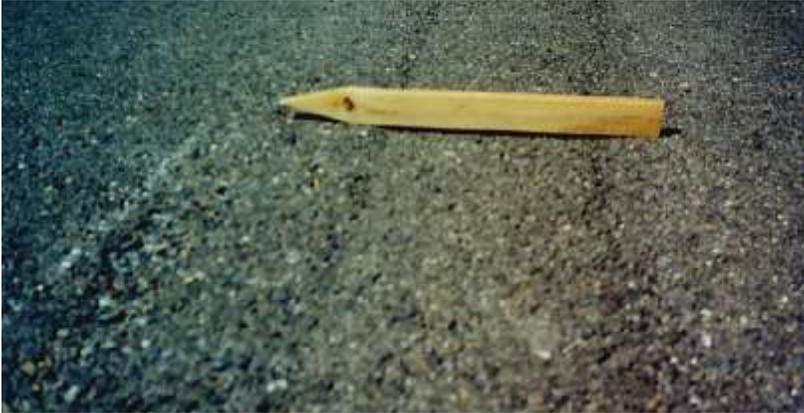
**Light**  $\leq \frac{1}{4} - \frac{1}{2}$  inch mean depth  
Repair: Do nothing

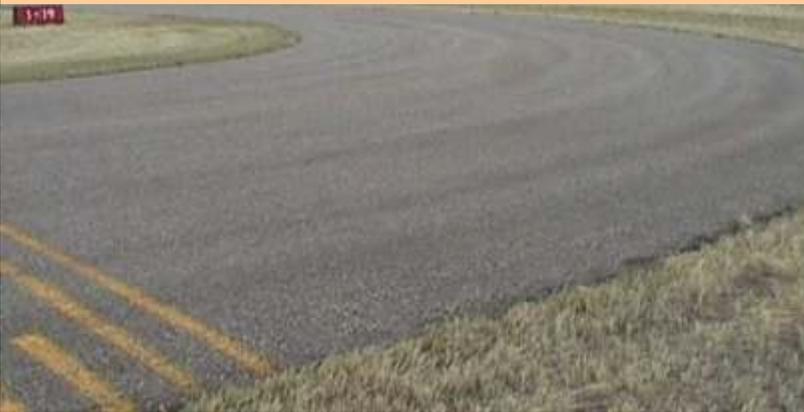
**Medium**  $> \frac{1}{2}$  inch  $\leq$  1 inch mean depth  
Repair: Partial or full depth patch / Patch and overlay

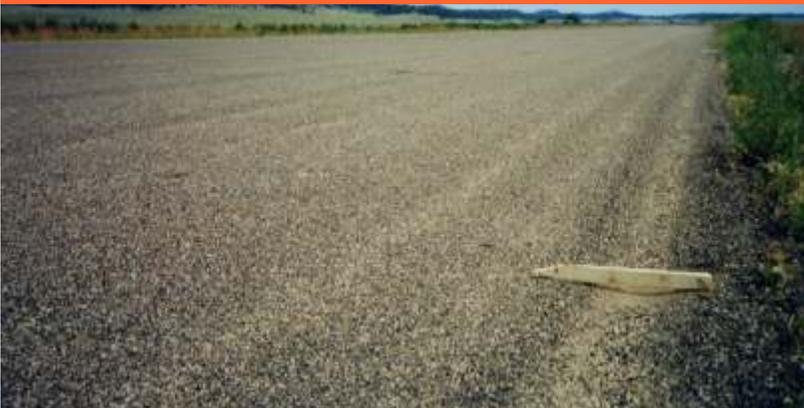
**High**  $>$  1 inch mean depth  
Repair: Partial or full depth patch / Patch and overlay
