# MONTANA

## Aviation System Plan - 2009 Update

PAVEMENT CONDITION INDEXES

PREPARED BY  
ROBERT PECCIA & ASSOCIATES  
HELENA, KALISPELL, & BUTTE, MONTANA

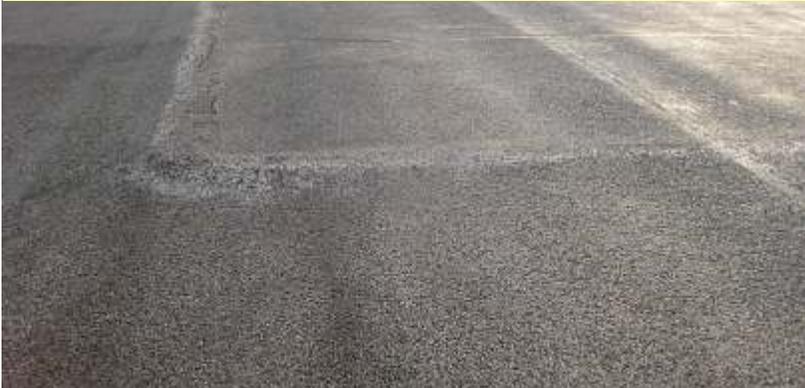
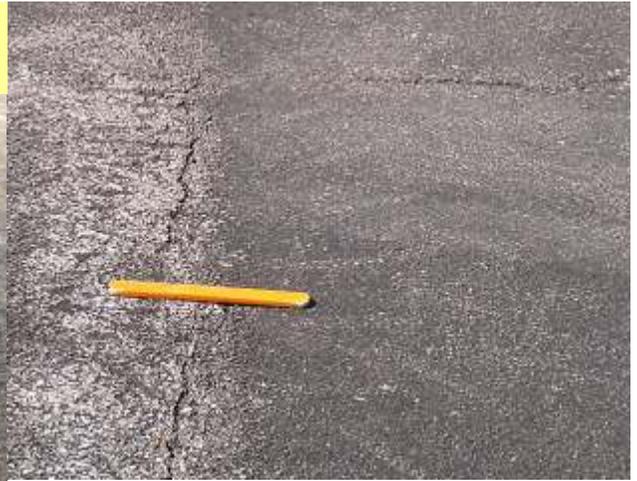
**Light** A slight amount of shoving has occurred, with little effect on ride quality and no asphalt break-up.  
Repair: Do nothing

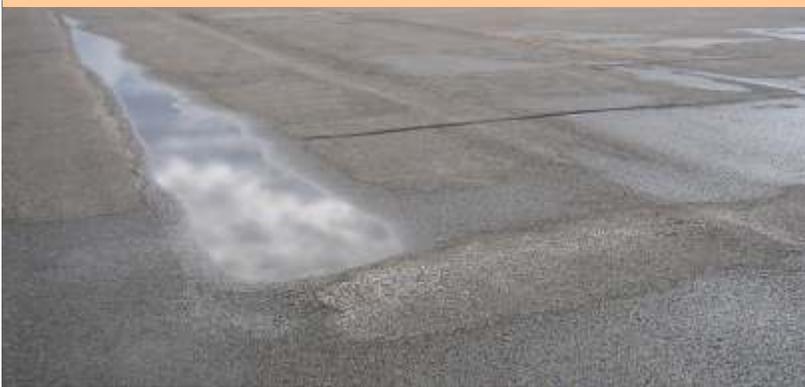
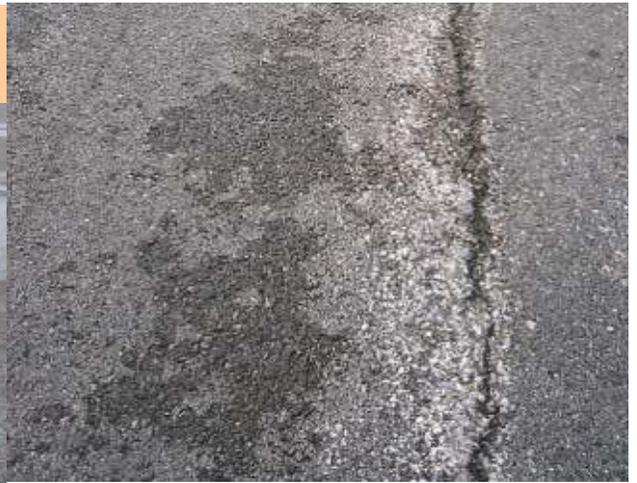
**Medium** A significant amount of shoving has occurred, causing moderate roughness and little or no asphalt break-up.  
Repair: Partial depth patch / full depth patch

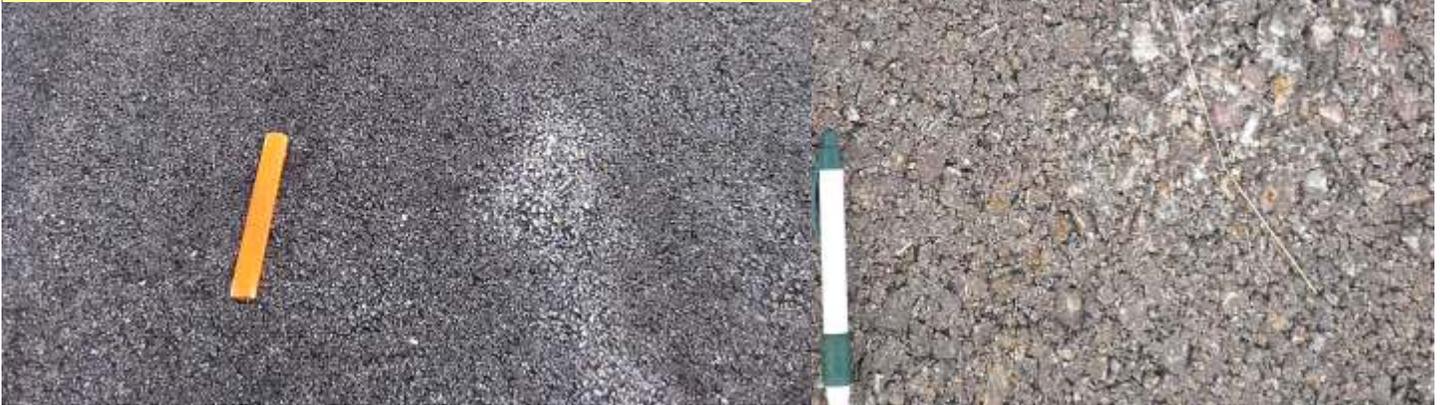
**Light** < 3/4 inch height differential  
Repair: Do nothing

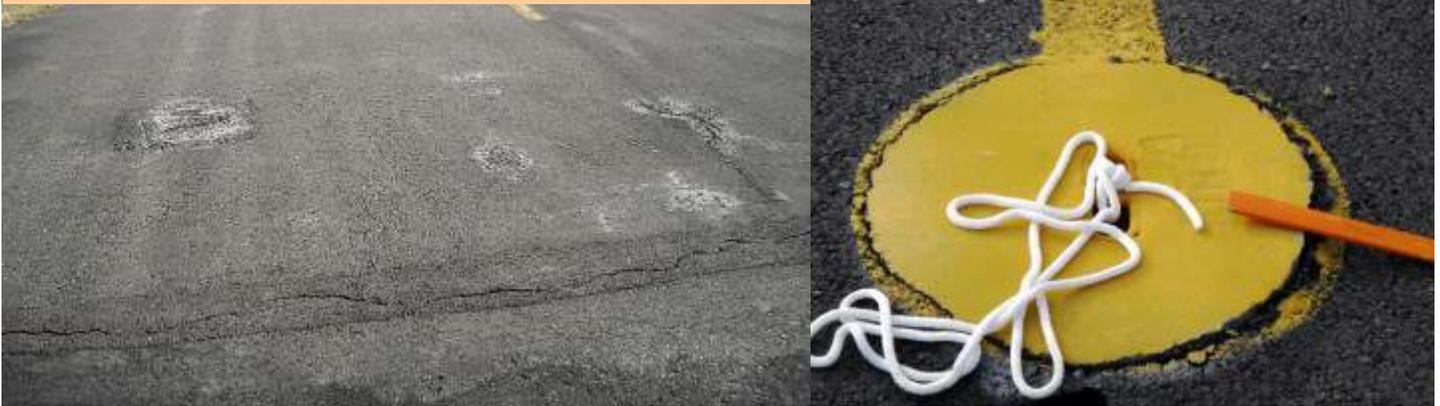
**Medium** 3/4 - 1 1/2 inches height differential  
Repair: Reconstruct / Patch

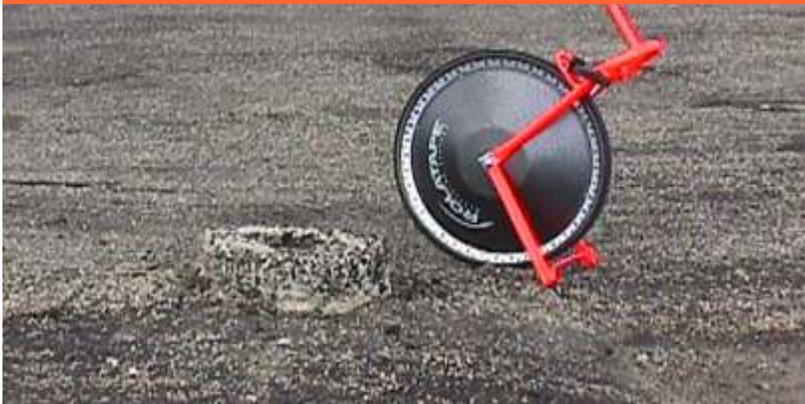
**High** > 1 1/2 inch height differential  
Repair: Reconstruct / Patch

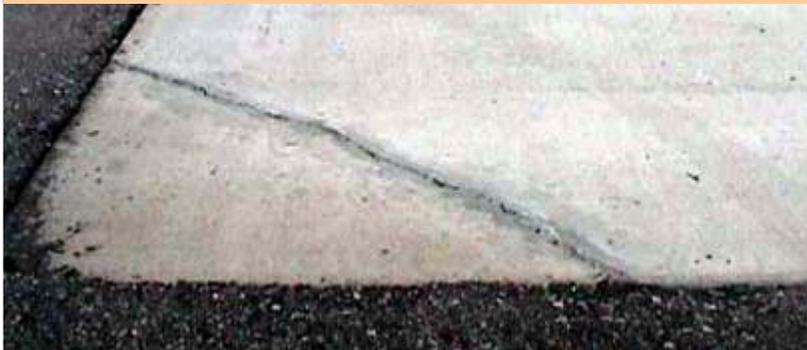
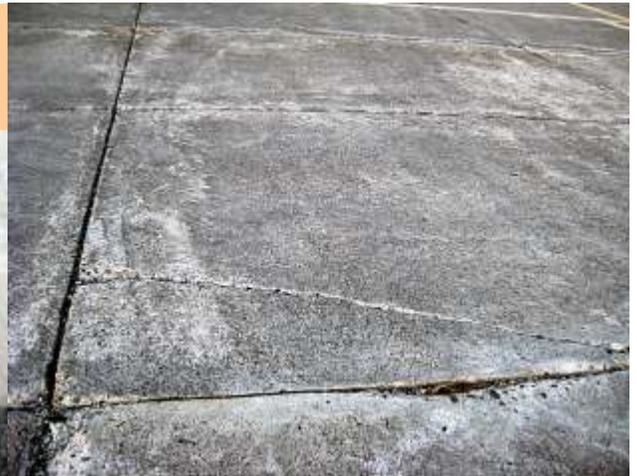
\* A nonfilled crack has a mean width between 1/8 inch and 1 inch.

\* Moderately spalled.

\* Failed filler.

Repair: Seal cracks / Full depth patch / Slab replacement / Undersealing project

**Description:** A crack that intersects the joints at a distance less than or equal to one-half the slab length on both sides, measured from the corner of the slab. The crack extends vertically through the entire slab thickness.

Causes: Load repetition combined with loss of support and curling stresses.

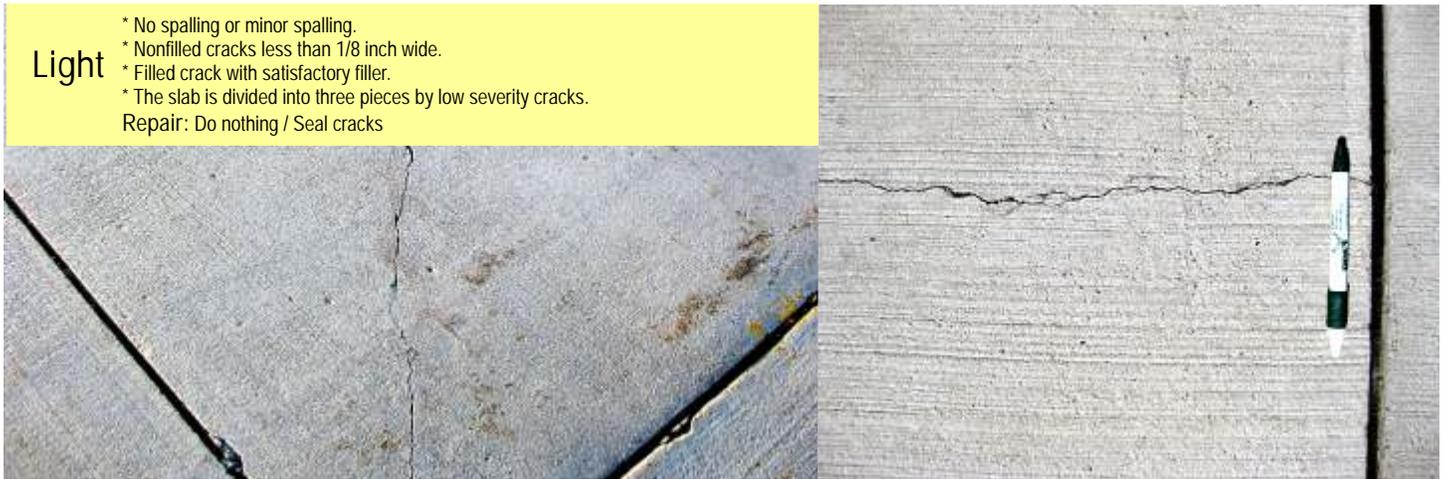
- \* No spalling or minor spalling.
- \* Nonfilled cracks less than 1/8 inch wide.
- \* Filled crack with satisfactory filler.
- \* The slab is divided into three pieces by low severity cracks.

Repair: Do nothing / Seal cracks

**Description:** Cracks that divide the slab into two or three pieces.

**Causes:** Load repetition, curling stresses and shrinkage stresses.

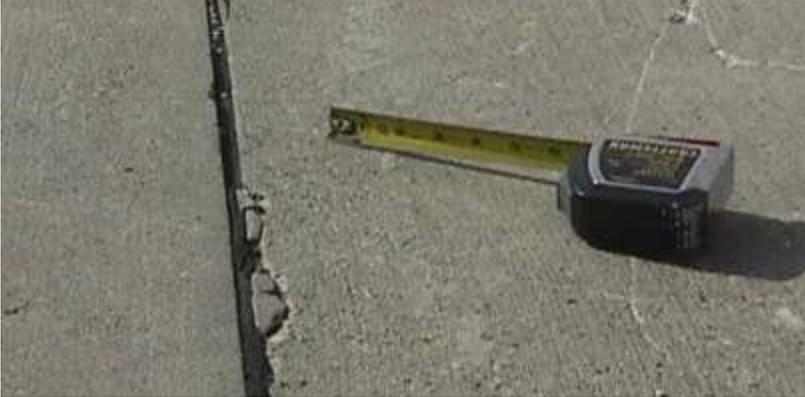
**Light** Sealant is performing well with minor, if any, damage.  
Repair: Do nothing

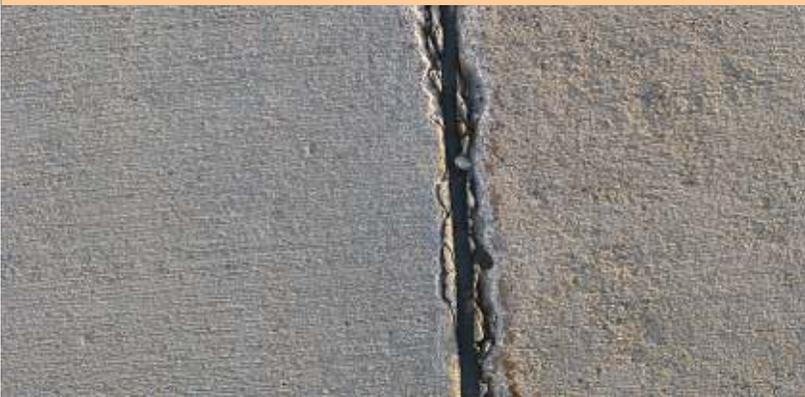
**Medium** Joint sealer is in generally fair condition with some moderate damage.  
Repair: Sealant needs replacement within 2 years

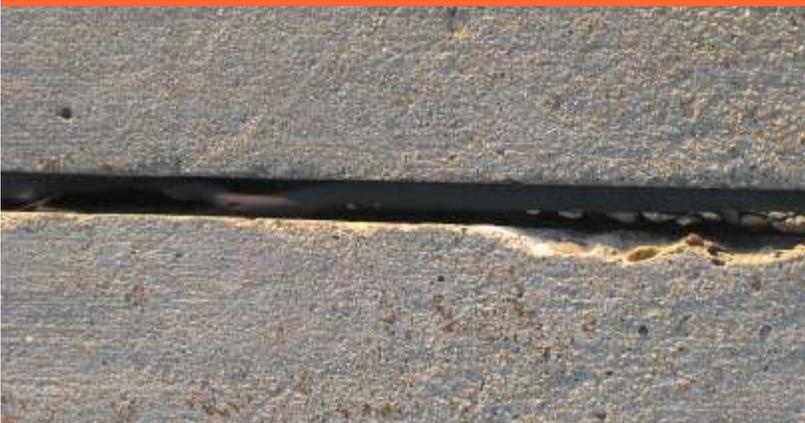
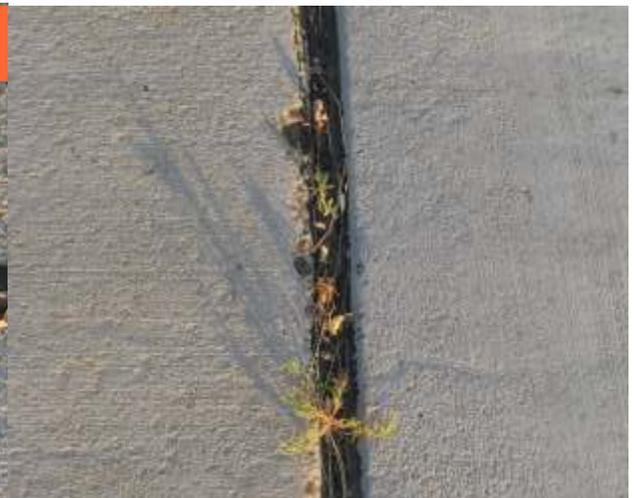
**High** Joint sealer is in generally poor condition, or lacking over the entire surveyed section.  
Repair: Sealant needs immediate replacement or application

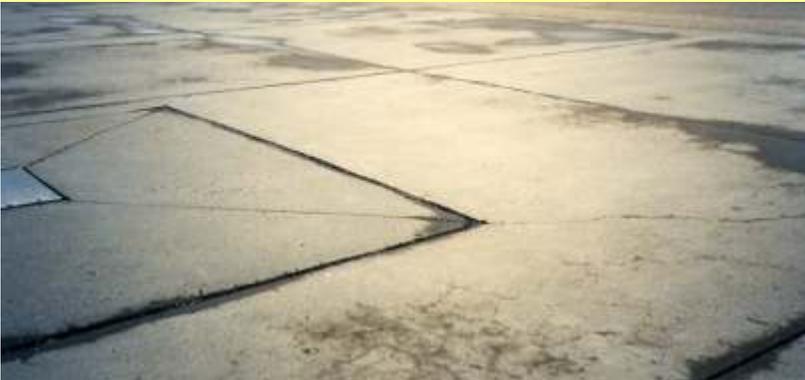
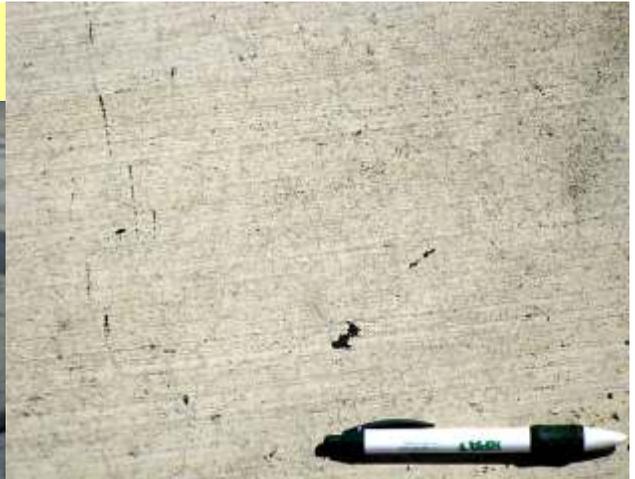
Crazing or map cracking exists over most of the slab area; the surface is in good condition with no scaling.  
Repair: Do nothing

**Description:** A network of shallow, fine, or hairline cracks tending to intersect at angles of 120 degrees, which extend only through the upper surface of the concrete. May lead to "scaling" of the surface (the breakdown of the slab's top approx. ¼" - ½").

**Causes:** Over-finishing the concrete, use of deicing salts, freeze-thaw cycles, and poor aggregate.

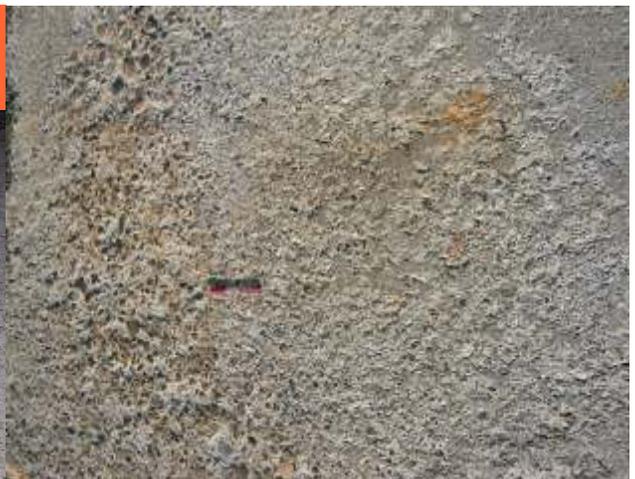
Slab is severely scaled, causing a high FOD potential. Usually more than 5 percent of the surface is affected.  
Repair: Slab replacement

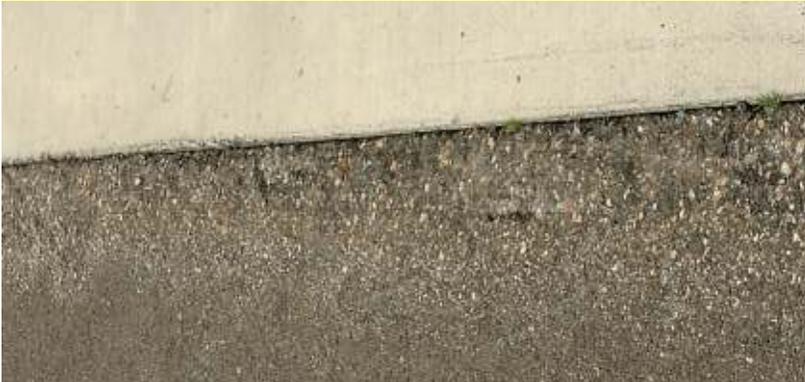
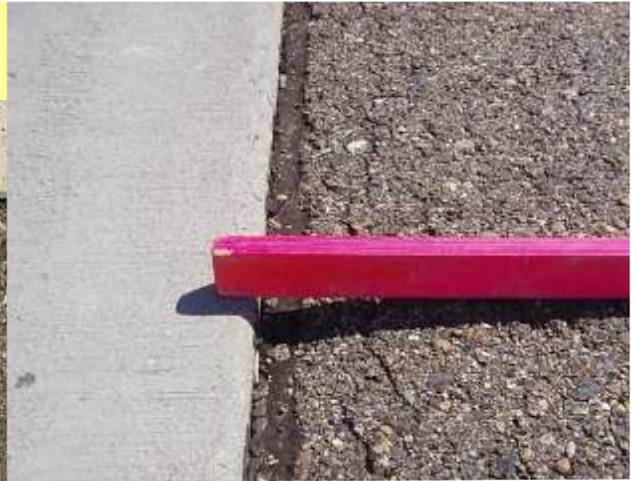
Edge Elevation Difference: Runways/Taxiways: < 1/4 inch  
Aprons: 1/8 - 1/2 inch  
Repair: Do nothing / Joint seal / Injection-fill under slab / Underseal.

**Description:** A difference of elevation at a joint or crack.

**Causes:** Water intrusion into expansive subgrades, base course leach-out and consolidation or contamination, and/or poor construction practices.

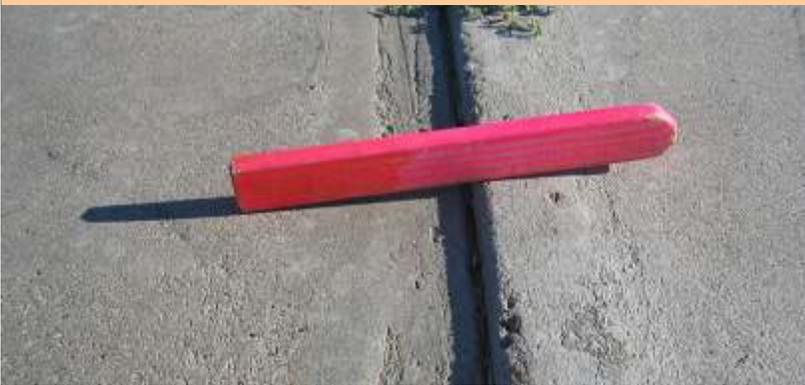
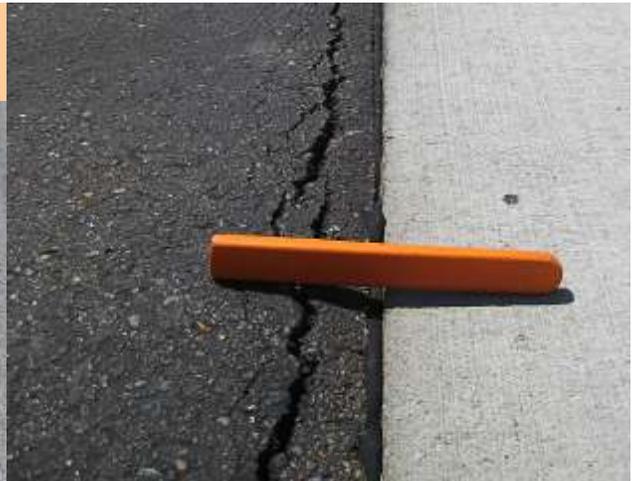
Edge Elevation Difference: Runways/Taxiways: 1/4 - 1/2 inch  
Aprons: 1/2 - 1 inch  
Repair: Slab grinding / Joint seal / Injection-fill under slab / Underseal.

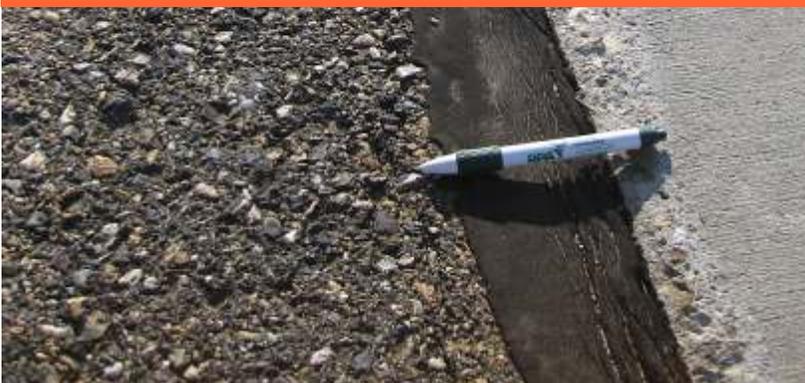
Edge Elevation Difference: Runways/Taxiways: > 1/2 inch  
Aprons: > 1 inch  
Repair: Slab grinding / Slab replacement / Joint seal / Injection-fill under slab / Underseal.

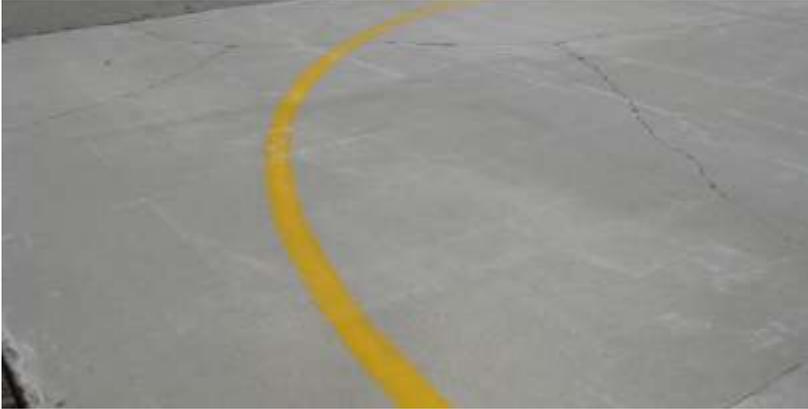
**Light** The slab is broken into 4 or 5 pieces with over 85% of the cracks of low severity  
Repair: Seal cracks

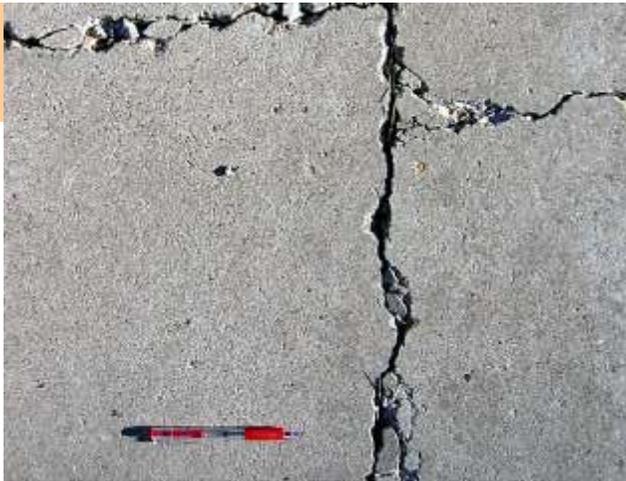
**Medium** The slab is broken into 4 or 5 pieces with over 15% of the cracks of medium severity or the slab is broken into 6 or more pieces with over 85% of the cracks of low severity.  
Repair: Seal cracks / full depth patch / slab replacement

**Description:** The slab is broken into four or more pieces, not all contained in a corner break.

**Cause:** Overloading or inadequate support of the slab.

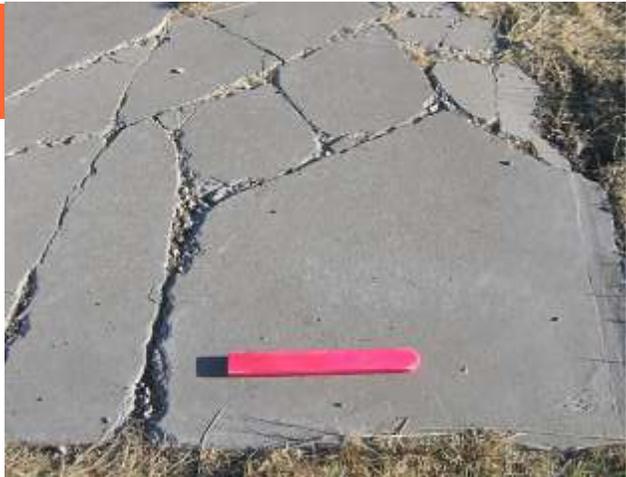
**High** The slab is broken into 4 or 5 pieces with some or all of the cracks of high severity or the slab is broken into 6 or more pieces with over 15% of the cracks of medium or high severity.  
Repair: Full depth patch / slab replacement

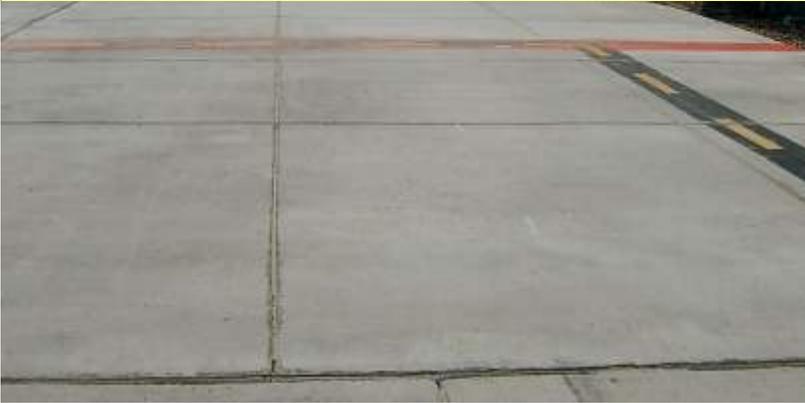
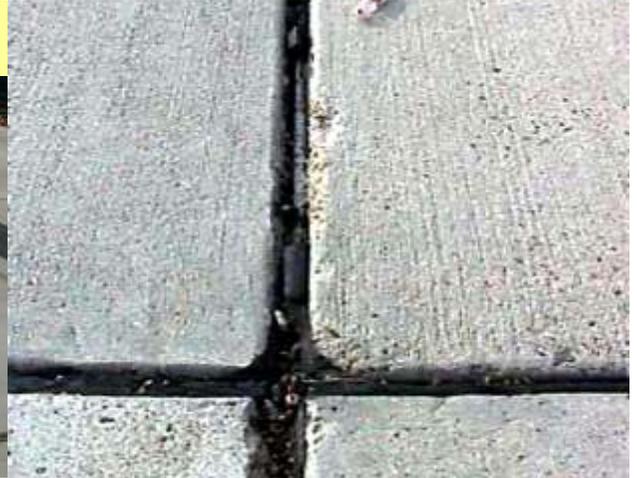
**Light** Corner edges are lightly frayed with few pieces (little or no FOD potential).  
Repair: Do nothing

**Description:** The raveling or breakdown of the slab within approximately 2 feet of the corner. Spalls angle downward to intersect the joint, not vertically through the slab.

**Causes:** Infiltration of incompressible materials, excessive traffic loads, or weak (overworked) concrete at the joint.

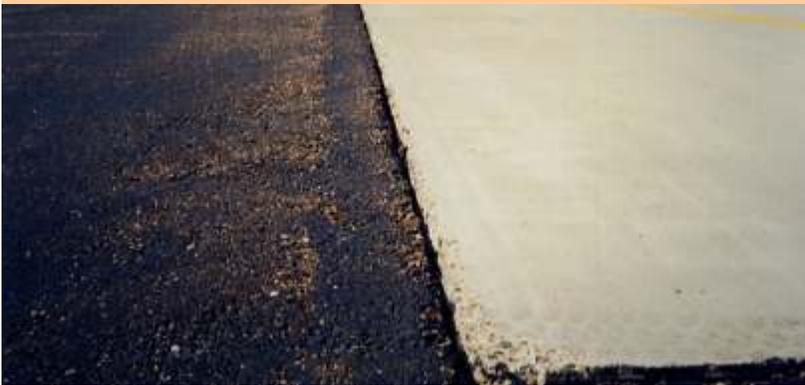
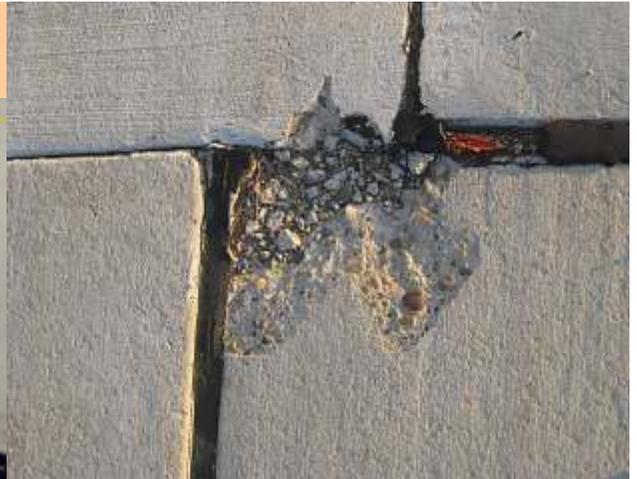
**Medium** Moderately frayed edge, fractured pieces may be loose or absent (some FOD or tire damage potential).  
Repair: Partial depth patch

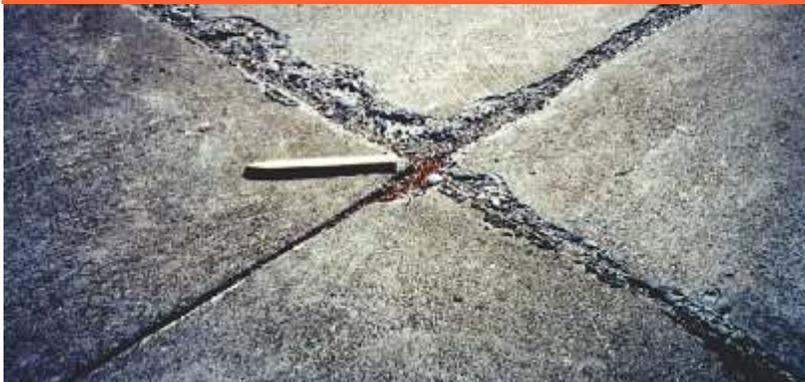
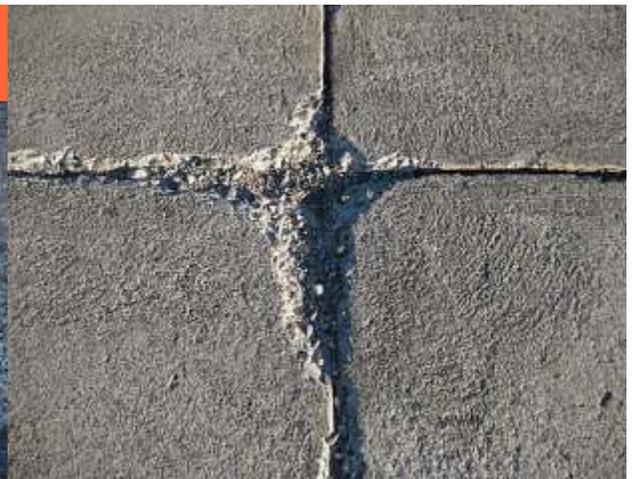
**High** Severely frayed, high severity cracks, fractured pieces absent (high FOD or tire damage potential).  
Repair: Partial depth patch

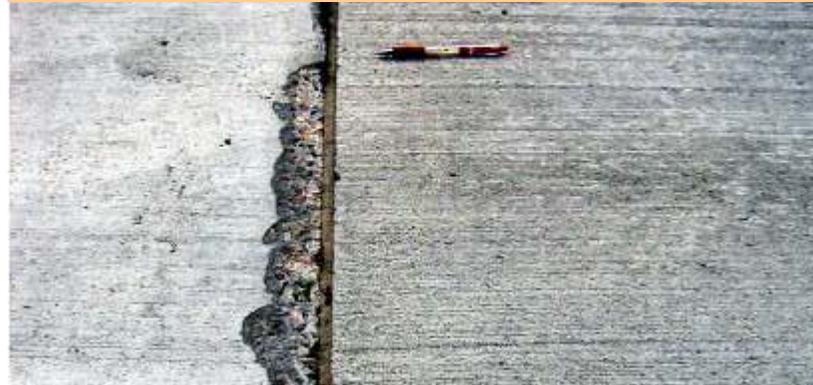
**Medium** Moderately frayed edge, fractured pieces may be loose or absent (some FOD or tire damage potential).  
Repair: Partial depth patch

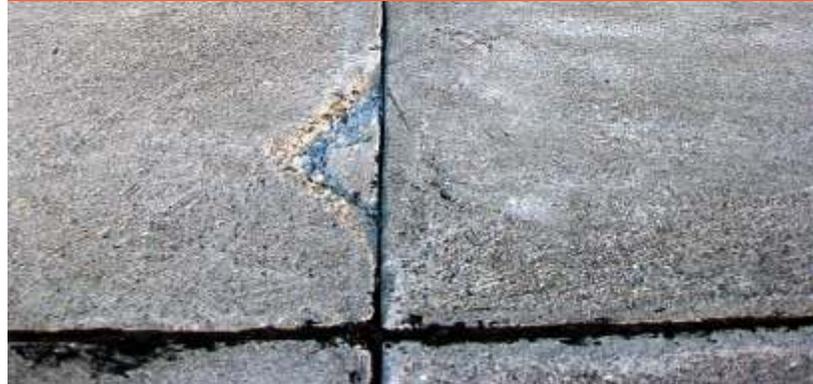
**High** Severely frayed, high severity cracks, fractured pieces absent (high FOD or tire damage potential).  
Repair: Partial depth patch
