HARLEM AIRPORT

PAVEMENT STRENGTH SURVEY/PAVEMENT CONDITION SURVEY

LEGEND □ 2000 SURVEY AREA ▨ 2003 SURVEY AREA ▩ 2006 SURVEY AREA (NOT SURVEYED) ▪ 2009 SURVEY AREA ▫ 2012 SURVEY AREA	DATE OF PAVEMENT STRENGTH SURVEY:	SEPT. 23, 1987	MONTANA AVIATION SYSTEM PLAN 2012 UPDATE - PAVEMENT CONDITION INDEXES
	EVALUATED BY:	C. NEW	
	DATE OF MOST RECENT PAVEMENT CONDITION SURVEY:	AUG. 20, 2012	HARLEM AIRPORT
	EVALUATED BY:	S. BROWN	
			PREPARED FOR:

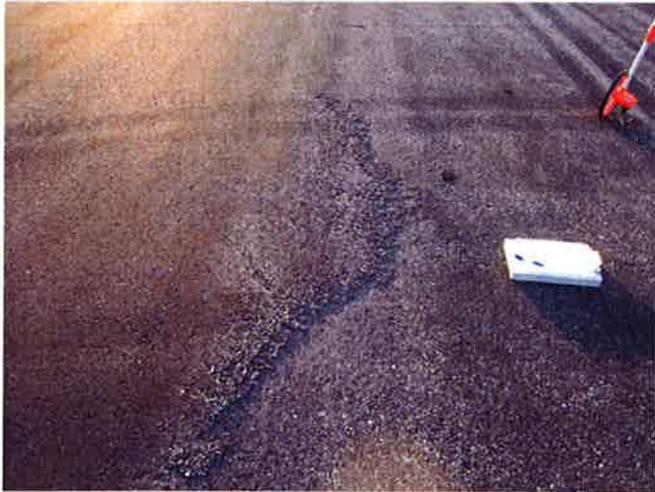
Distress Description	Severity	Quantity	Density	Deduct
DEPRESSION	L	41 SF	0.06%	0.30
LONGITUDINAL/TRANSVERSE CRACKING	L	1,121 LF	1.72%	6.66
WEATHERING	M	25,621 SF	39.22%	13.37

A-11, Overview with depression

Plan Year: 2013		Estimated Cost: \$110,499		PCI				
Section	Maintenance	Local	Global	Major<Crit	Major>Crit	Total	Before	After
A-11	Global MR + Preventive	\$870	\$16,330	\$0	\$0	\$17,200	79	86
R-11	Global MR + Preventive	\$7,806	\$72,188	\$0	\$0	\$79,994	76	80
R-12	Global MR + Preventive	\$507	\$4,688	\$0	\$0	\$5,194	76	80
T-11	Global MR + Preventive	\$1,066	\$7,044	\$0	\$0	\$8,110	73	77

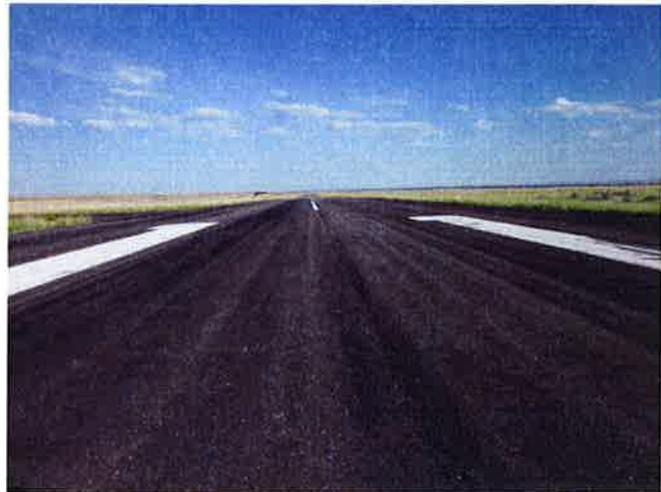
R-11 and 12, Overview

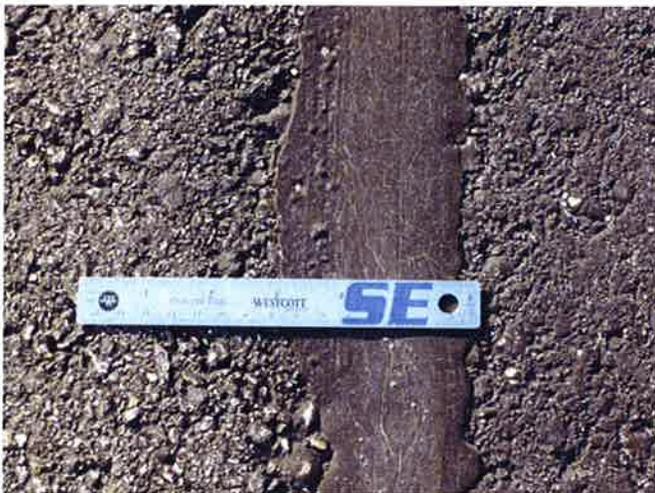
Distress Description	Severity	Quantity	Density	Deduct
LONGITUDINAL/TRANSVERSE CRACKING	L	10,163 LF	3.52%	11.36
LONGITUDINAL/TRANSVERSE CRACKING	M	79 LF	0.03%	4.00
RAVELING	L	4 SF	0.00%	1.00
WEATHERING	M	189,758 SF	65.72%	17.39

R-11 and 12, Surface detail with crack

Section	Distress Description	Severity	Quantity	Work Description	Quantity	Cost	Policy
R-11	L & T CR	M	79 LF	Crack Sealing - AC	79 LF	\$196	PREV.

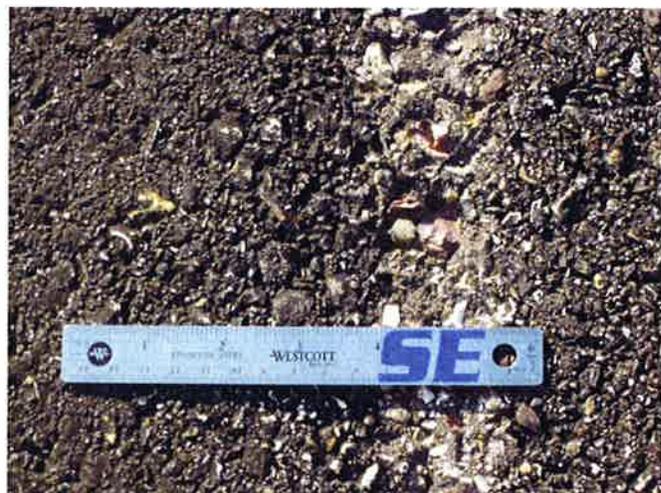
Distress Description	Severity	Quantity	Density	Deduct
LONGITUDINAL/TRANSVERSE CRACKING	L	606 LF	3.23%	10.64
RAVELING	L	0 SF	0.00%	1.00
WEATHERING	M	14,064 SF	75.01%	18.38

R-11 and 12, Surface detail with raveling

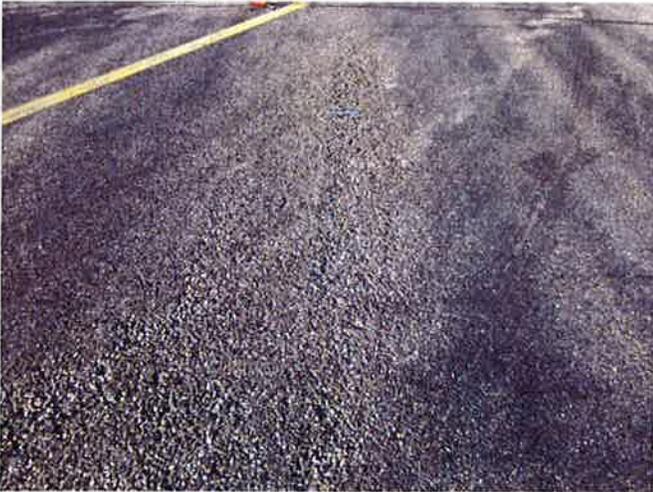
Distress Description	Severity	Quantity	Density	Deduct
WEATHERING	M	15,145 SF	53.76%	15.82
RAVELING	M	140 SF	0.50%	6.13
LONGITUDINAL/TRANSVERSE CRACKING	L	400 LF	1.42%	5.91
WEATHERING	L	13,027 SF	46.24%	4.63
RAVELING	L	63 SF	0.22%	1.26
DEPRESSION	L	1 SF	0.00%	0.3

T-11, Overview with raveling

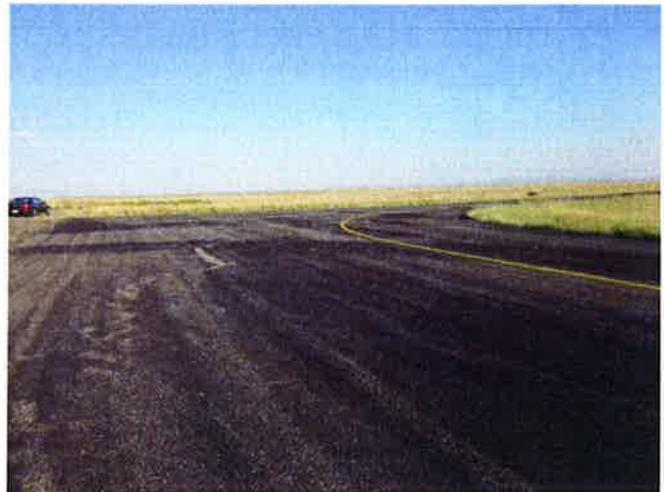
T-11, Overview

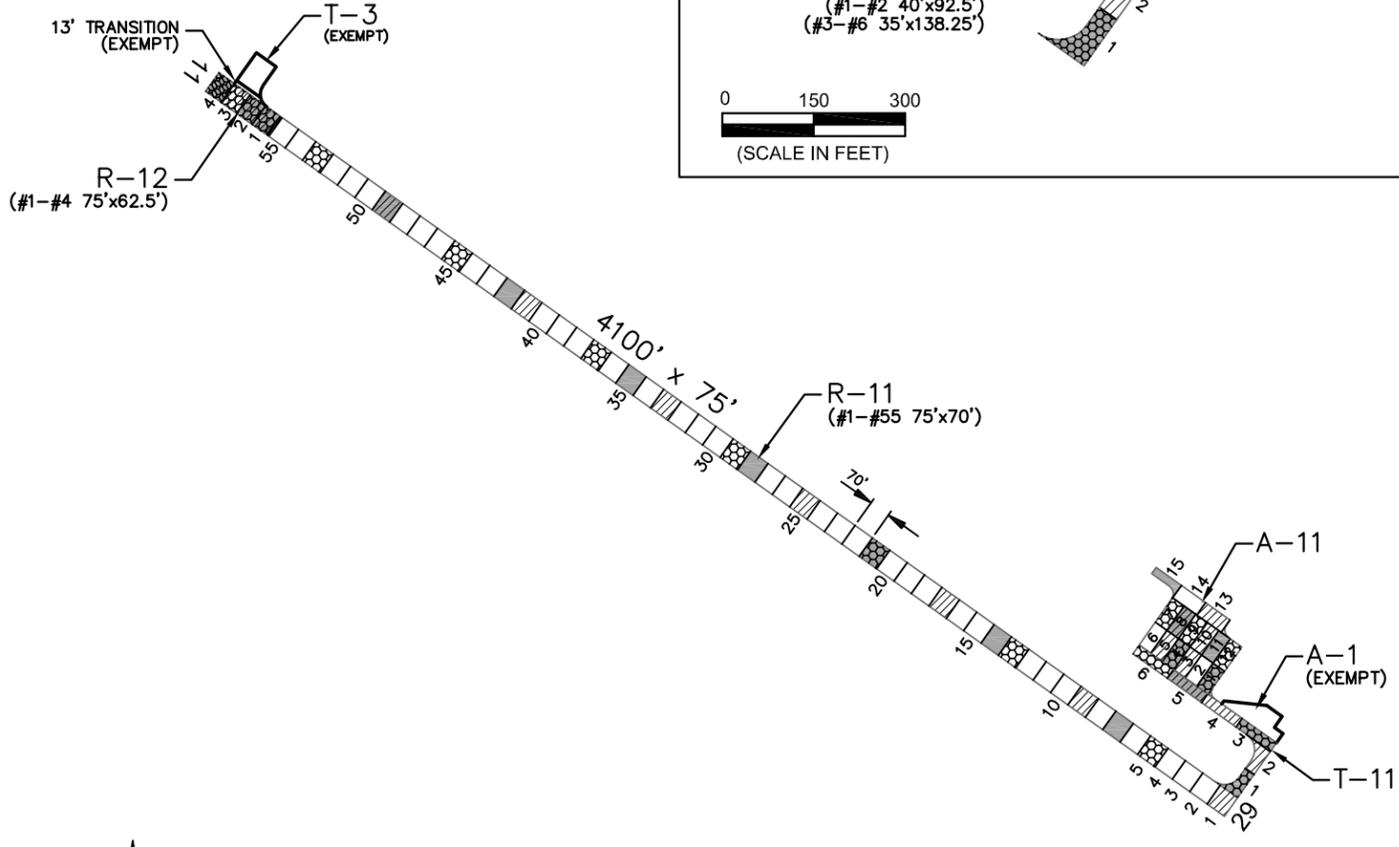
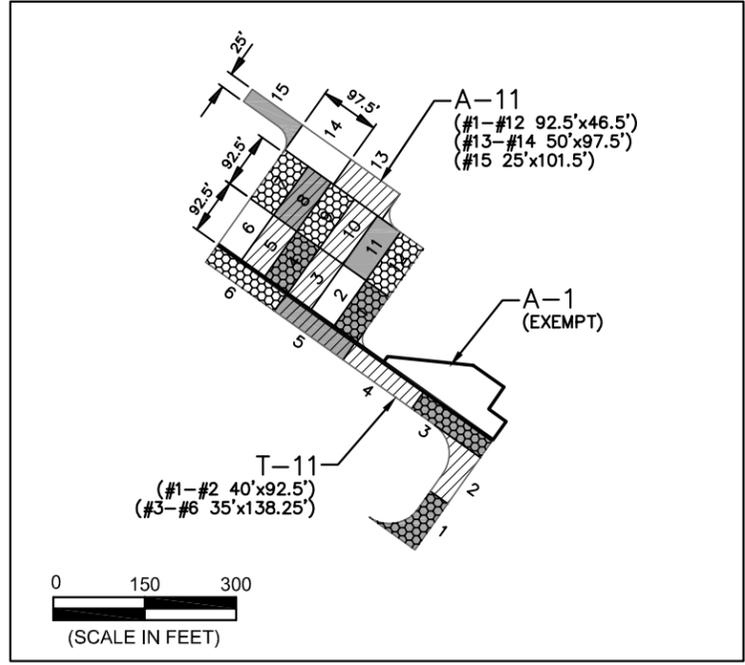
PAVE. IDENT.	SOIL CLASS	SUB GRADE CLASS	SUBBASE COURSE	BASE COURSE	SURFACE COURSE	OVERLAY	PAVEMENT STRENGTH			REMARKS
							MAX. GROSS LOAD (LBS)			
							SINGLE	DUAL	DUAL TAN.	
RUNWAYS										
R-11	E-7	CBR=2	10.5"(MIN)P-154	6" P-208	3" P-401	P-609	12,500			△1 △2 △3 △4
R-12	E-7	CBR=2	10.5" P-154	6" P-208	3" P-401	P-609	12,500			△3 △4
TAXIWAYS										
T-11	E-7	CBR=2	10.5" P-154	6" P-208	3" P-401	P-609	12,500			△1 △2 △3 △4
T-3	E-7	CBR=2		8.5" P-208	1.5" P-609	1" P-402	8,000			△1 △2
APRONS										
A-1	E-7	CBR=2		8.5" P-208	1.5" P-609	1" P-402	8,000			△1
A-11	E-7	CBR=2	10.5" P-154	6" P-208	3" P-401	P-609	12,500			△3 △4

- △1 AIP-001, 1983, CONSTRUCT RUNWAY, CONNECTING TAXIWAY, AND APRON
- △2 AIP-002, 1992, P-402 OVERLAY RUNWAY AND TAXIWAY, SEVERAL RUNWAY SECTIONS WERE REMOVED, REGRADED, COMPACTED, AND PAVED WITH 2" P-401 PRIOR TO P-402 OVERLAY.
- △3 AIP-004, 2003, RECONSTRUCT AND WIDEN RUNWAY; CONSTRUCT NEW TAXIWAY (T-11) AND APRON (A-11).
- △4 AIP-008, 2010, PAVEMENT MAINTENANCE INCLUDING CRACK REPAIR, CRACK SEAL, FOG SEAL, AND REMARK PAVEMENTS ON RUNWAY, TAXIWAY, AND APRON.
