**MONTANA DEPARTMENT OF TRANSPORTATION
WETLAND MITIGATION MONITORING REPORT: YEAR 2006**

*Ringling - Galt
Ringling, Montana*

December 2006

Project No: B43054.00 - 0214

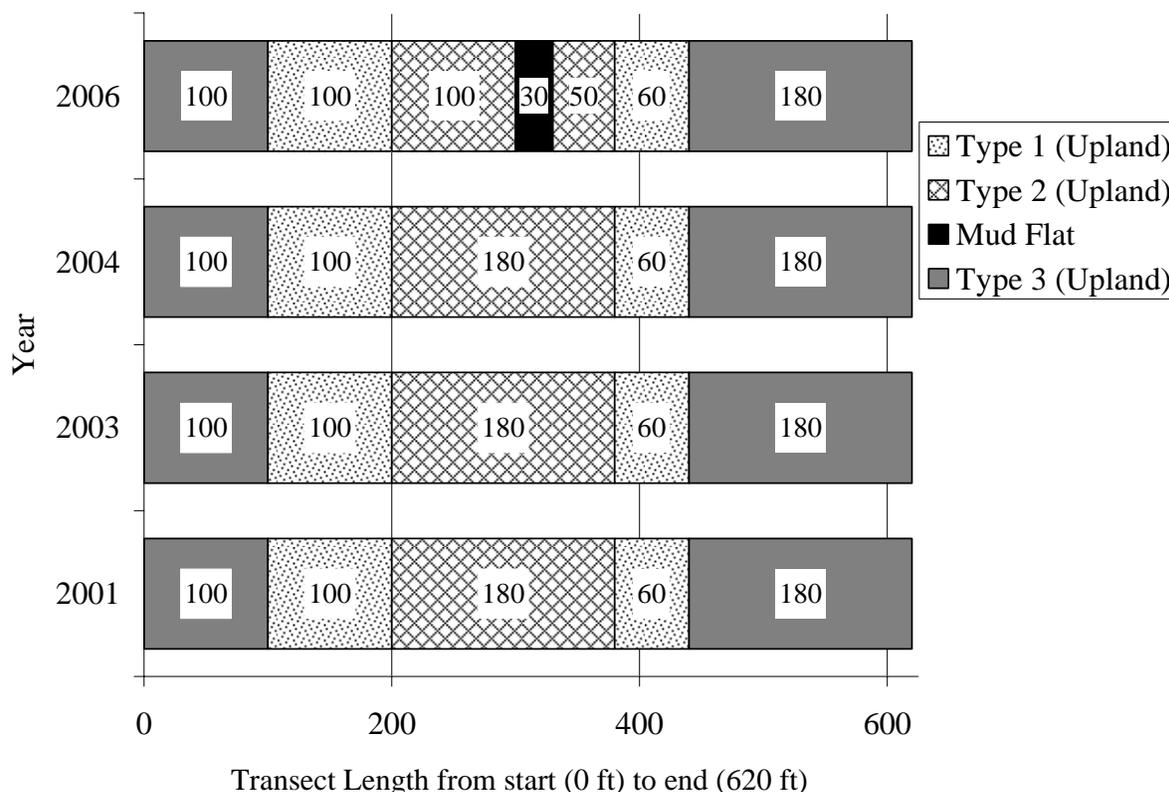
Chart 1: Transect maps showing vegetation types from the start of transect (0 feet) to the end of transect (620 feet) for each year monitored. Due to lack of water, the site was not monitored in 2002 and 2005.

Vegetation transect results are detailed in the **Monitoring Form (Appendix B)**, and are summarized in the transect map (**Chart 1**). Sagebrush communities dominate the landscape with the exception of a narrow band along the Agate Creek channel, where sagebrush does not persist. This area showed some minor changes in 2006 with trace amounts of hydrophytic vegetation showing up along the channel as a result of inundation. The primary change though was the conversion of upland grass to mud flat. Inundation was sufficiently long to kill the existing upland grasses, but was not replaced in 2006 by emergent wetland species except in trace amounts as previously mentioned. Continued inundation in 2007 would further advance the conversion to wetland habitat in the analysis area.

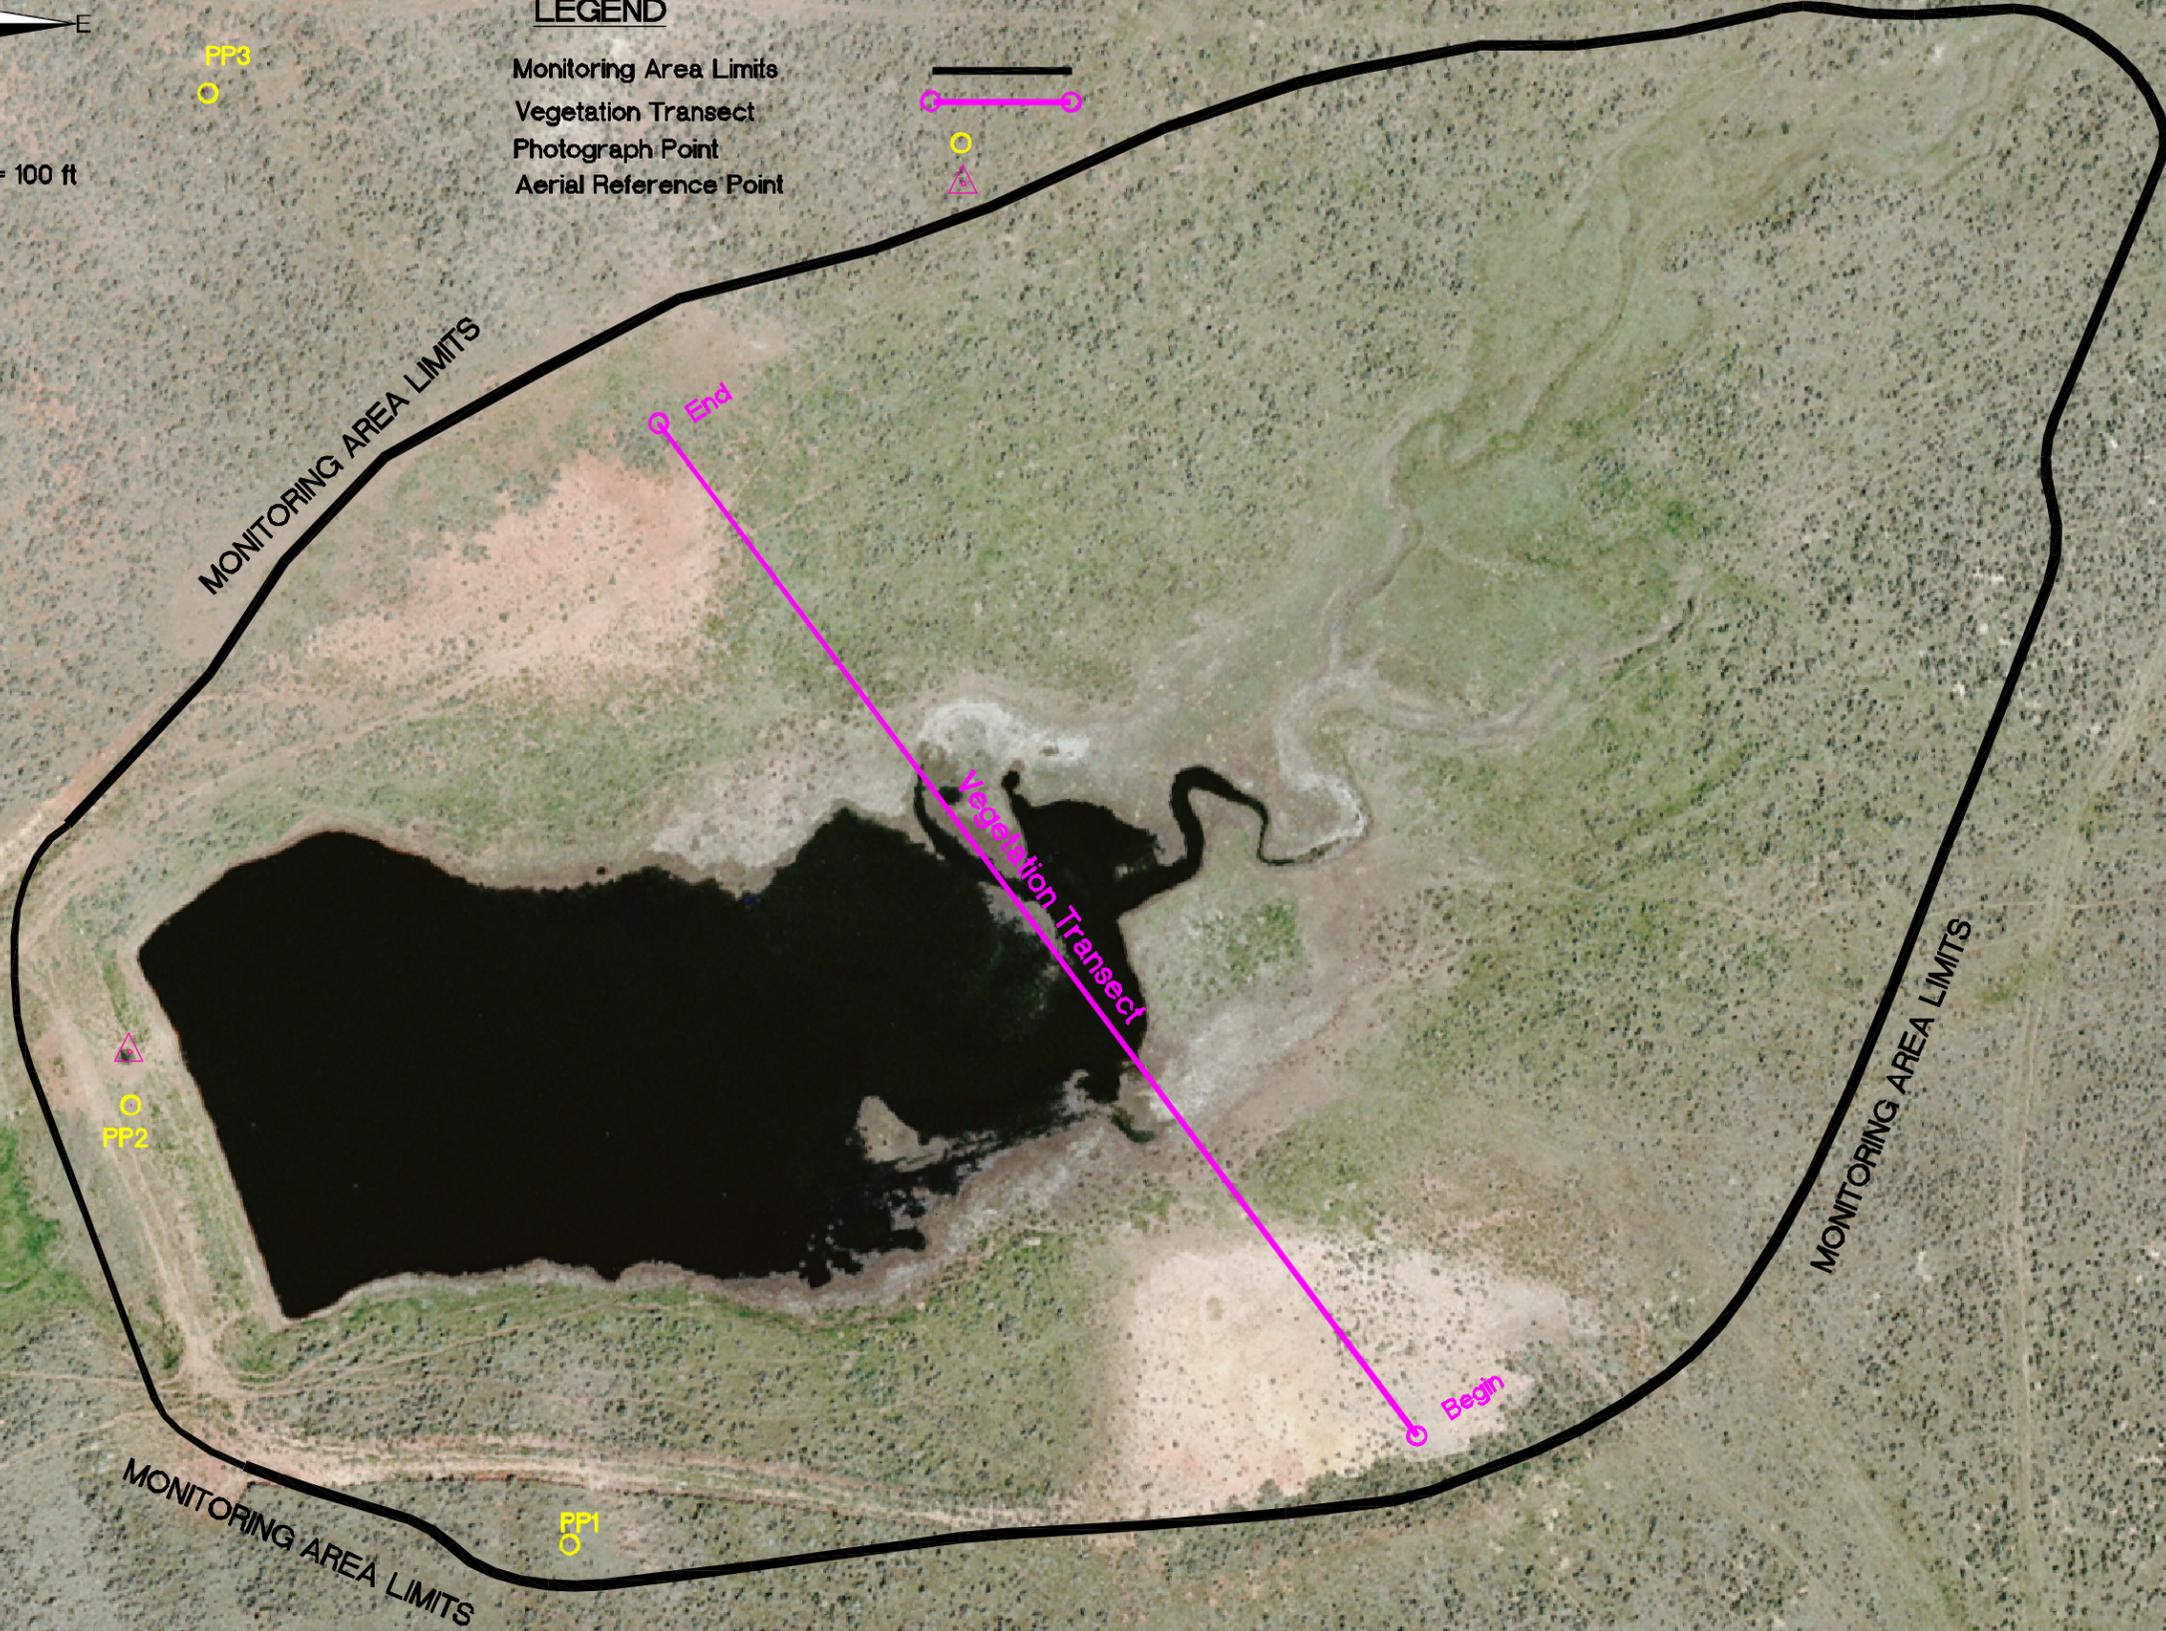
Figure 2- Monitoring Activity Locations

The 10-foot wide belt transect that was established in 2001 was evaluated for the fourth time **Figure 2 (Appendix A)**. Percent cover was estimated for each successive vegetative species encountered within the “belt” using the following values: + (<1%); 1 (1-5%); 2 (6-10%); 3 (11-20%); 4 (21-50%); and 5 (>50%). The purpose of the transect is to evaluate changes over time, especially the establishment and increase of hydrophytic vegetation. The transect location was marked on the air photo and all data recorded on the mitigation site monitoring form. Transect endpoint locations were initially recorded in 2001 with the GPS unit. Photos along the transect were taken from both ends during the mid-season visit.

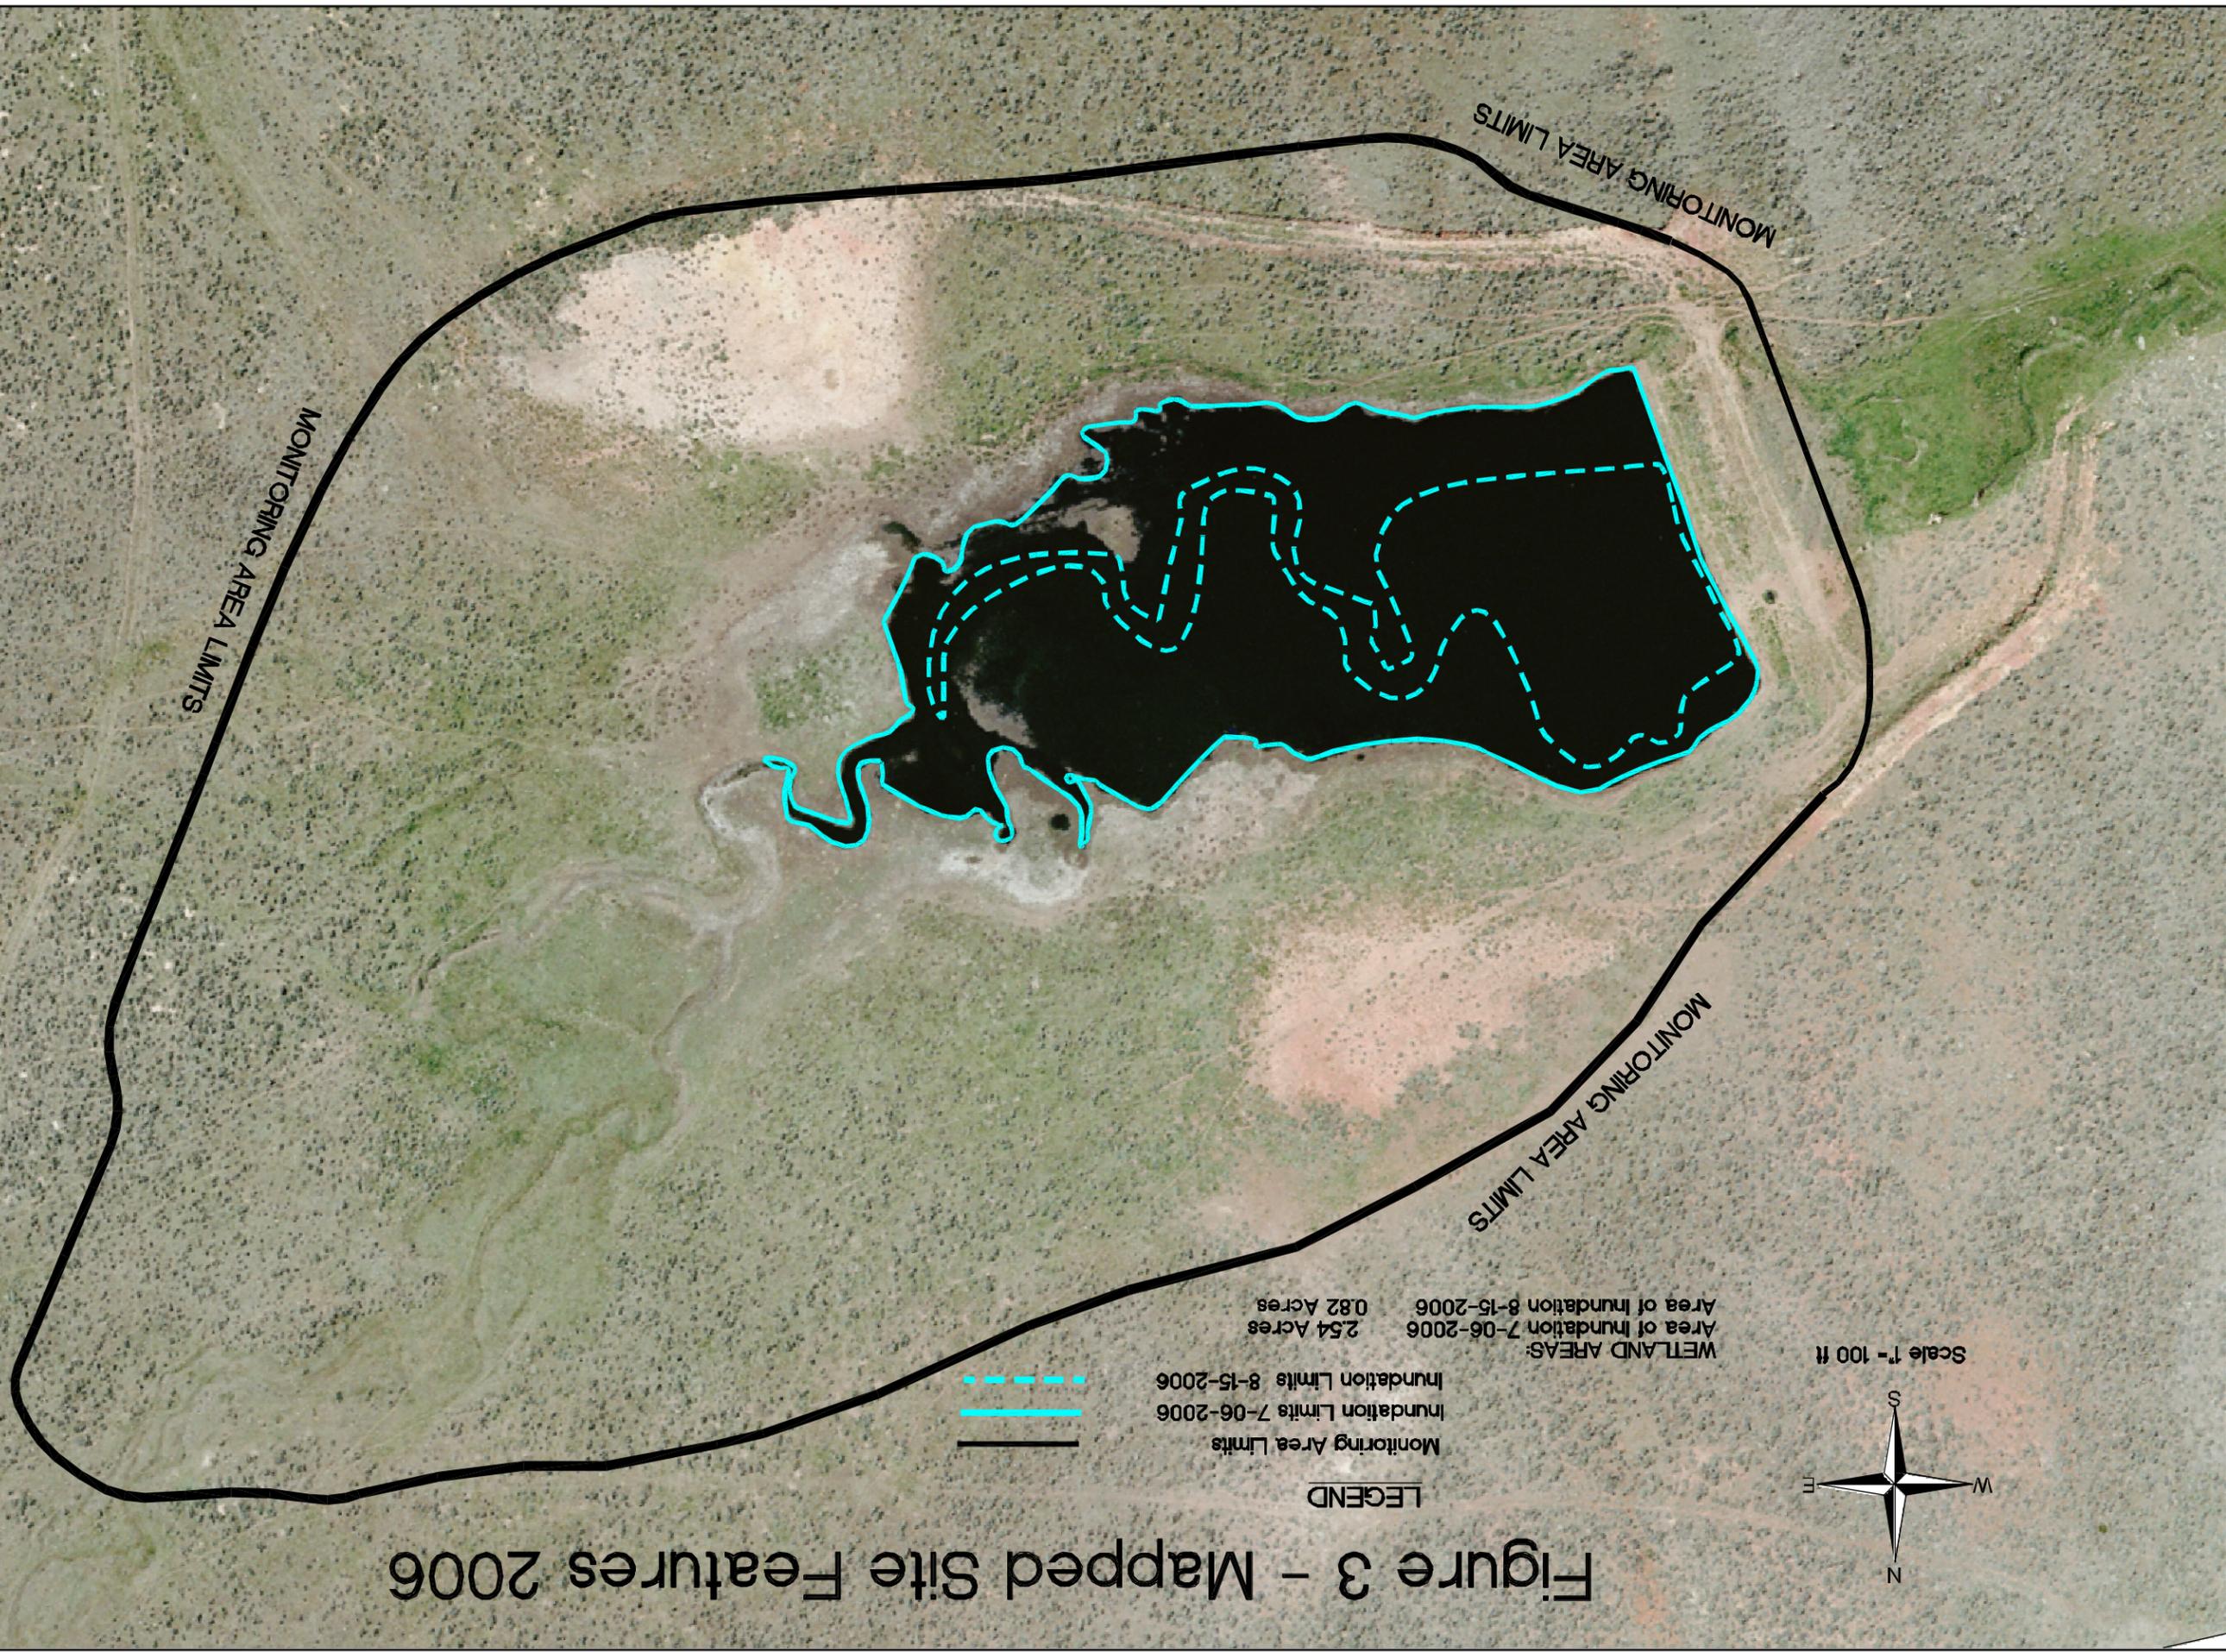
Figure 3 - Mapped Site Features 2006

Inundation Limits 7-06-2006

Inundation Limits 8-15-2006

Area of Inundation 7-06-2006

2.54 Acres

Area of Inundation 8-15-2006

0.82 Acres

As previously stated, in May 2000, the COE determined that this site could not be used as permanent mitigation for the Ringling – North project due to the lack of a perpetual conservation easement. No specific performance criteria were required to be met at this site in order to document its success. To date, the site has yet to create any wetland habitat and therefore no credit, COE approved or otherwise, for wetland creation can be attributed to this project. At its maximum in 2006, the site supported 2.54 acres of non-wetland aquatic habitat (open water). Through evaporation and infiltration, the amount of open water decreased to 0.82 acres at the time of the mid-season site visit on August 15th.
