**MONTANA DEPARTMENT OF TRANSPORTATION
WETLAND MITIGATION MONITORING REPORT: YEAR 2007**

*American Colloid Mitigation Site
Alzada, Montana*

December 2007

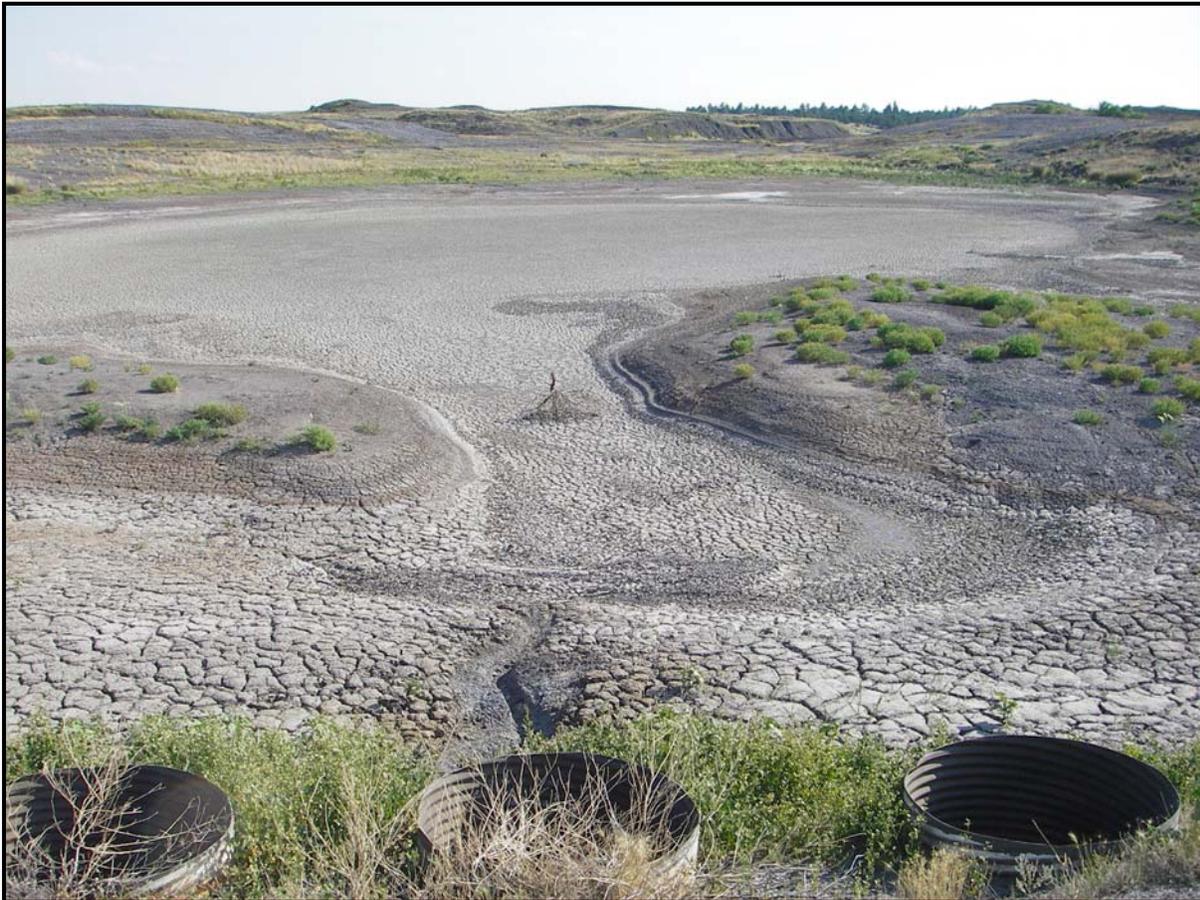
Cover Photograph: The Colloid Wetland with no water, which is a result of the 2007 dam breach.

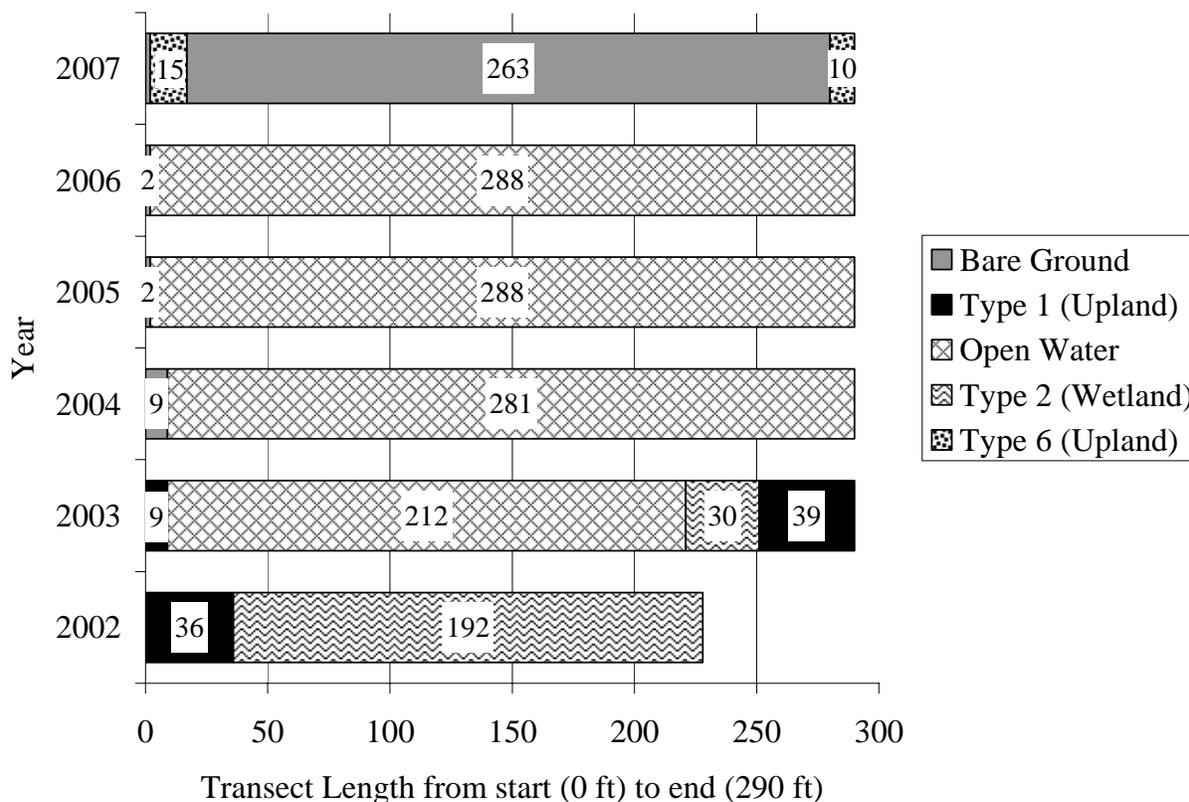
Chart 2: Transect maps showing vegetation types from the start (0 feet) to the end of transect (228 ft in 2002; 290 ft in 2003-2007).

The small wetland vegetation communities scattered around the wetland site did not change appreciably since 2006, except for the development of the new community type 6 around the outer periphery of the area that was inundated prior to the dam breach event (**Figure 3 in Appendix A**). The dominant vegetation in community type 6 is *Atriplex suckleyi* (formerly *A. dioaca*), which is not listed in the Region 4 wetland indicator manual (Reed 1988). Habitat as listed by several plant identification keys states this species is found in barren, alkaline habitats, with no mention of the plant associating with water habitats (Dorn 1984). Therefore, this plant and community type is assumed to be upland.

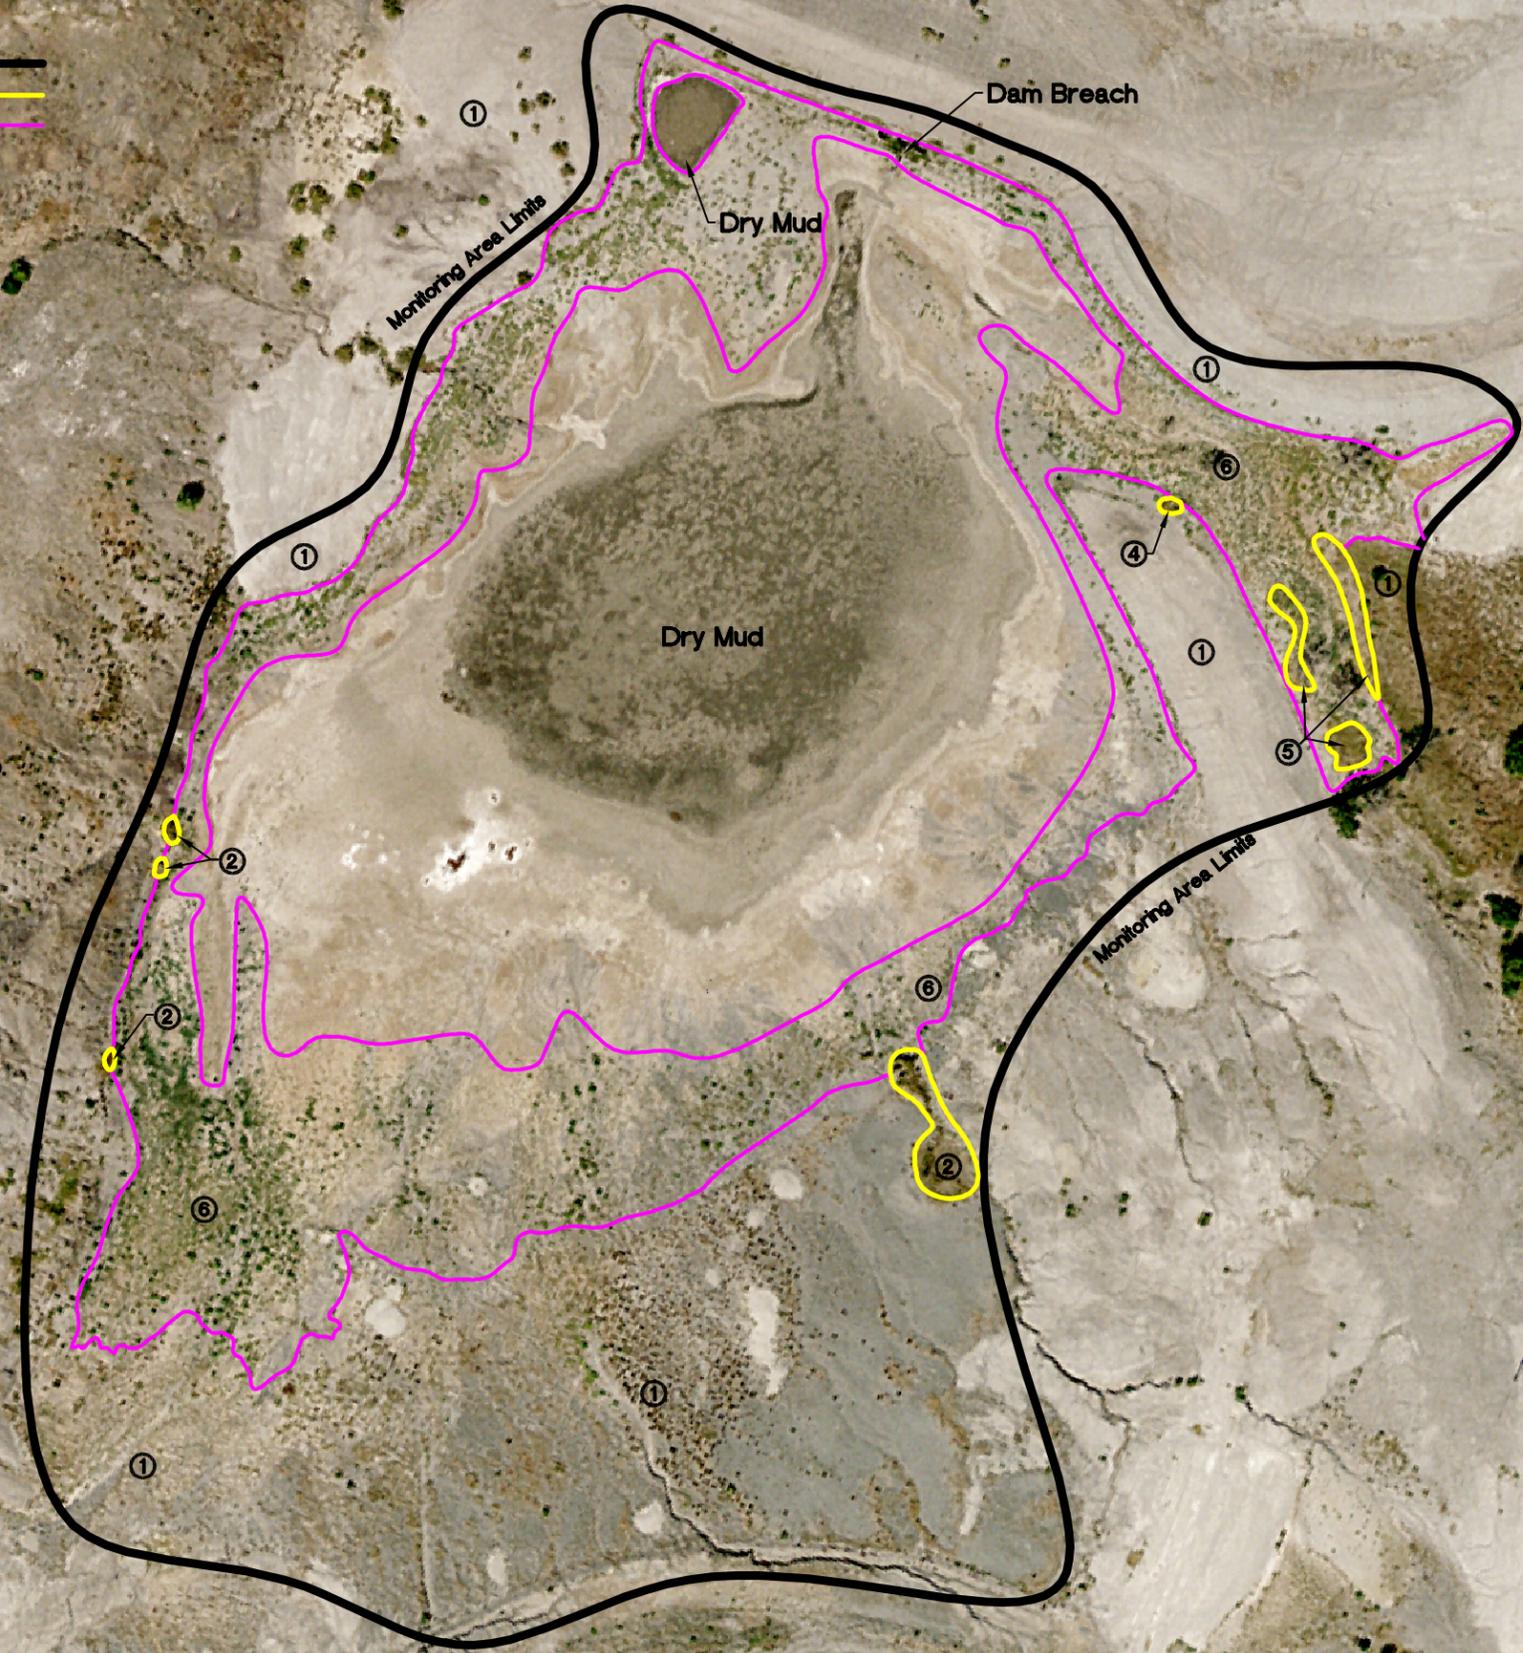
Wetland Area
 Gross Wetland Area 0.06 Acres
 Open Water 0.00 Acres
 Net Wetland Area 0.06 Acres

- Vegetation Community Codes**
- ① *Grindelia squarrosa*/*Chrysothamnus* spp.
 - ② *Spartina pectinata*
 - ③ *Hordeum jubatum*
 - ④ *Typha angustifolia*
 - ⑤ *Beckmannia syzigachne*/*Juncus tenuis*
 - ⑥ *Atriplex suckleyi*

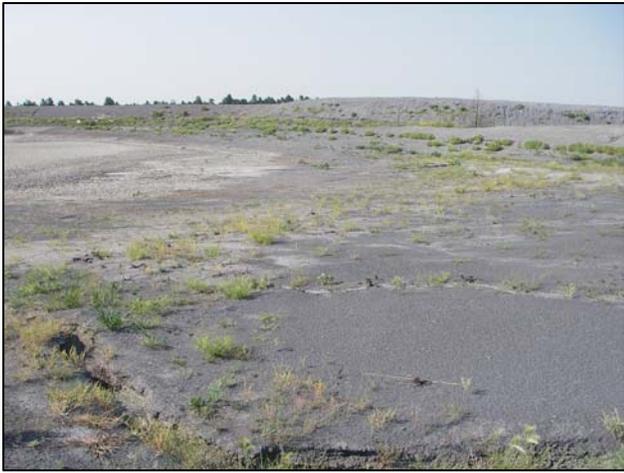
**Location: A Description: Toward outlet
Compass Reading: 2°**

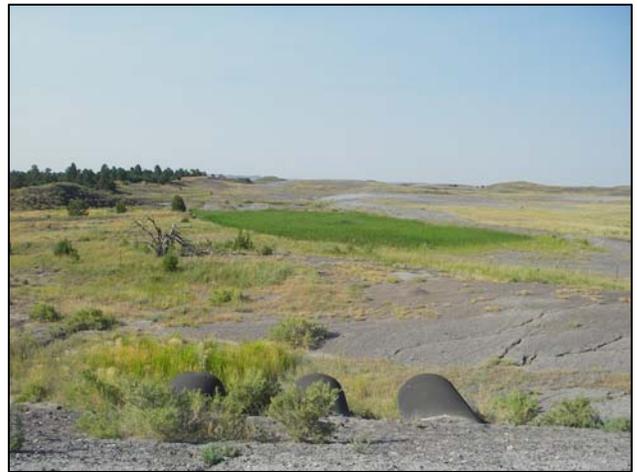
**Location: D Photo Frame: 16 Description:
Downstream of dam Compass Reading: 25°**

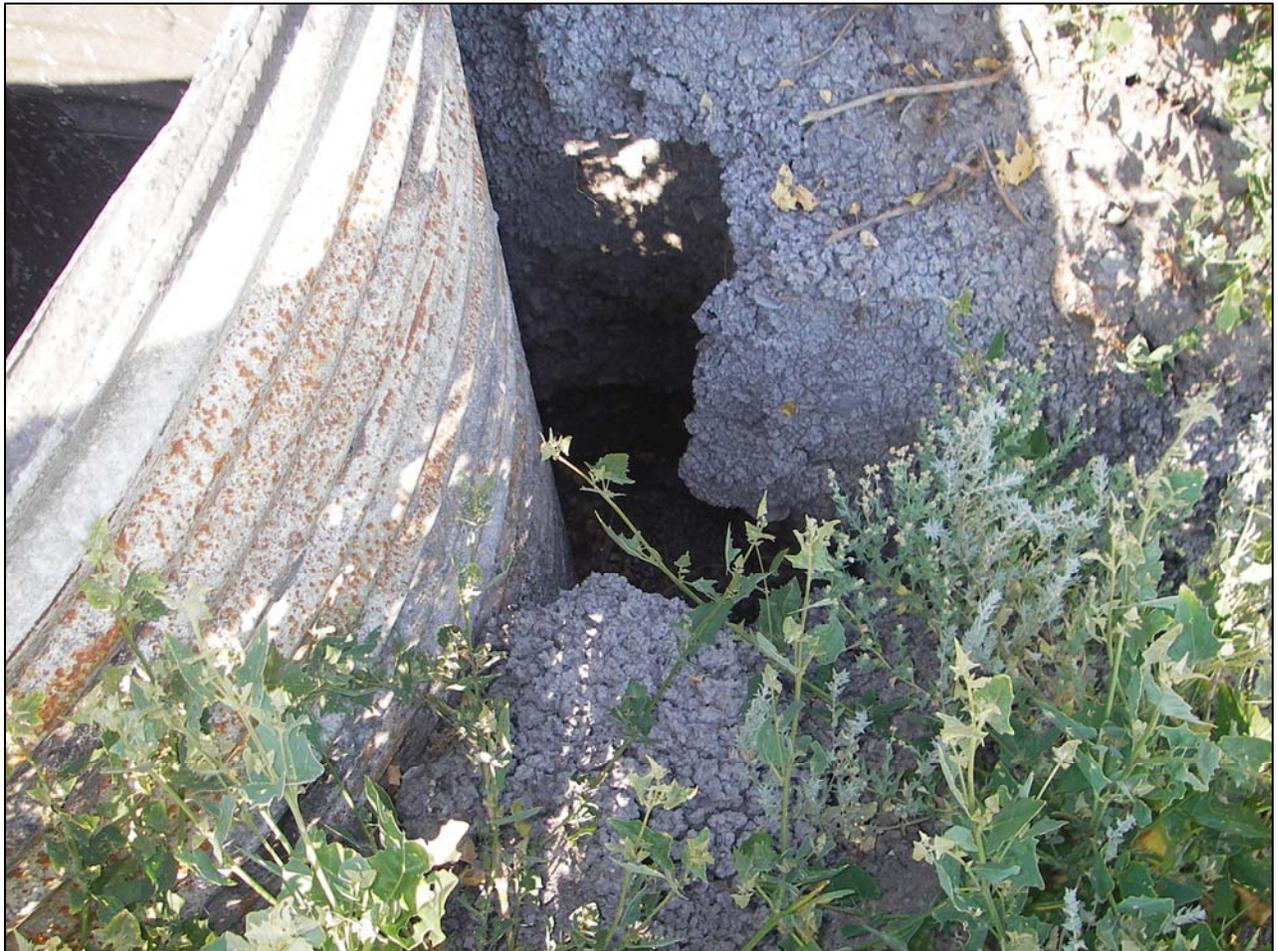
MDT was notified by the aerial photographer in early July that the site was dry (Urban pers. comm.). At the time of the investigation in mid-July it was confirmed that no water was in the site and the dam had been breached. There are three risers on the south side of the berm and three horizontal culverts attached to these risers which convey overflow water to the north side of the dam. The dam failed due to a horizontal hole on the east side of the center riser on the south side of the berm. A hole was also observed on the north side of the dam beneath a different culvert (there was not a straight line to the culvert hole on the south side). It appeared that the dam was undermined by water flowing beneath a least two of the culverts in a diagonal fashion. MDT was immediately notified of the breach and photographs were sent to assist the staff with diagnosing the situation.

Comments / Problems: **The center culvert has a deep hole (4-5ft) on the east side where water flowed through the dam. A hole was also observed on the north side of the dam but not the same culvert.**

Location: I **Description:** Middle culvert washout on south side of berm resulting in draining of site; hole was more than 4 feet deep.

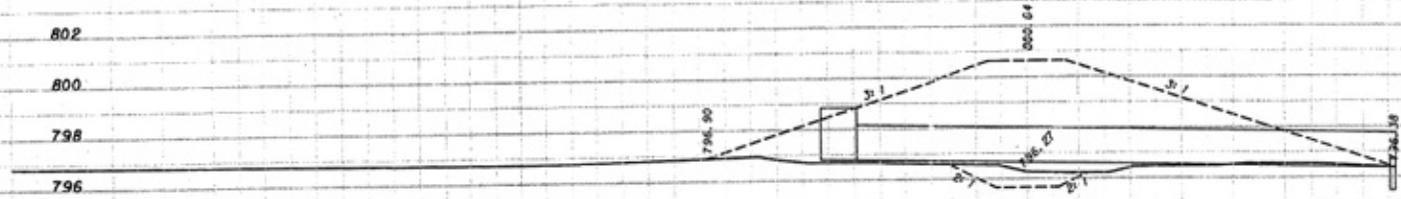
0+20.00

0+20
TRIPLE 1350 mm x 63.0 m CSP
TRIPLE 1350 mm x 5.5 m CSP RISER LT
2.5 m³ CL DD CONC CUTOFF WALL
0.7 m³ CL DD CONC BASE
2.9 m COVER
