**MONTANA DEPARTMENT OF TRANSPORTATION
WETLAND MITIGATION MONITORING REPORT: YEAR 2010**

*Rock Creek Ranch
Hinsdale, Valley County, Montana*

WETLAND MITIGATION MONITORING REPORT:

MDT Project Number STPX-STPS 53(88)
Control Number 5230

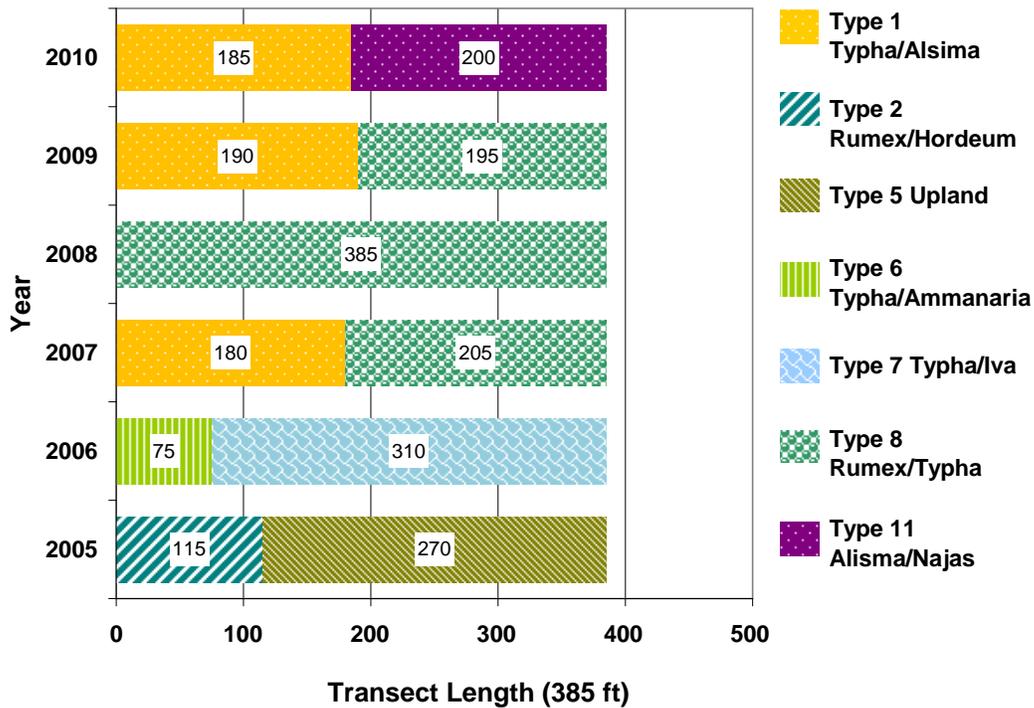
Chart 1. Transect map showing vegetation types on Transect 1 from the start (0 feet) to end (385 feet) for 2005 to 2010.

areas and by broad-leaf cattail in the less inundated areas. Only dead curly dock stems were observed, suggesting increased levels of inundation from above average precipitation during the 2010 growing season. There was abundant cover of green algae, pond weed, and slender naiad.

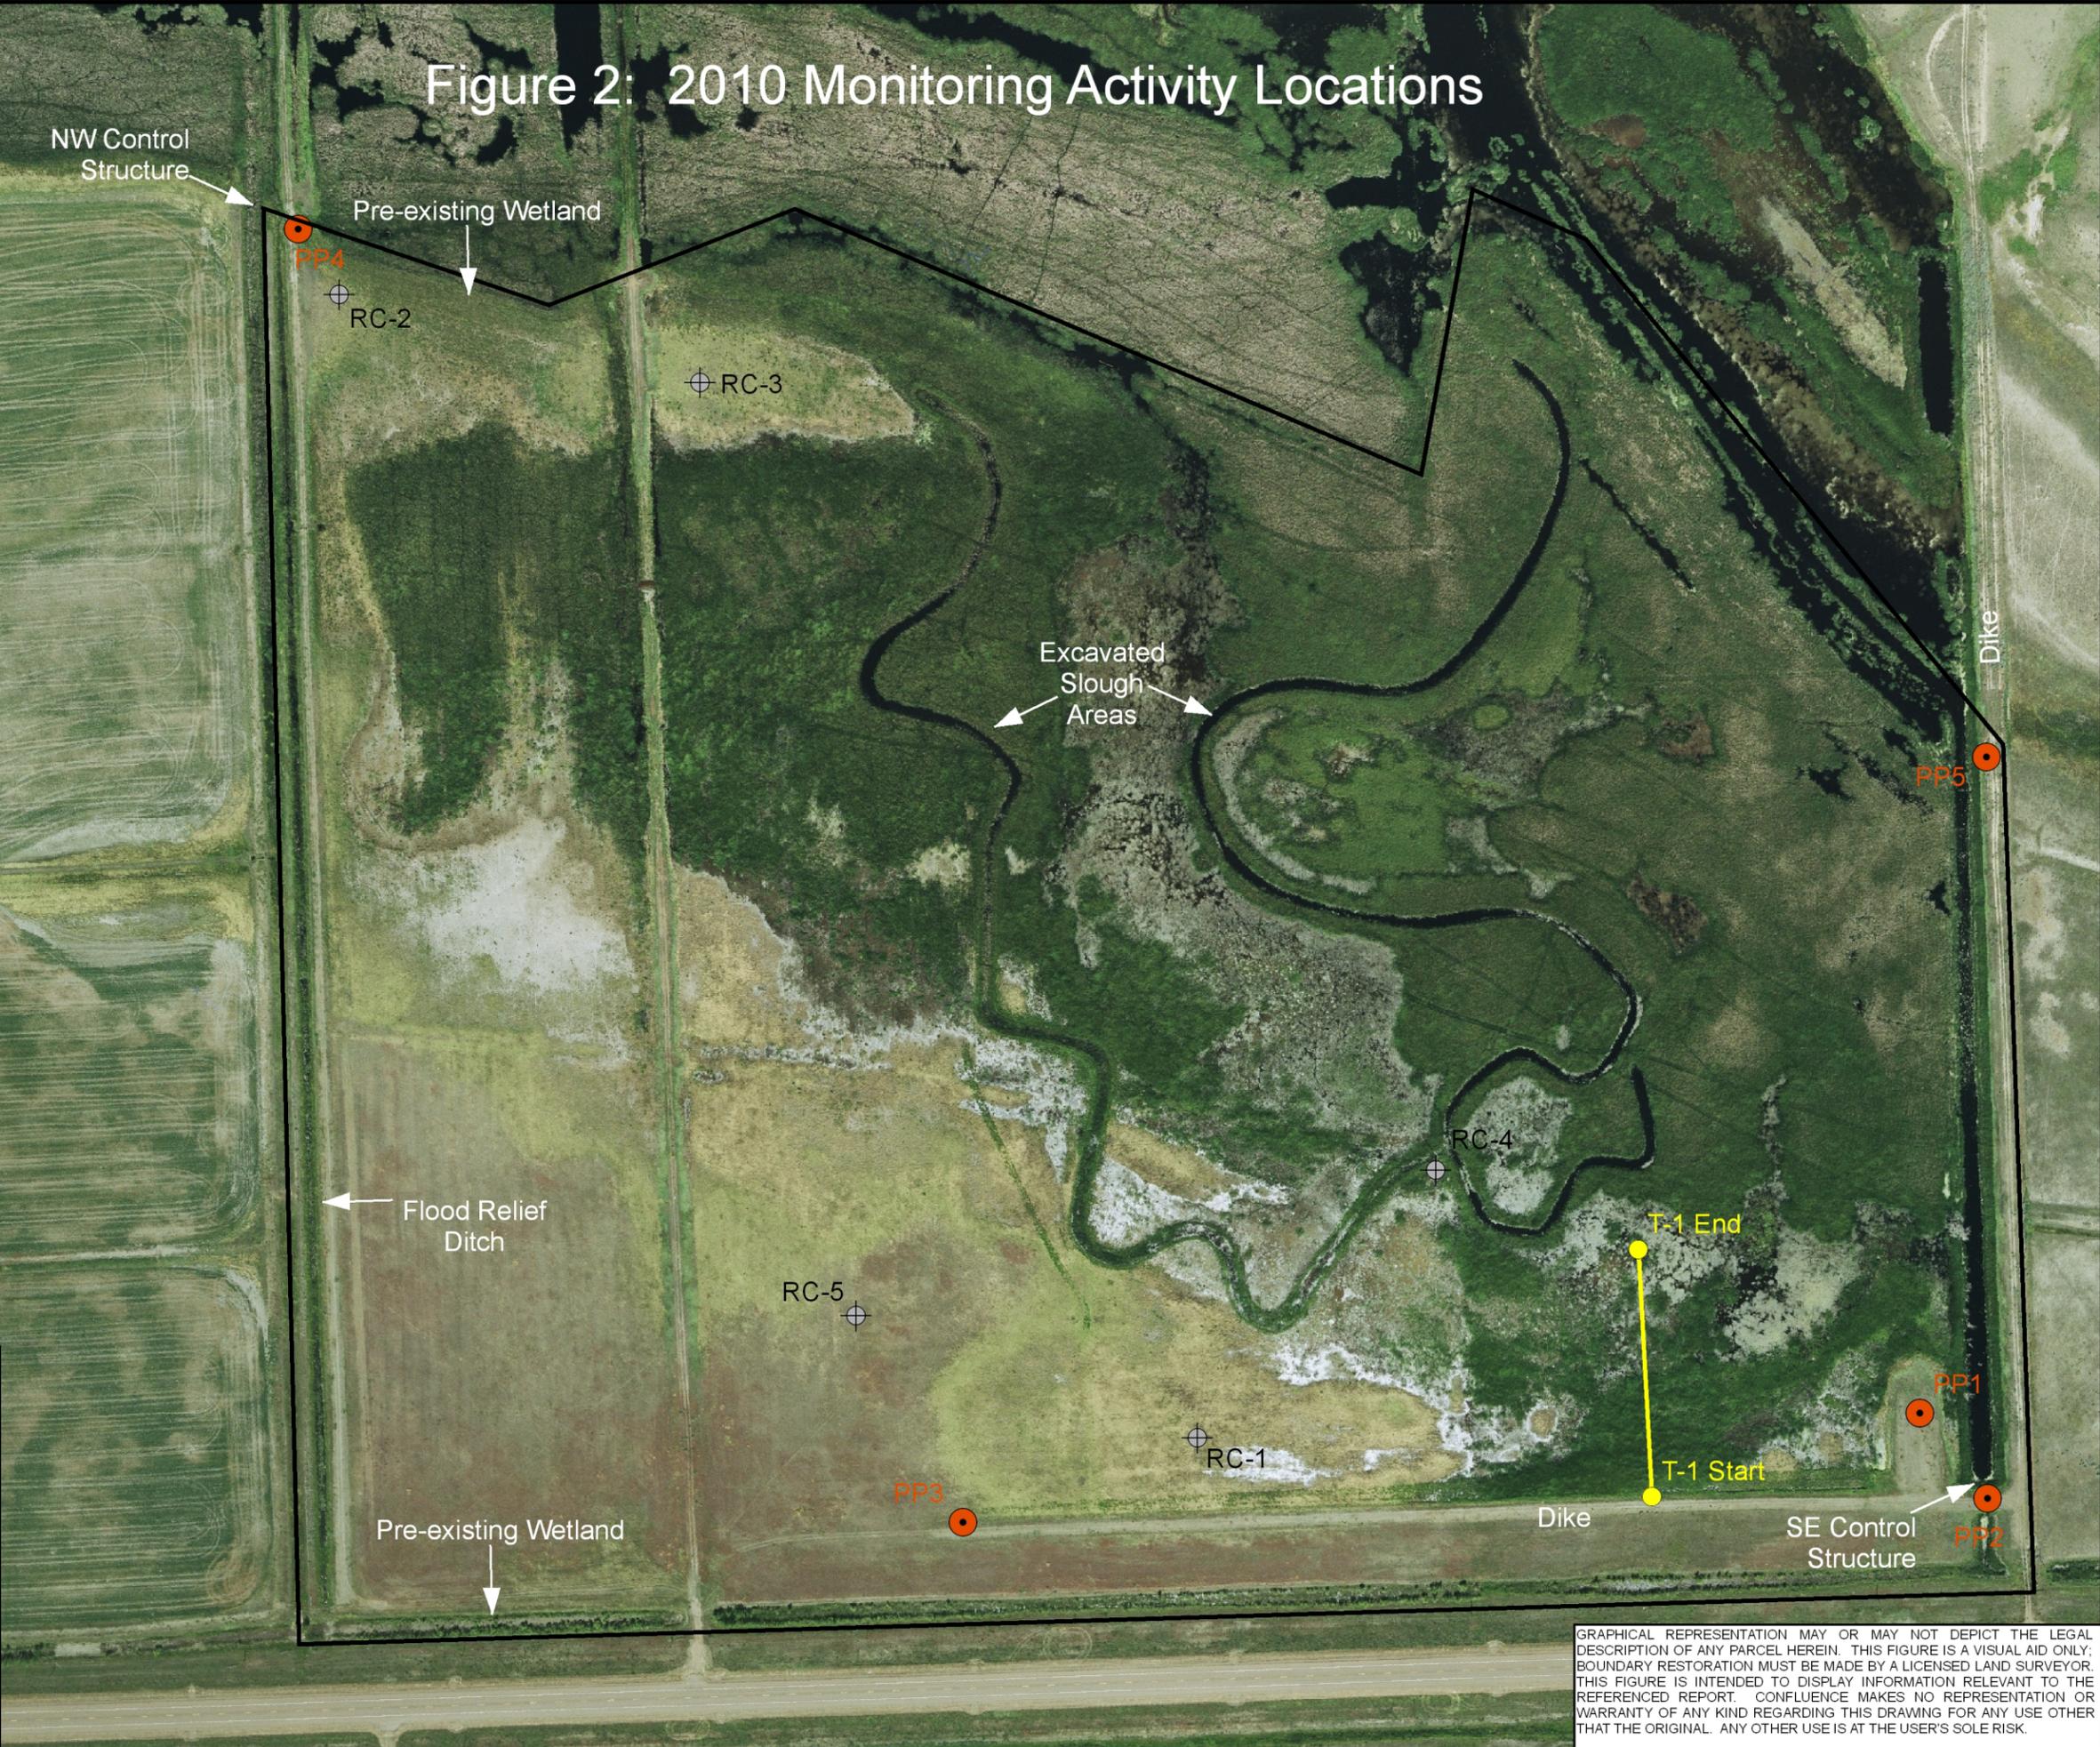
Figure 2: 2010 Monitoring Activity Locations

The monitoring area is illustrated on Figure 2 of Appendix A and Figure 3 of Appendix A shows the mapped site features. The MDT Mitigation Monitoring Form, the US Army Corps of Engineers (USACE) Routine Wetland Determination Data Forms (Environmental Laboratory 1987), and the 2008 MDT Montana Wetland Assessment Forms completed in 2010 are included in Appendix B. Appendix C shows representative photographs of the site and Appendix D is the Project Plan Sheet.

Temporal changes in vegetation were evaluated through annual assessments of a static belt transect (Figure 2, Appendix A). Vegetation composition was assessed and recorded along a single vegetation belt transect approximately 10 feet wide and 385 feet long (Figure 2, Appendix A). The transect location was recorded with a GPS unit. Spatial changes in the dominant vegetation communities were recorded along the stationed transect. Percent cover of each vegetation species within the “belt” was estimated using the same values and cover ranges listed for the community polygon data on the aerial photograph (Appendix B). Photographs were taken at the transect endpoints during the monitoring event (Appendix C). Woody species were planted at the site in May 2007. Woody species survival was tracked from 2007 through 2010.

Monitoring at photo points provides supplemental information documenting wetland condition, trends, current land use surrounding the site, the upland buffer, the monitored area, and the vegetation transects. Photographs were taken at established photo points throughout the mitigation site during the site visit (Appendix C). Photo point locations were recorded with a resource grade GPS unit (Figure 2, Appendix A).

Data points RC-1 and RC-2 (Figure 2, Appendix A) exhibited saturation at 6 inches and 8 inches, respectively, below the ground surface (bgs) and the depth to free water in the pit (high water table) at 12 inches bgs. The sample plot for RC-3 represented a potential problem area based on seasonal hydrologic fluctuations and the absence of saturation within 12 inches of the ground surface during the August evaluation. Surface soil cracks provided evidence of seasonal inundation. The area was mapped as upland in 2009. There were no other primary indicators of wetland hydrology. Data point RC-4 located adjacent to the excavated slough was inundated with surface water to a depth of 8 inches. Data point RC-5 was located in an upland with no wetland hydrologic indicators.

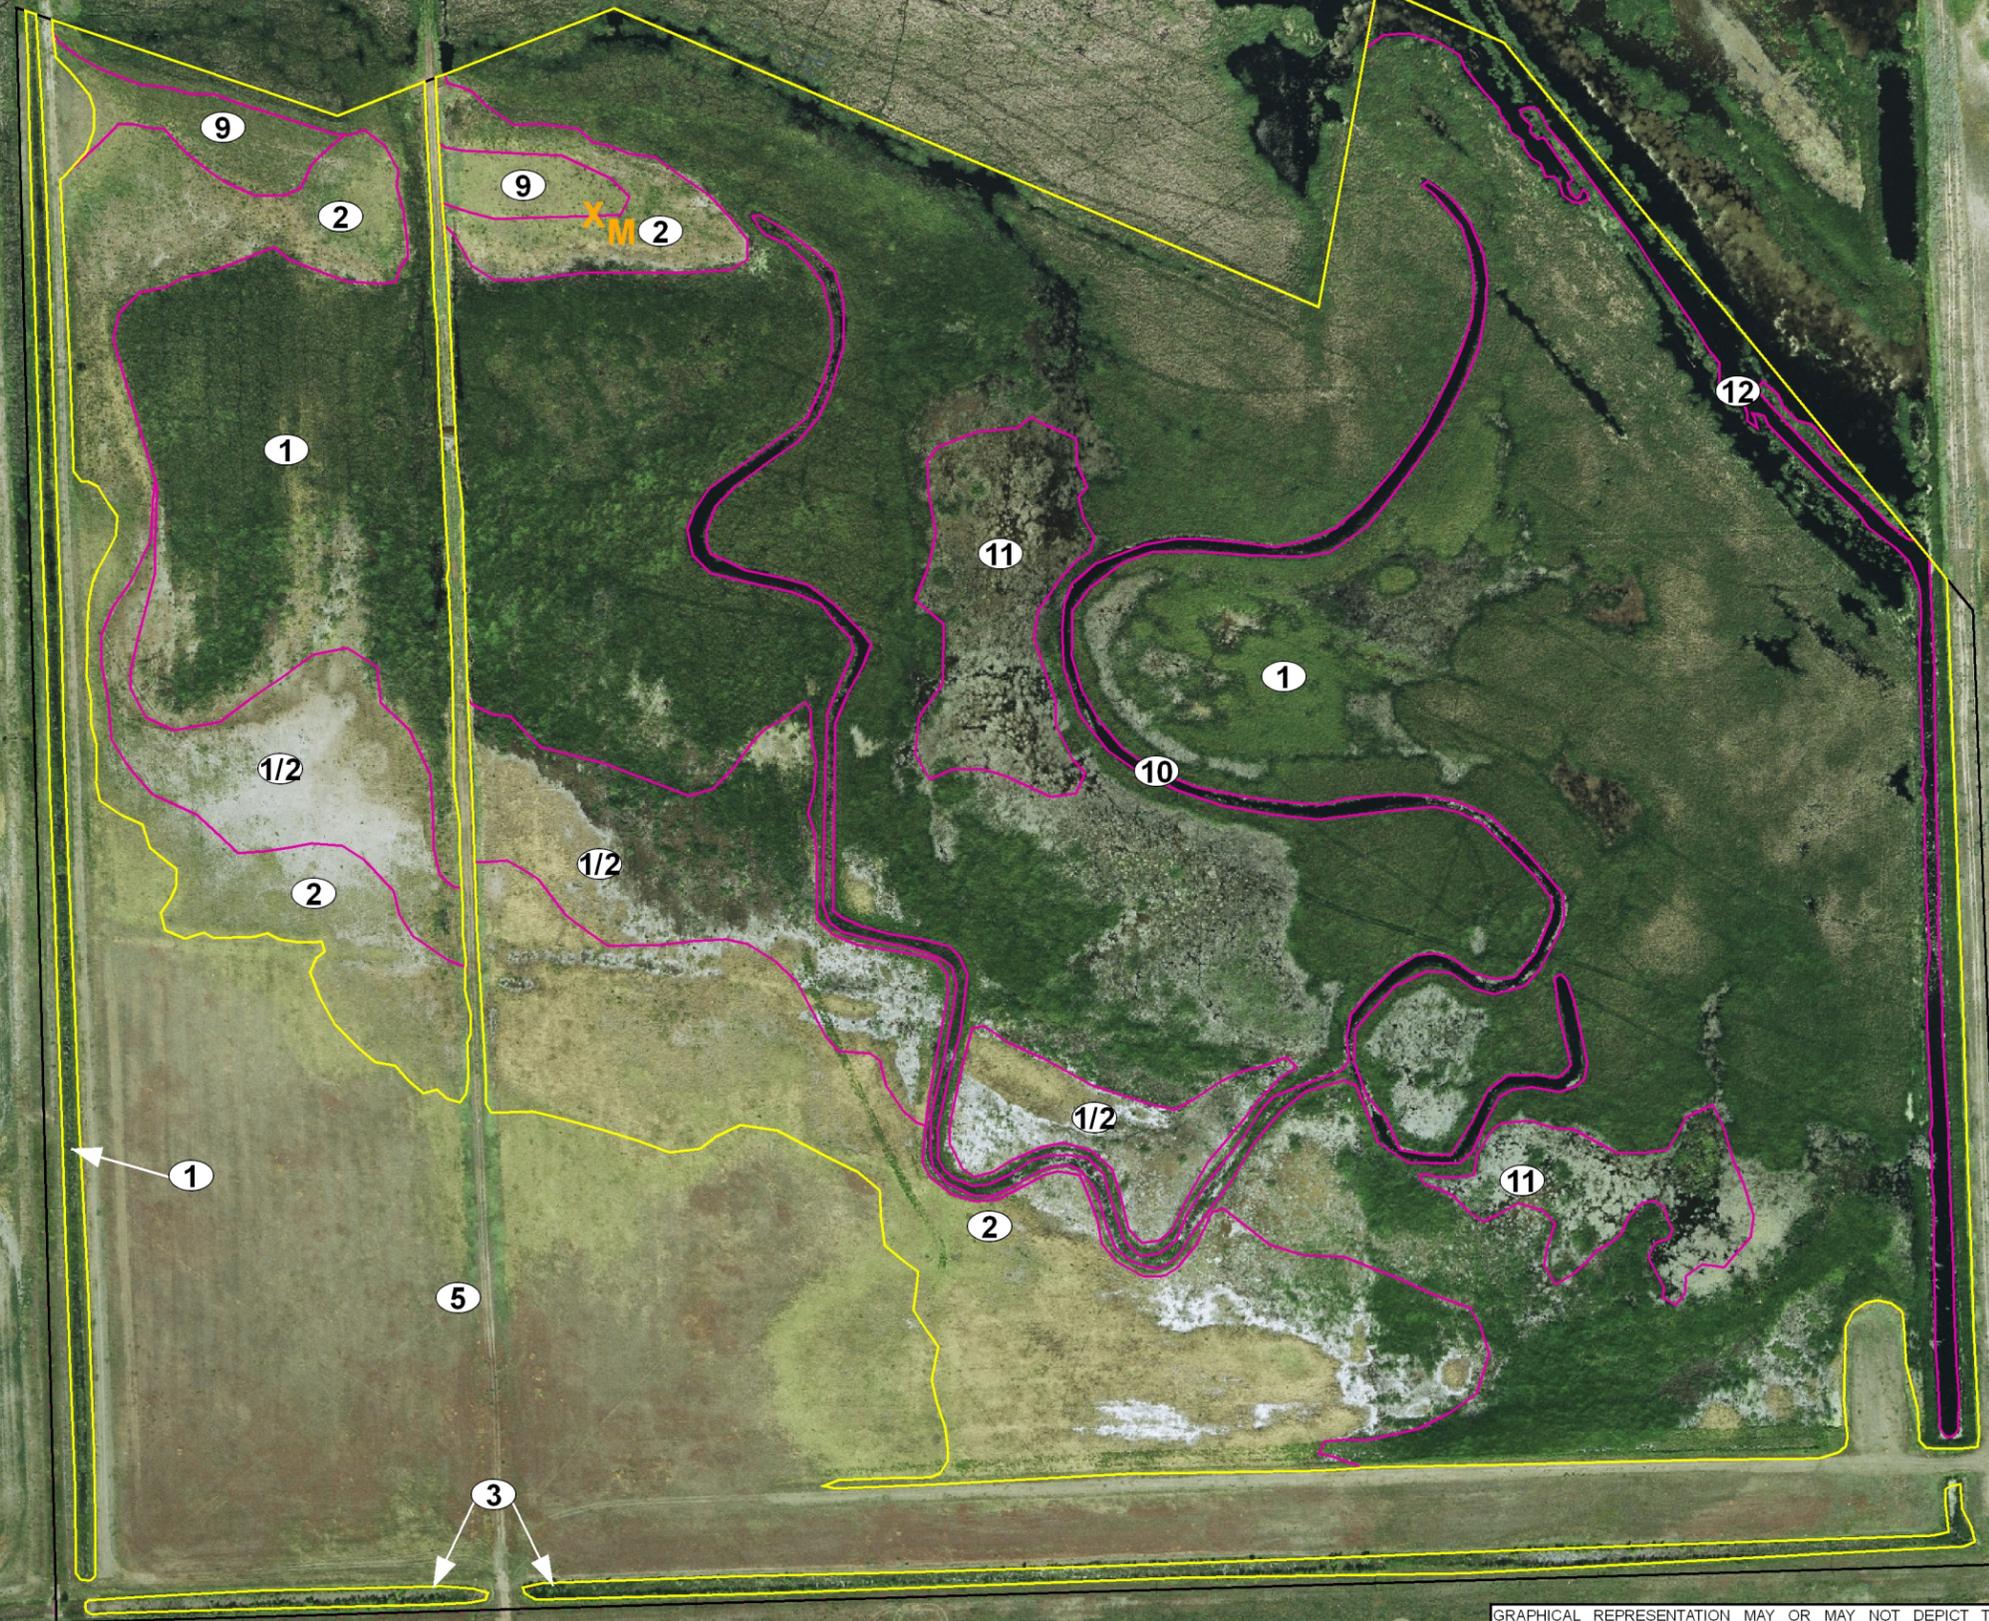
Project Name: Rock Creek Ranch Wetland Mitigation
Drawing Title: 2010 Mapped Site Features

The location of noxious weeds was noted in the field and mapped on the aerial photo (Figure 3, Appendix A). The noxious weed species identified are color-coded. The locations are denoted with the symbol “+”, “▲”, or “■” representing 0 to 0.1 acre, 0.1 to 1.0 acre, or greater than 1 acre in extent, respectively. Cover classes are represented by T, L, M, or H, for less than 1 percent, 1 to 5 percent, 2 to 25 percent, and 25 to 100 percent, respectively, as listed on Figure 3 (Appendix A).

No man-made nesting structures were installed onsite. The control structures were in good repair. An infestation of Canada thistle (*Cirsium arvense*), a Priority 2B noxious weed, was identified in 2010 in the northwest corner of the site (Figure 3, Appendix A), a limited number of plants were also identified in Type 5 - Upland. The weed control plan should continue to be implemented to prevent encroachment of the weed into disturbed areas.

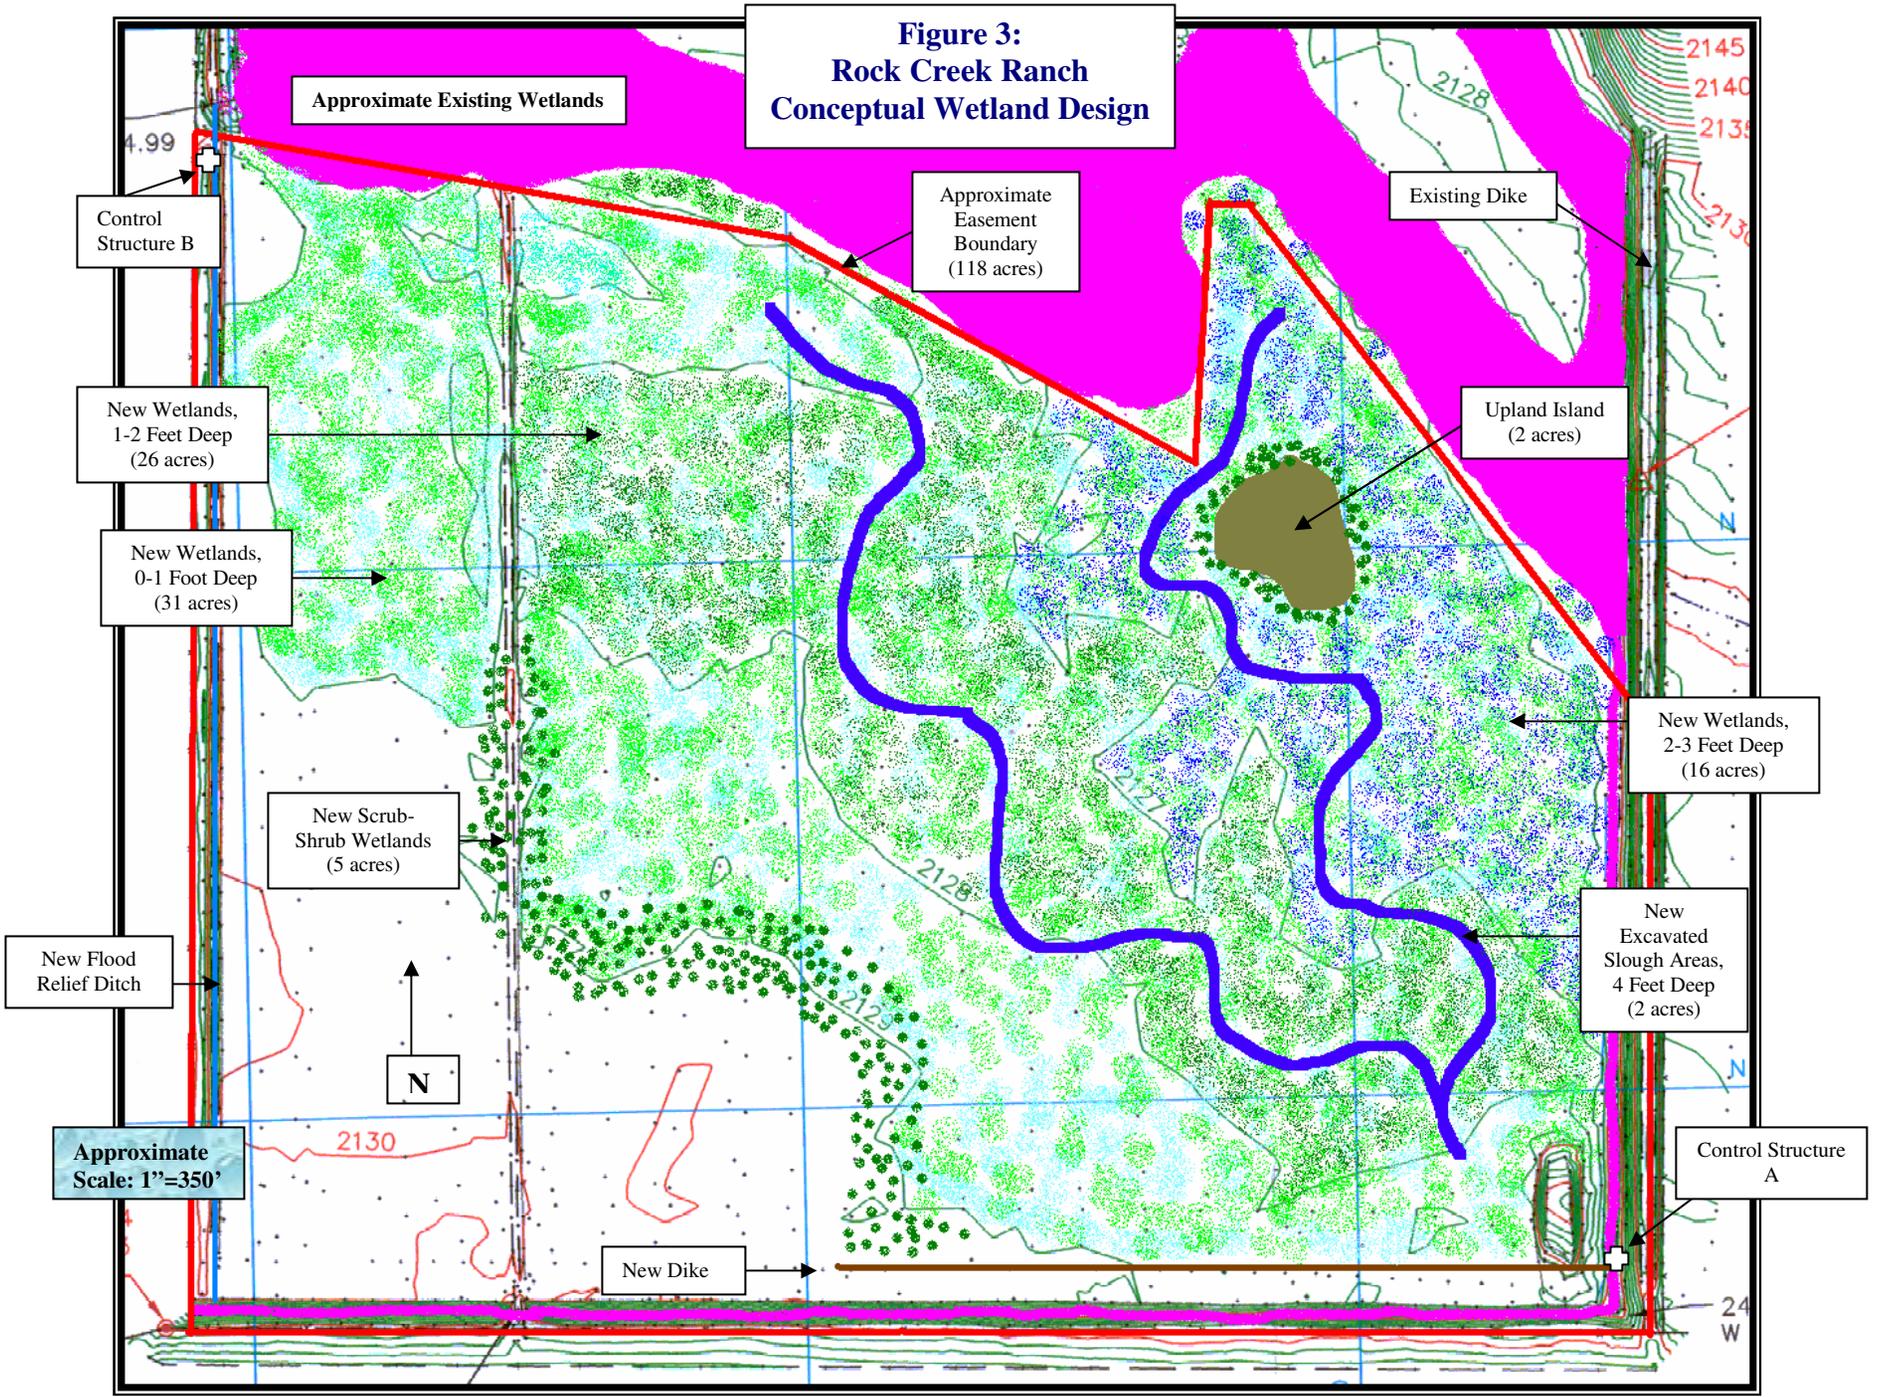
**Figure 3:
Rock Creek Ranch
Conceptual Wetland Design**

The approximate design water depths are shown on the conceptual plan in Appendix D. Hydrological indicators outlined on the USACE wetland determination form were documented at five data points (RC-1 to RC-5) established within the project area. Hydrologic indicators were evaluated according to features observed during the site visit. The data were recorded on electronic field data sheets (Appendix B). Hydrologic assessments allow evaluation of mitigation goals addressing inundation and saturation requirements. No groundwater monitoring wells were installed at this site. Soil pits excavated during the wetland delineation were used to evaluate groundwater levels within 18 inches of the ground surface. The data were recorded electronically on the wetland determination form (Appendix B).
