MONTANA DEPARTMENT OF TRANSPORTATION WETLAND MITIGATION MONITORING REPORT: YEAR 2011

*American Colloid Mitigation Site
Alzada, Carter County, Montana*

Initial Construction:
MDT Project Number NH STPS BR 6(10)
Control Number 1396

Watershed 16 Repair:
MDT Project Number STPX 6(15)
Control Number 6714

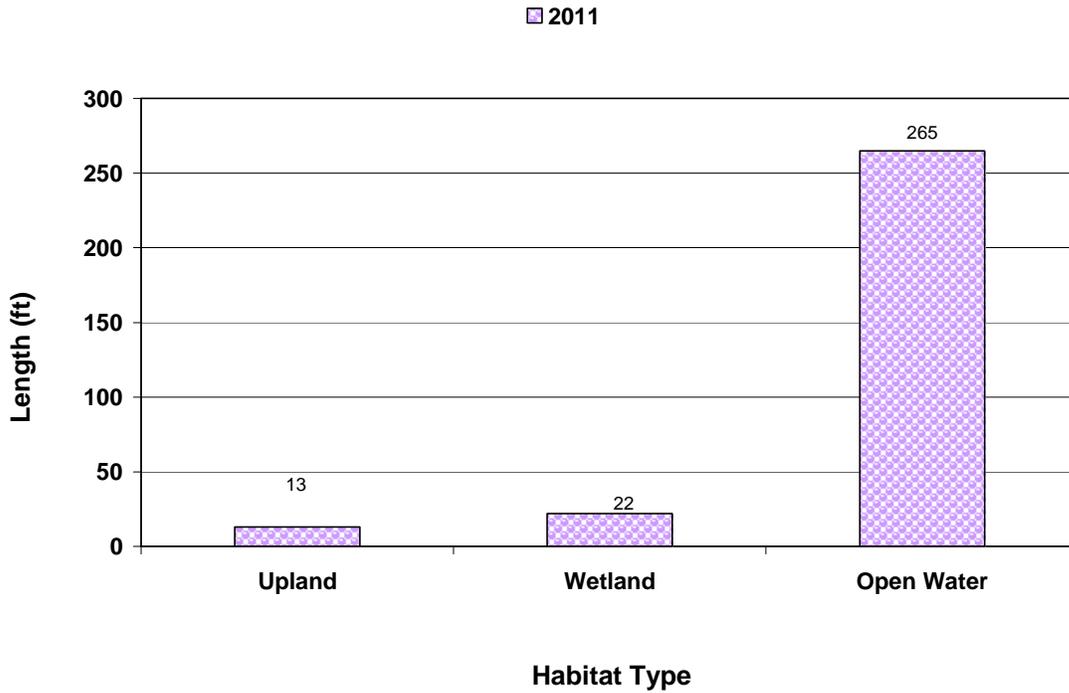
Chart 1. Transect map showing community types on Transect 1 in 2011 from start (0 feet) to finish (300 feet) at American Colloid.

Monitoring Year	2011
Transect Length (feet)	300
Vegetation Community Transitions along Transect	3
Vegetation Communities along Transect	2
Hydrophytic Vegetation Communities along Transect	1
Total Vegetative Species	7
Total Hydrophytic Species	4
Total Upland Species	3
Estimated % Total Vegetative Cover	12
% Transect Length Comprising Hydrophytic Vegetation	7.3
% Transect Length Comprising Upland Vegetation Communities	4.3
% Transect Length Comprising Unvegetated Open Water	88.3
% Transect Length Comprising Bare Substrate	0.0

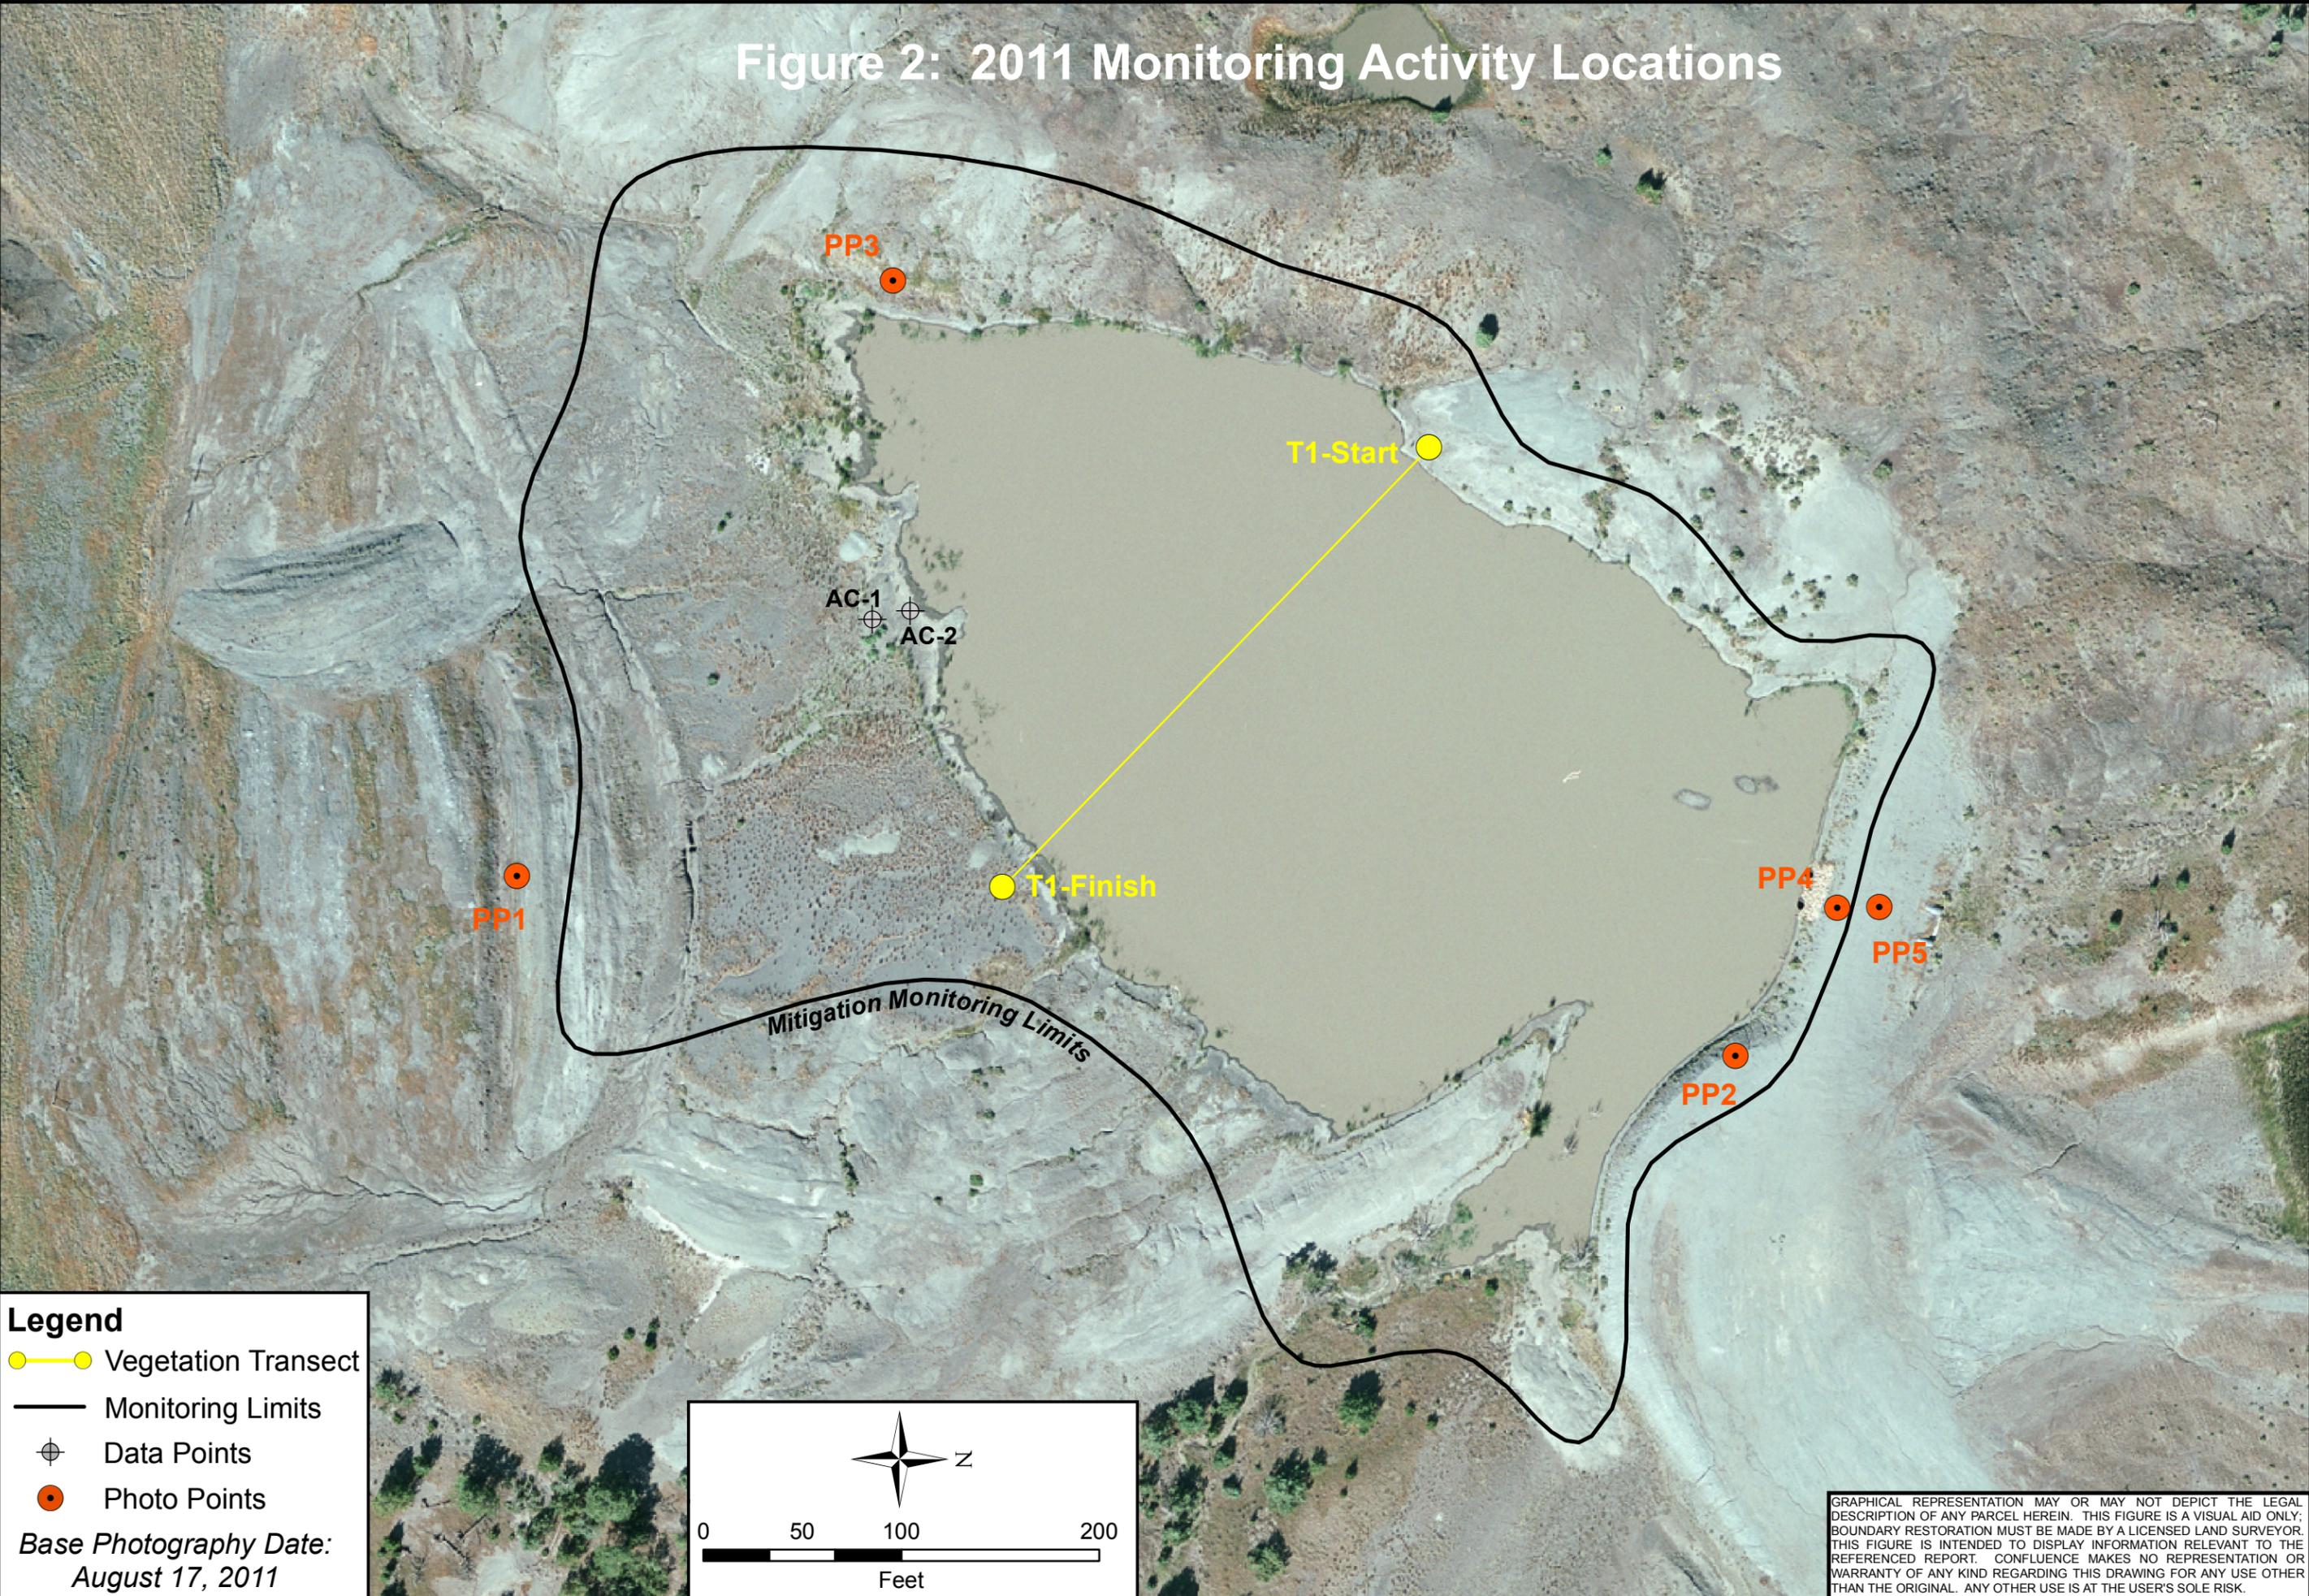
Figure 2: 2011 Monitoring Activity Locations

Monitoring at photo points provided supplemental information documenting wetland, upland, and transect conditions; site trends; and current land uses surrounding the site. Photographs were taken at established photo points throughout the mitigation site during the site visit (Appendix C). Photo point locations were recorded with a resource grade GPS unit (Figure 2, Appendix A).

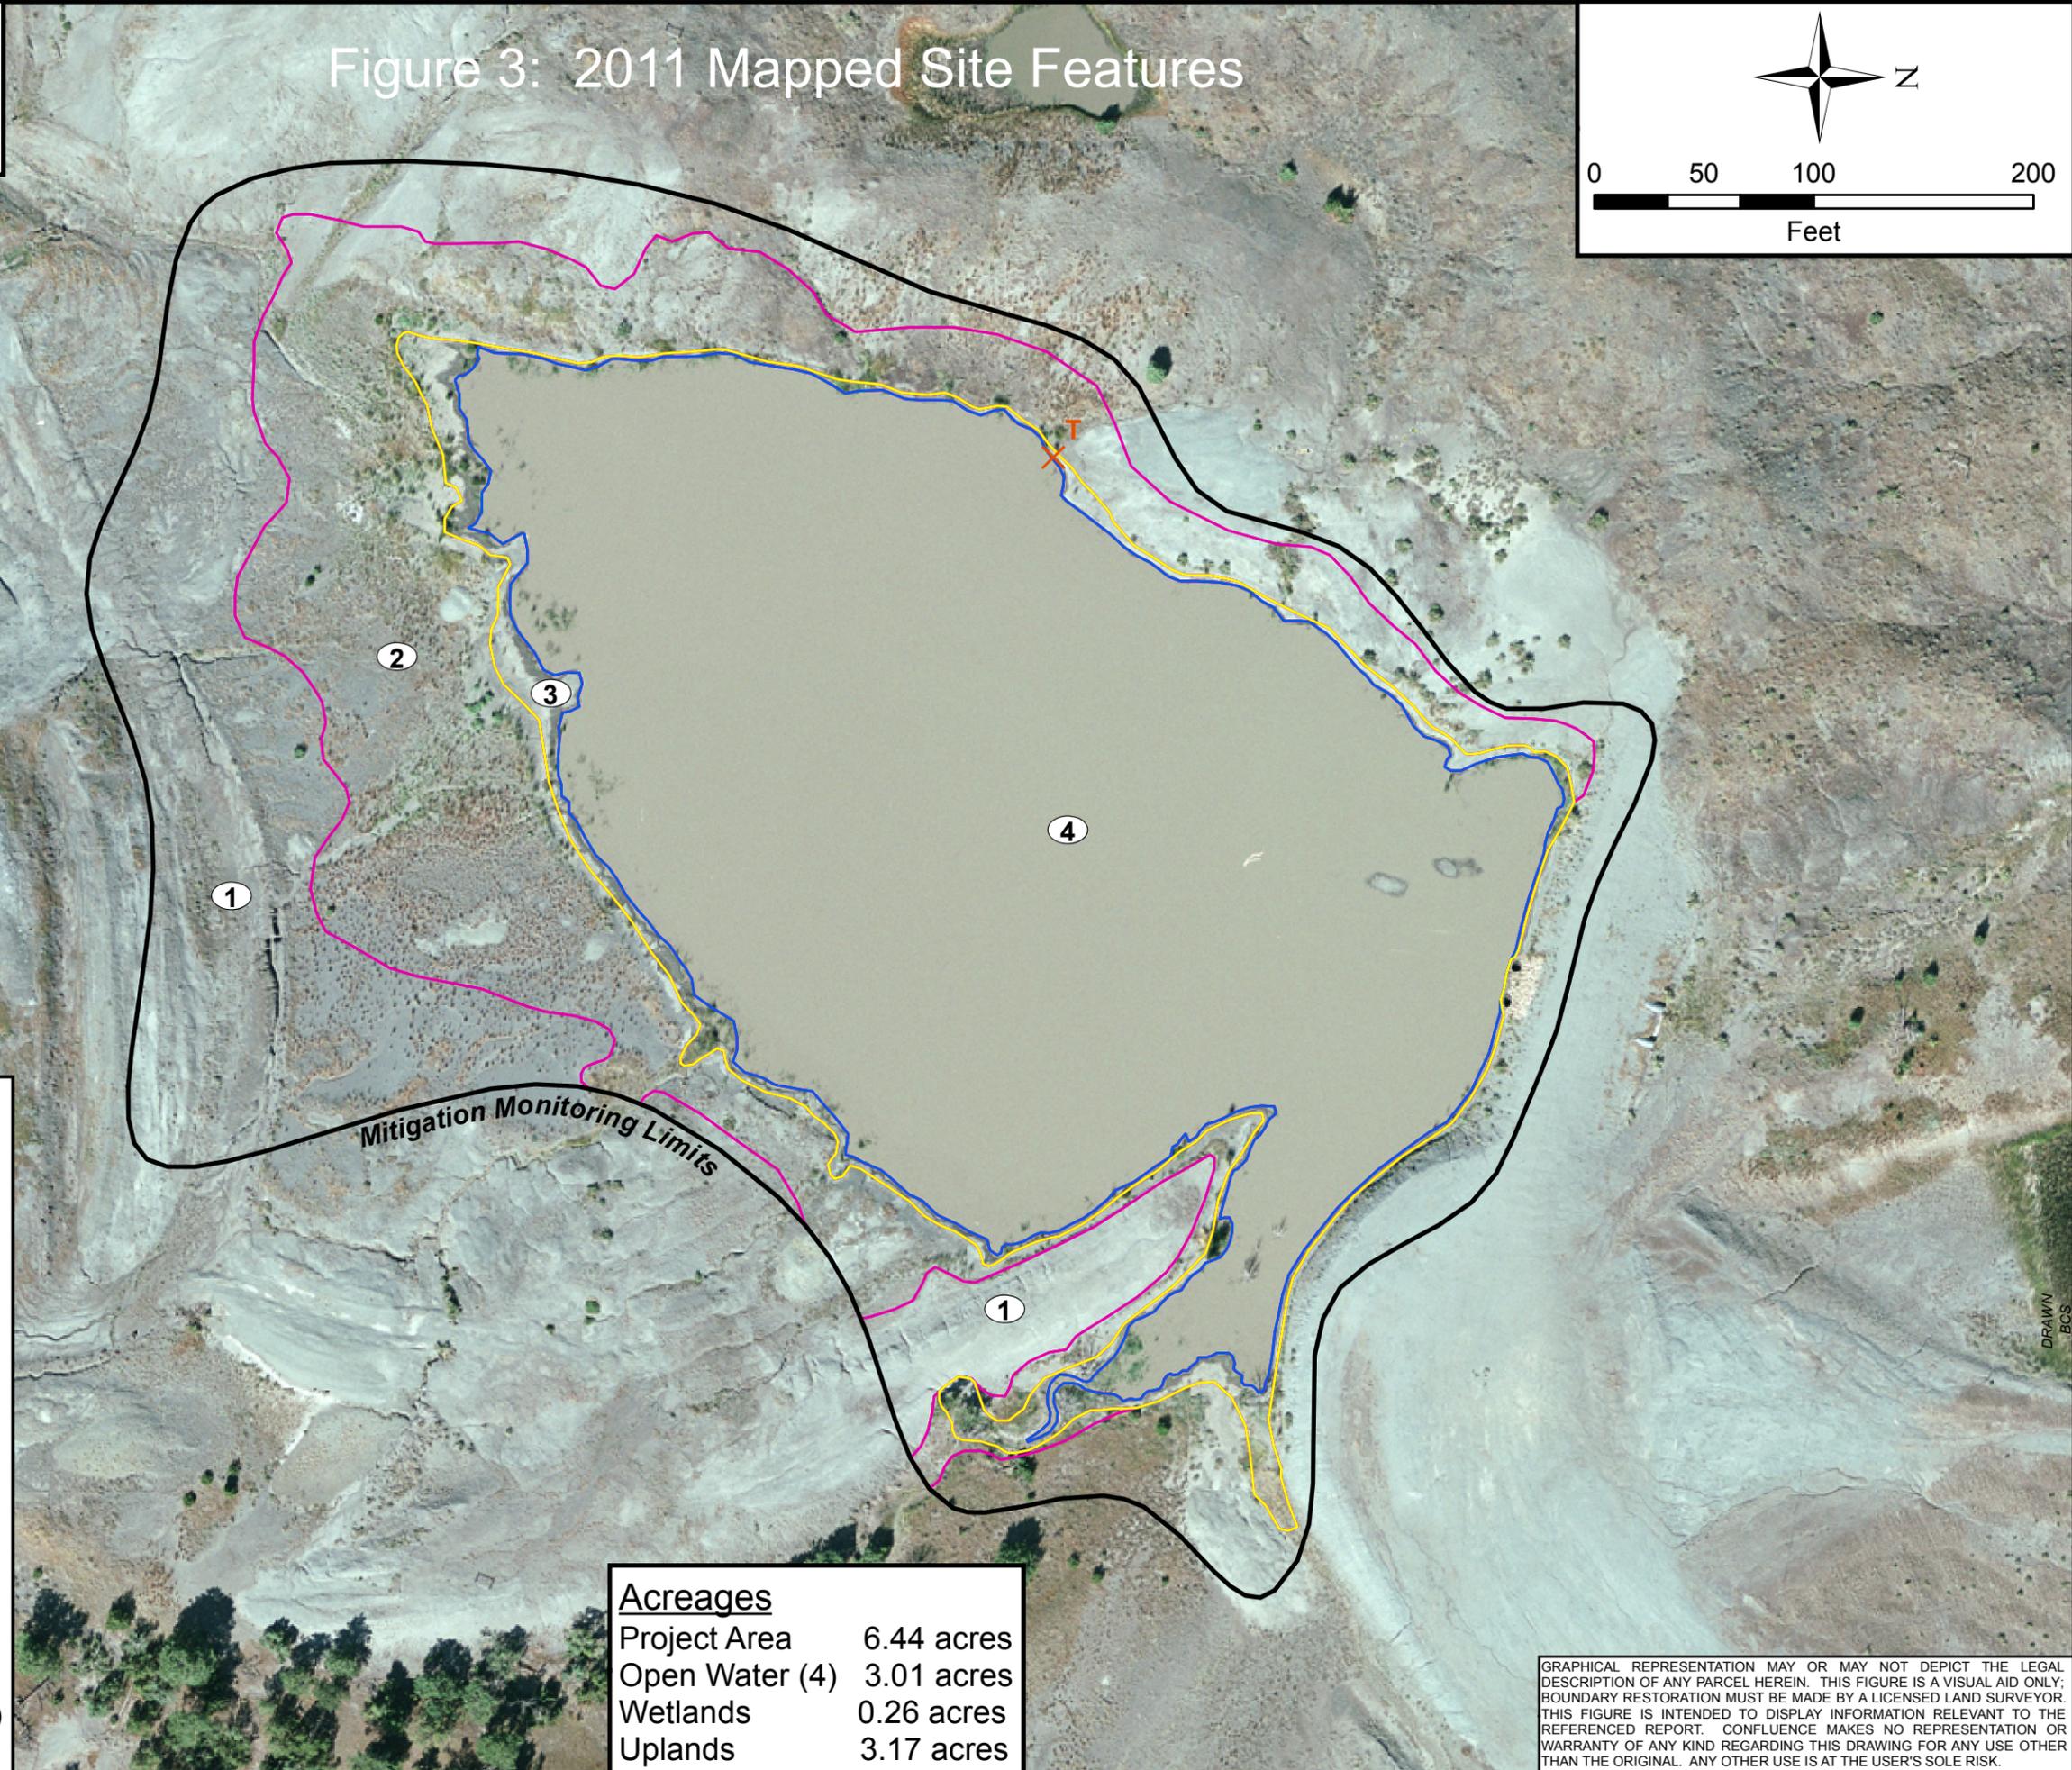
Figure 3: 2011 Mapped Site Features

Approximately three acres of open water (Polygon 4) were delineated for a majority of the area associated with the constructed wetland cell. The wetland cell has been flooded only since the dike repair in 2010, likely resulting in low productivity levels within the open water depression. The open water contained low cover levels of saltmarsh bulrush, prairie cordgrass, and Canada thistle (*Cirsium arvense*). The percent cover of aquatic macrophytes in the open water is expected to increase in subsequent growing seasons depending on the long-term water chemistry.

Less than 0.1 acre of Canada thistle, a Priority 2B weed, was noted near the northwest mitigation boundary. The cover was less than 1 percent. The MDT has an ongoing weed control program that annually assesses the location and size of State noxious weed infestations on each mitigation site.

Acreages	
Project Area	6.44 acres
Open Water (4)	3.01 acres
Wetlands	0.26 acres
Uplands	3.17 acres

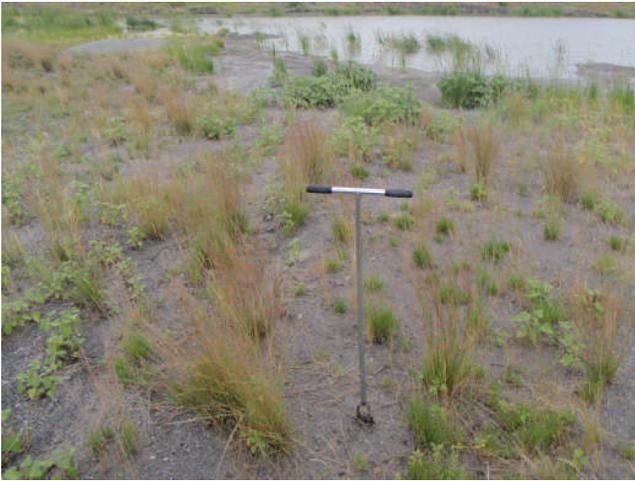
Data Point – AC-1
Bearing: 270 Degrees

No groundwater monitoring wells were installed within this site. Hydrological data were collected at two data points, AC-1 and AC-2. No hydrologic indicators were observed at data point AC-1, positioned approximately twenty feet from the edge of water. Saturated soils at eight inches below ground surface (bgs) and a water table elevation at ten inches bgs were hydrologic indicators present at wetland data point AC-2, located approximately ten feet from the water's edge. Salt deposits within the soil profile at AC-2 at a depth below 12 inches suggest areas surrounding open water may be seasonally saturated.

Location: Community 2
Taken in 2011

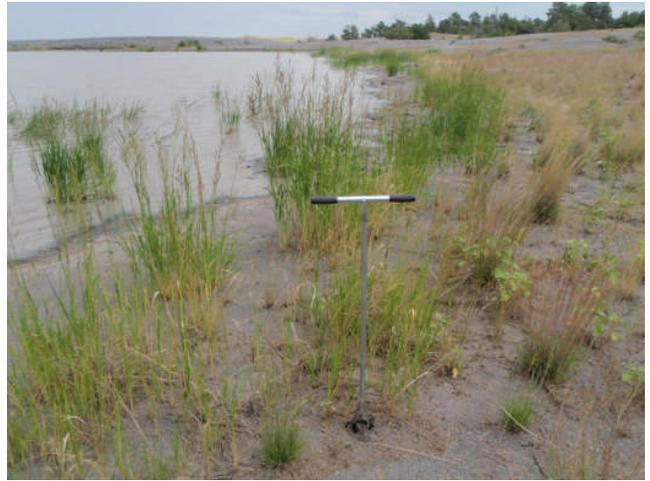
Data Point – AC-2
Bearing: 25 Degrees

Location: Community 3
Taken in 2011
