MONTANA DEPARTMENT OF TRANSPORTATION WETLAND MITIGATION MONITORING REPORT: YEAR 2011

*Woodson Creek
Ringling, Meagher County, Montana*

December 2011

MDT Project Number: NH-STPX-STPP 30(15)
Control Number: 5912

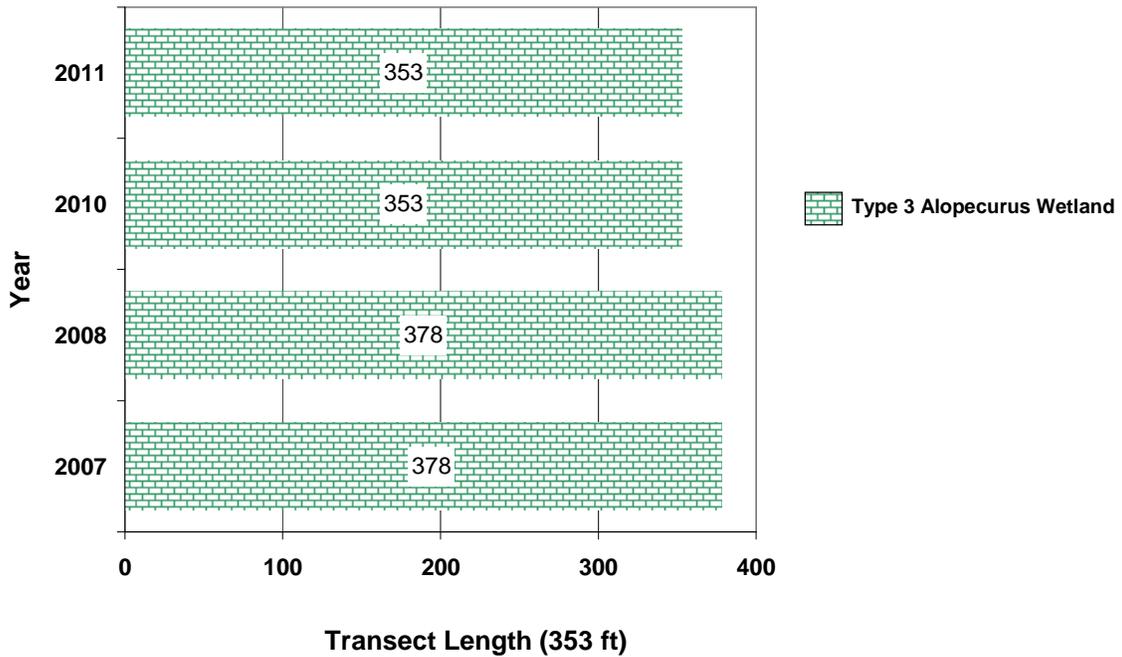
Chart 5. Transect map of vegetation communities from start (0 feet) to finish (353 feet) of Transect 3 for 2007, 2008, 2010, and 2011.

Table 5 and Charts 5 and 6 present the data collected on Transect 3. Photographs of the transect endpoints are shown in Appendix C. One wetland community located in the northwest corner of the site where a monoculture of creeping foxtail persists dominated the entire length of Transect 3. Hydrophytic species dominated 100 percent of the transect.

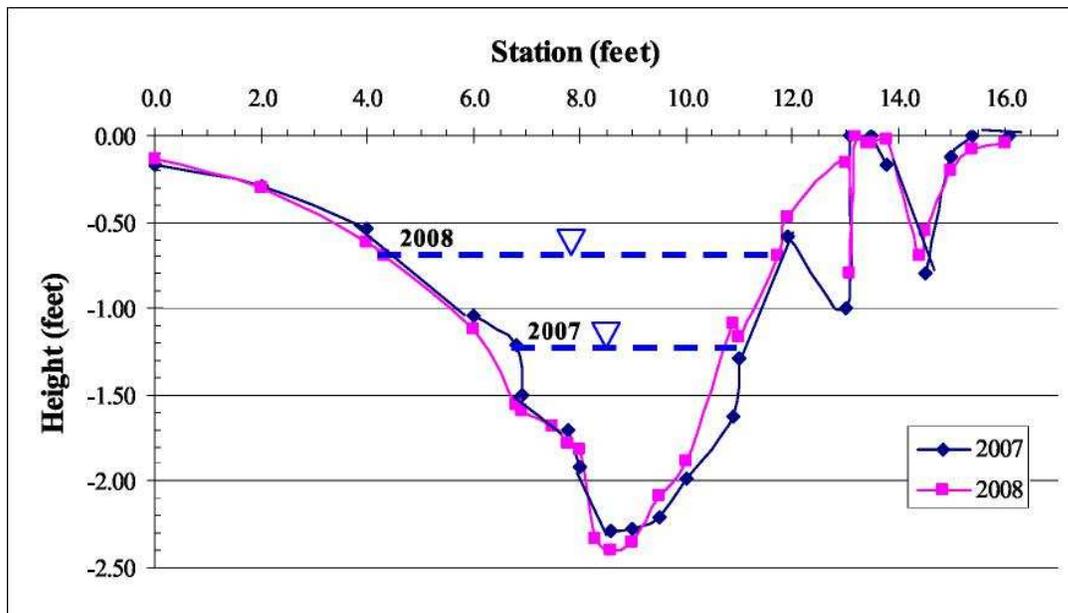
Chart 7. Survey data at XS-1 collected in 2007 and 2008.

Locations of the channel cross-sections are shown on Figure 2 (Appendix A) and photographs are shown on page C-10 of Appendix C. The 2007 and 2008, and 2010 and 2011 cross-sectional data are illustrated on Charts 7 through 10. Slight increases in channel depth and width were observed at both locations in 2007. The cause was unclear and assumed to be the result of minor adjustments in the channel geometry and settling of the banks. The channel conveyed substantially more water in 2008 than that observed in 2007. The estimated 2008 discharges at Cross-section 1 (XS-1) and Cross-section 2 (XS-2) were 7.4 cubic feet per second (cfs) and 11 cfs, respectively. The flow increase at cross-section 2 was attributed to return flows from upstream flooding and groundwater entering the site from seepage of the Sixteen Mile irrigation ditch located upgradient from cross-section 2.

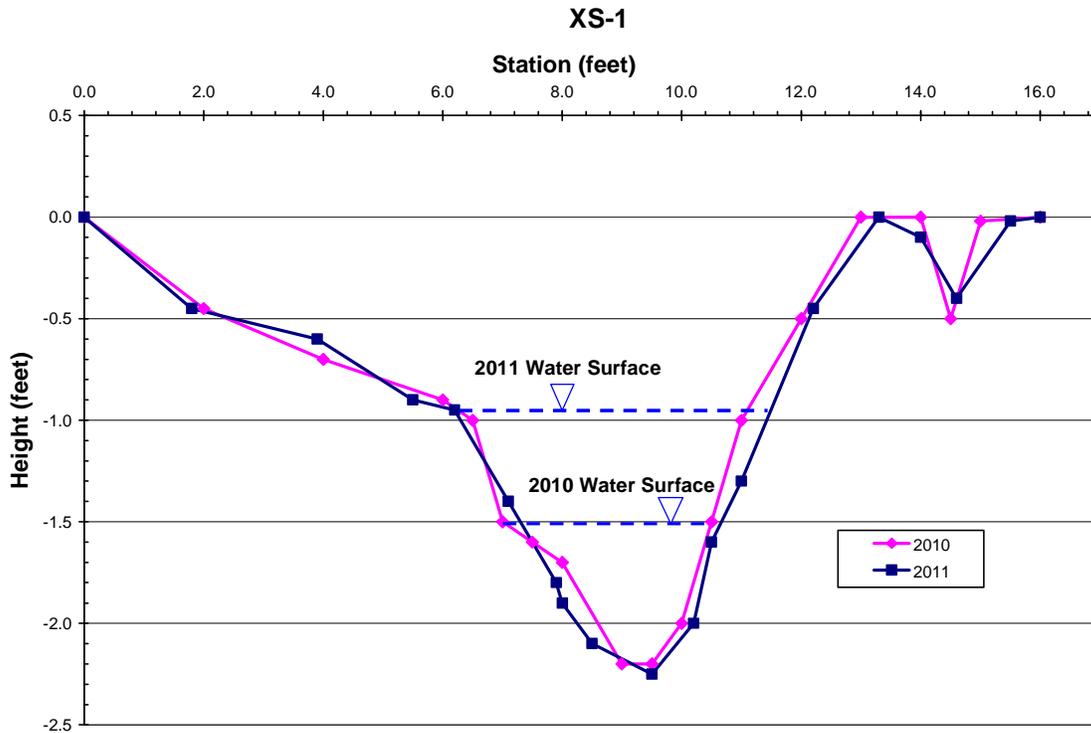
Chart 8. Survey data collected at XS 1 in 2010 and 2011.

The stream cross-section measured at both cross-sections in 2010 and 2011 showed little change in channel geometry. The depth and bankfull width adjustments were minimal at both cross-sections. The streambanks were well vegetated by species with high soil stability ratings, which contributed to the overall stability of the stream morphology. These species predominantly included creeping foxtail (stability class 6), creeping spikerush (6), and reed canary grass (9).

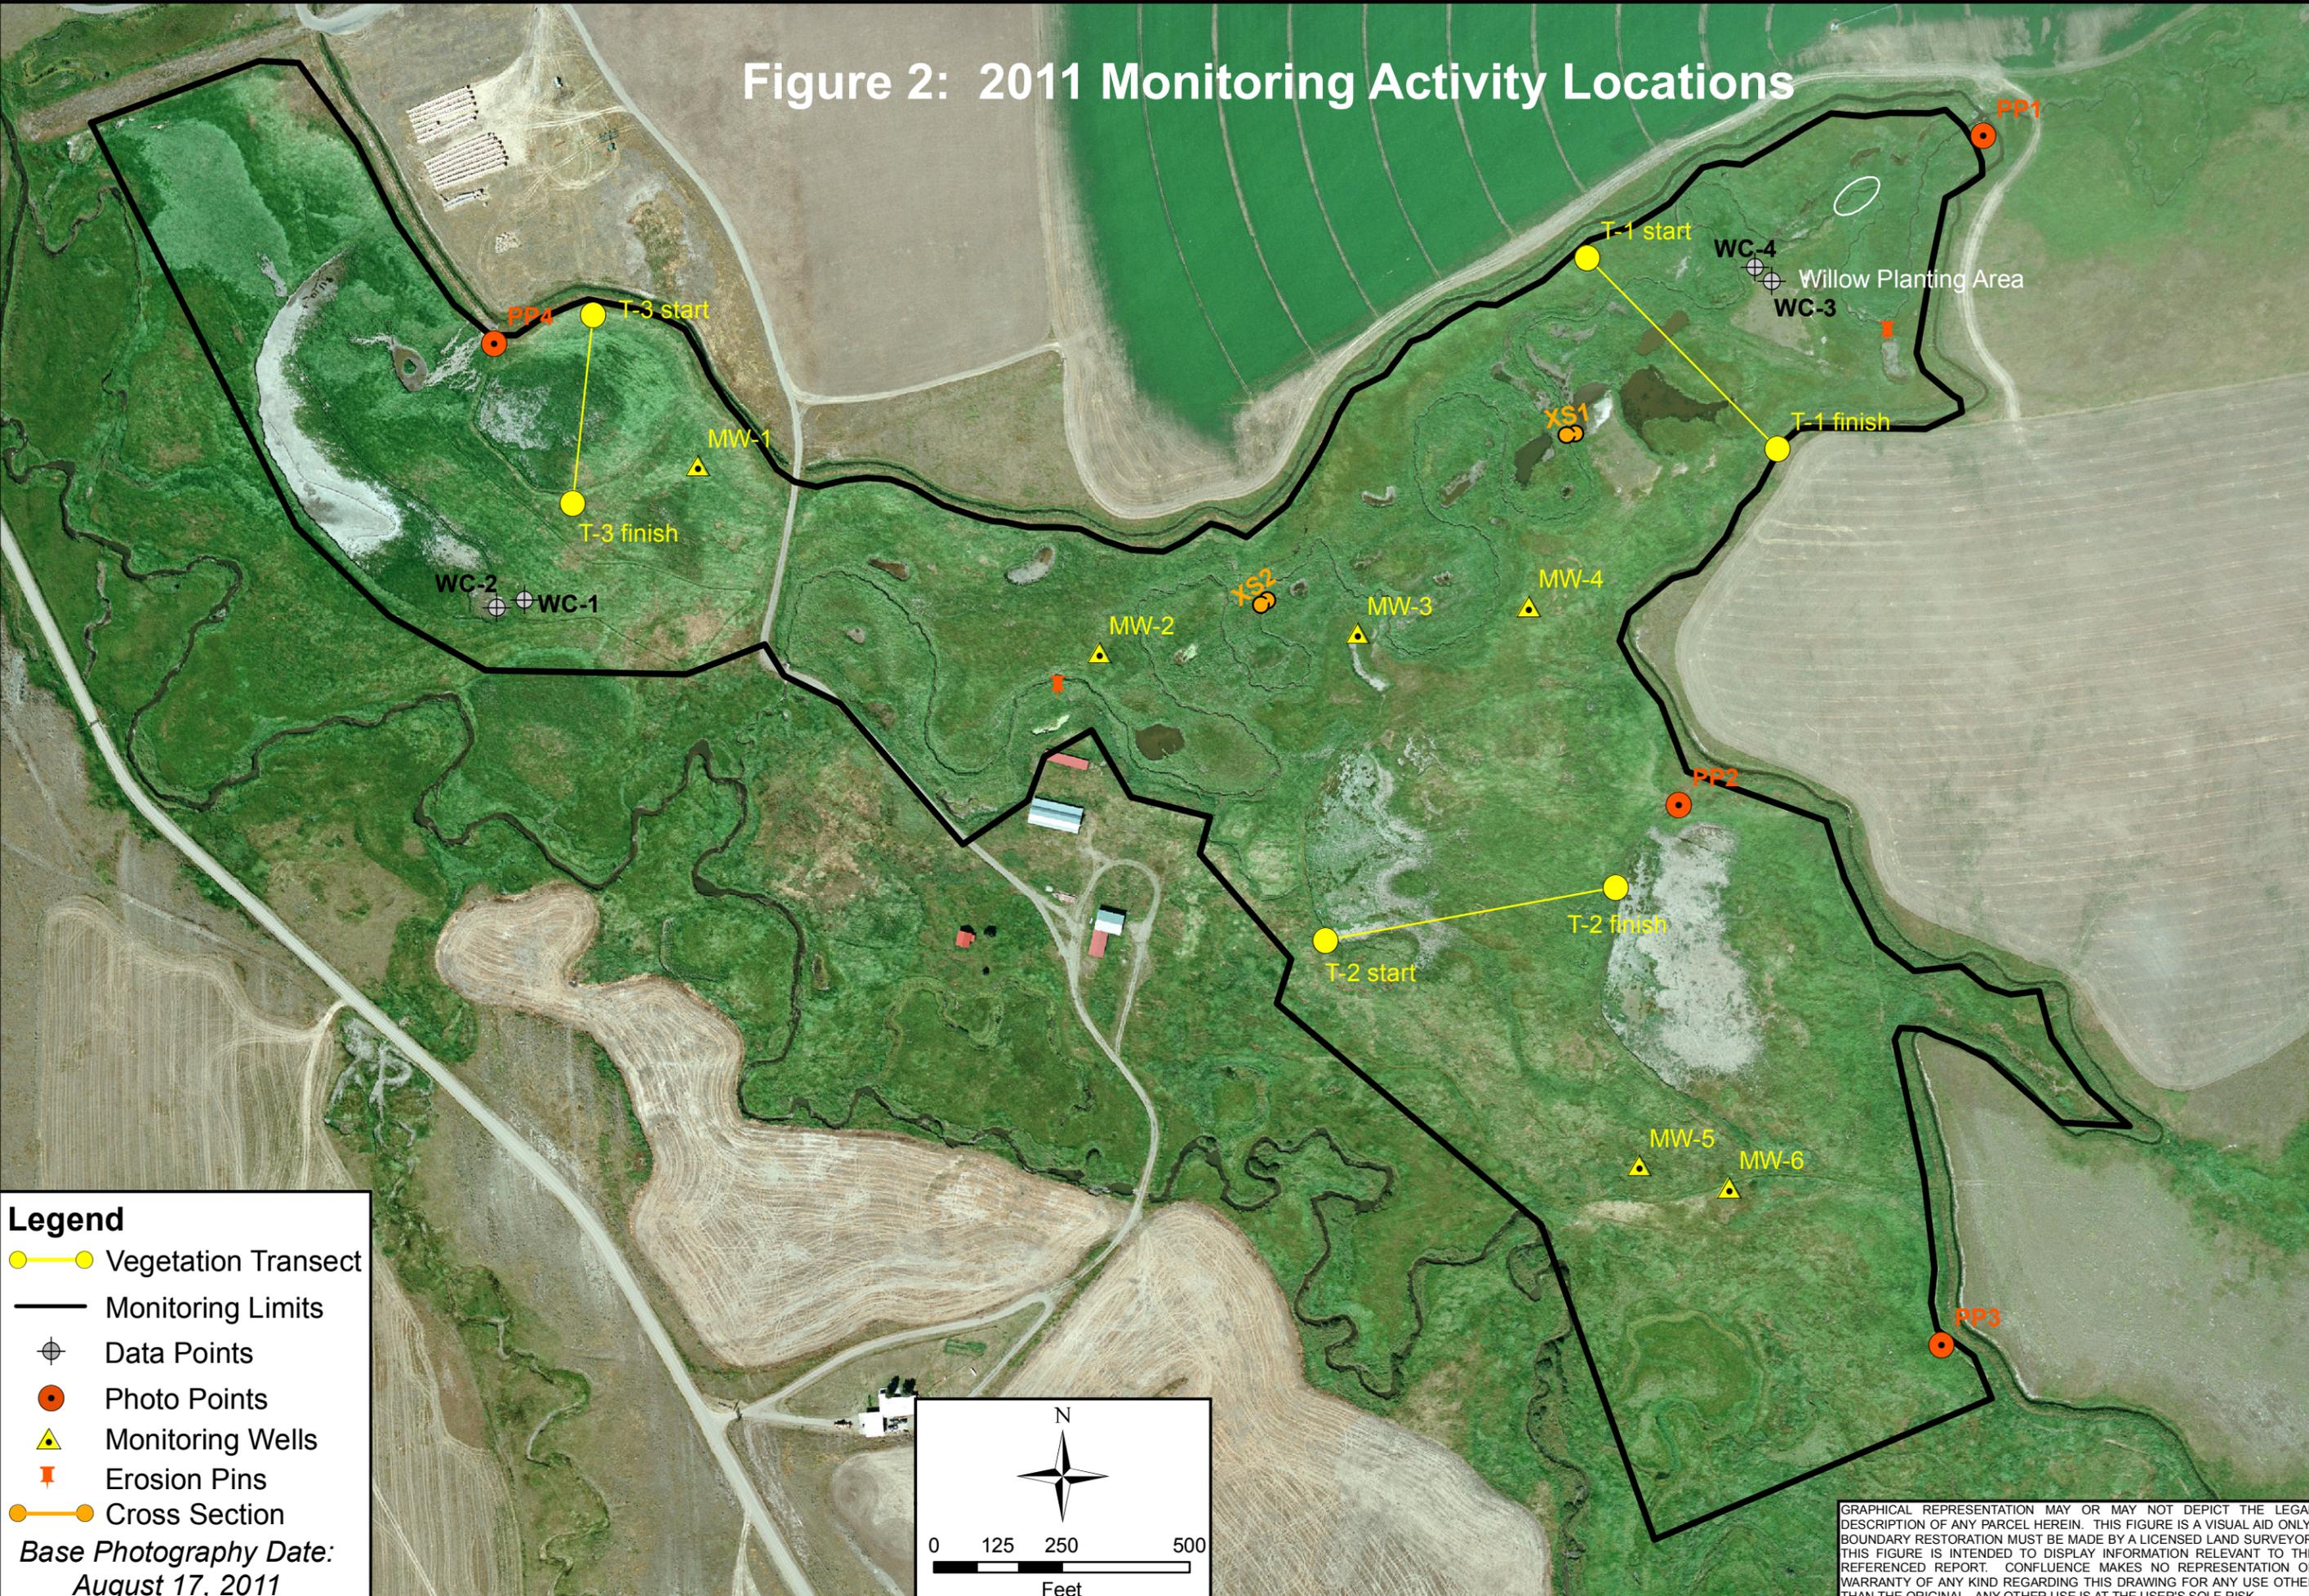
Figure 2: 2011 Monitoring Activity Locations

Data points WC-1 through WC-4 were established to determine the wetland/upland boundary (Figure 2, Appendix A, and Wetland Data Forms, Appendix B). Data points WC-2 and WC-4 were located in areas that met the wetland criteria. Saturation was present at 7 inches bgs at WC-2. The apparent water table was observed at 9 inches bgs. Data point WC-4 exhibited saturation at 10 inches bgs and a water table at 11 inches bgs. Secondary indicators at WC-4 included water-stained leaves, local soil survey data, and the FAC-Neutral test. There were no positive indicators of wetland hydrology at WC-1 and WC-3.

Streambank erosion pins were installed at upstream and downstream locations along outside meanders in the channel following construction (Figure 2, Appendix A). The pins were installed after the majority of runoff had occurred in 2007. The downstream location was chosen specifically at an area that was exhibiting severe bank erosion. Additional bank erosion was observed at both locations in 2008, with an average erosion rate of 0.29 feet per year at the upper pin and 0.14 feet per year at the lower pin. A slight decrease in the level of erosion was observed at the upstream pin (Pin 1) in 2010 with 0.50 feet of erosion measured since 2008 or a rate of 0.25 feet/year. Streambank erosion at Pin 1 was minor in 2011 as shown on the photo presented on page C-10 of Appendix C. Minimal erosion was noted in 2010 and 2011 at the downstream pin (Pin 2), measuring 0.10 feet since 2008. The established root systems of plant species with high soil stability ratings have been integral in maintaining the overall bank stability as demonstrated by the cross-section data and in limiting the current streambank erosion to minor annual channel adjustments.

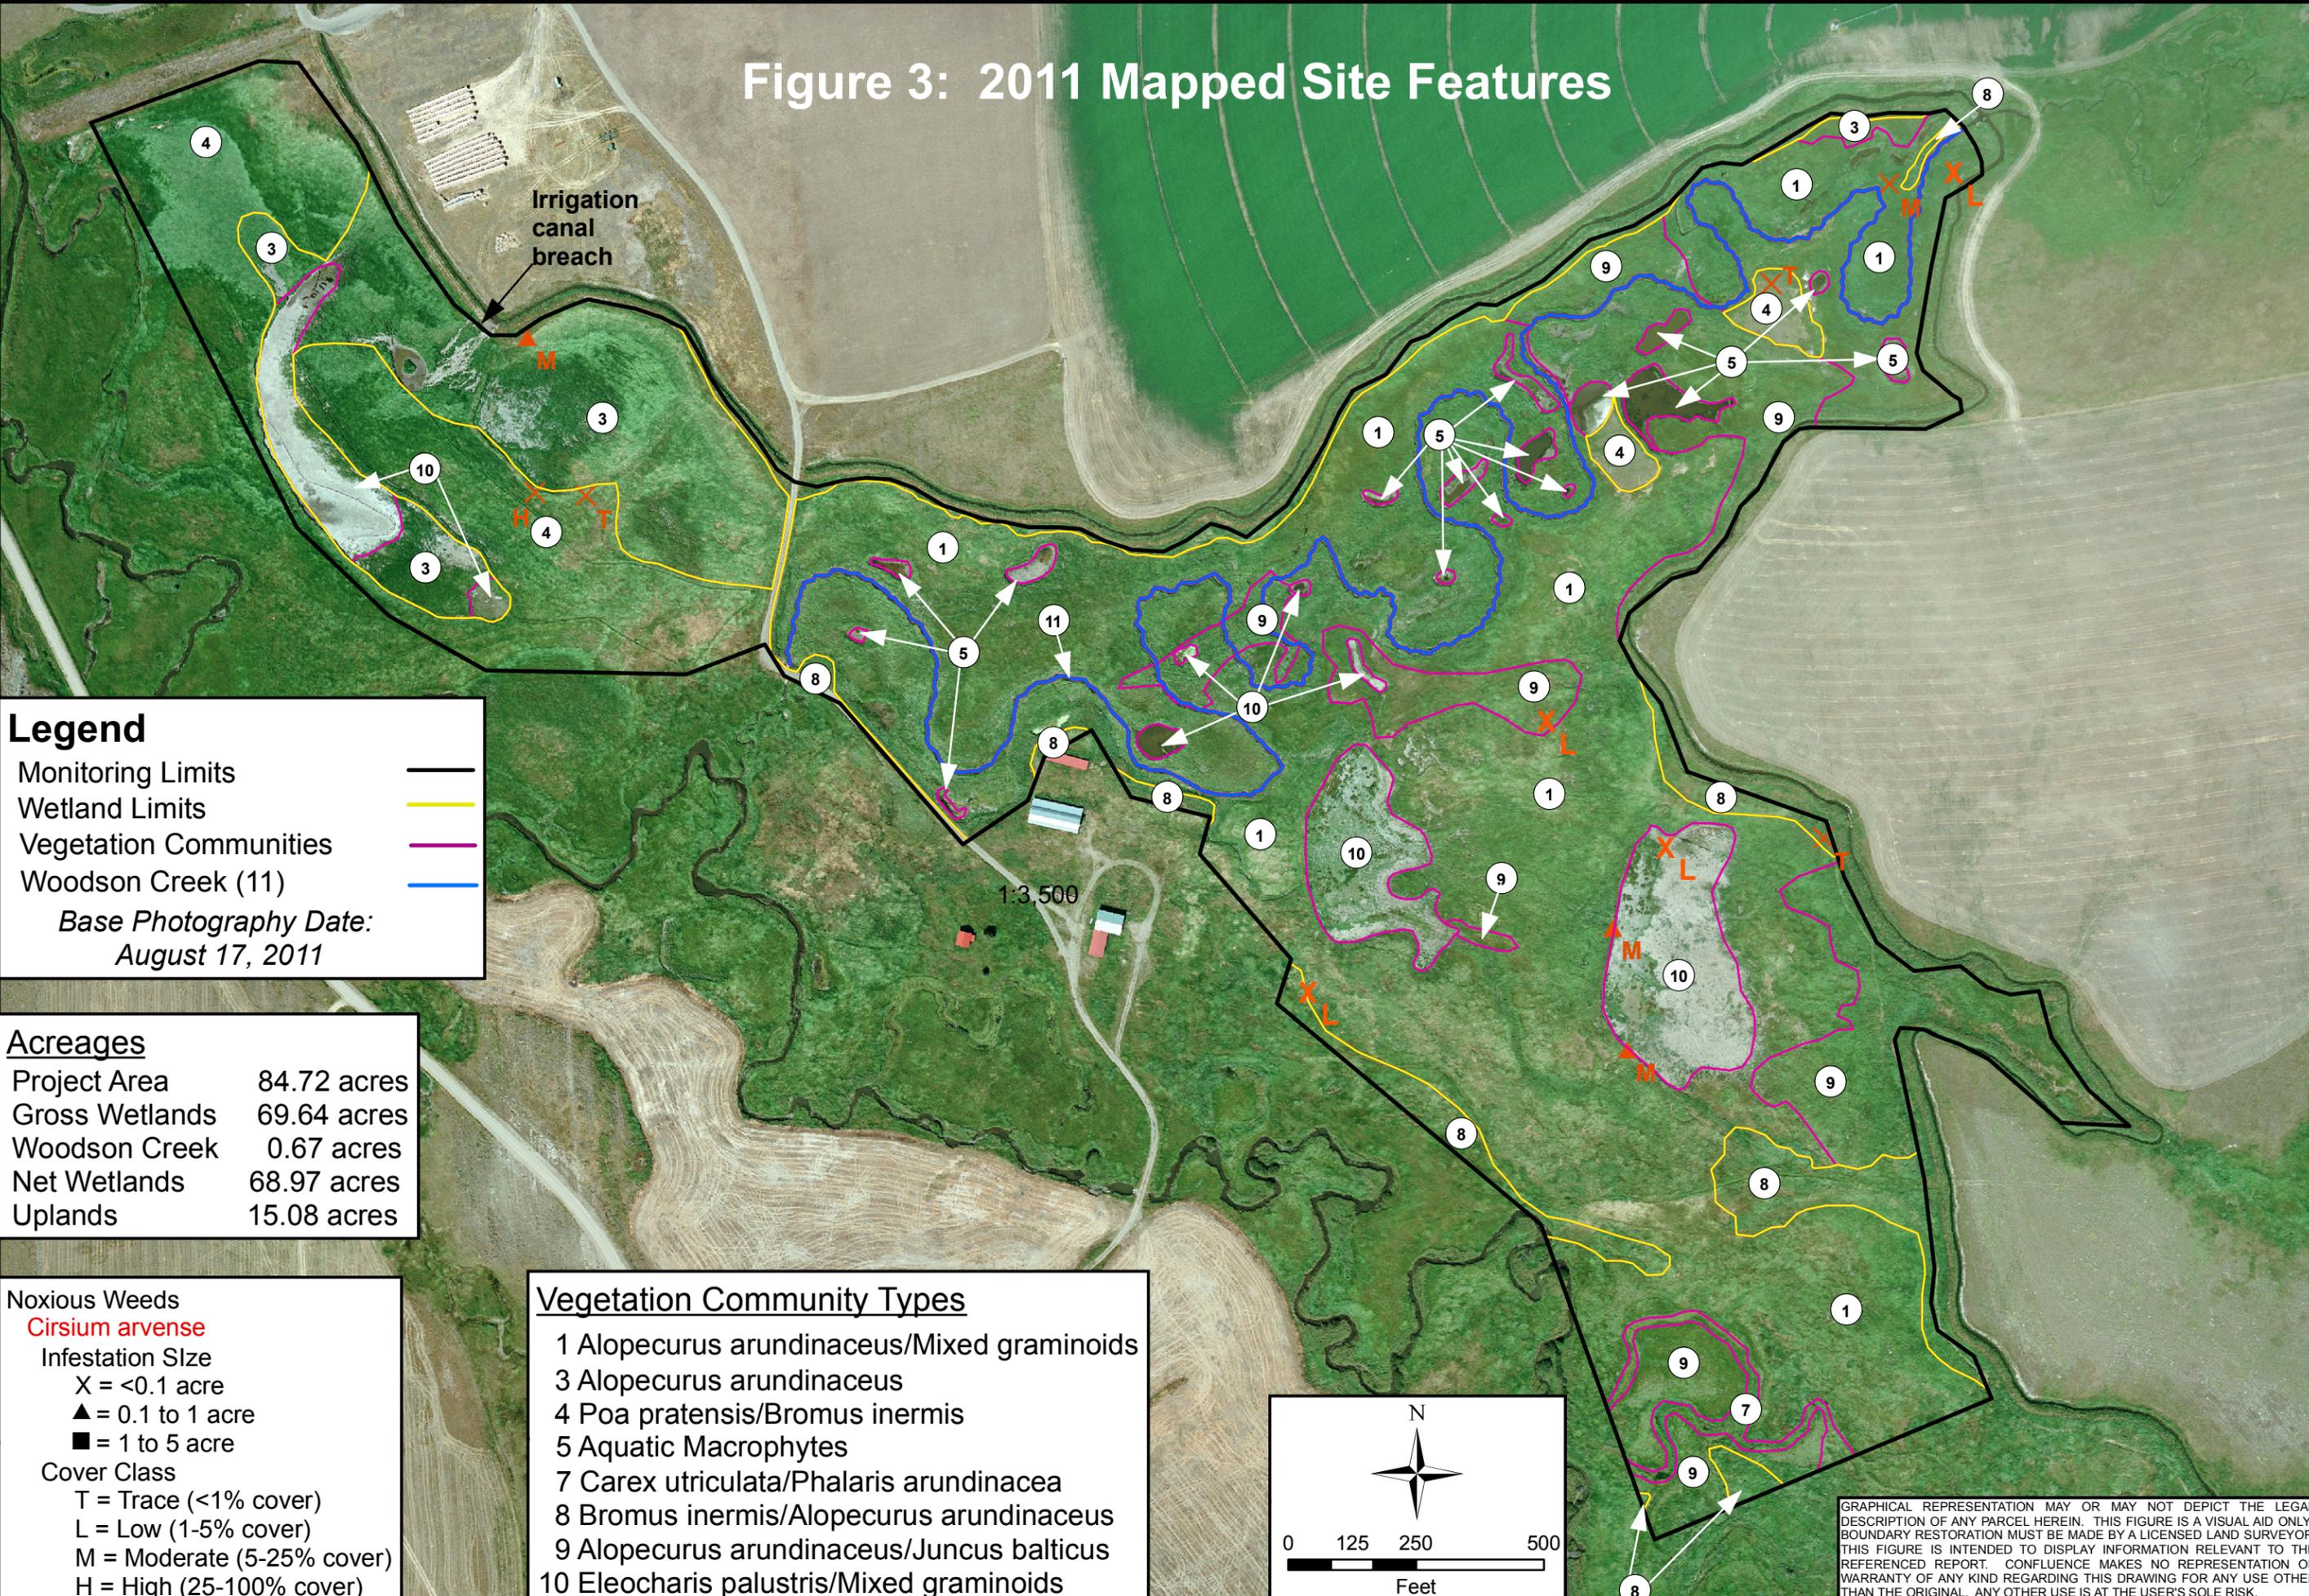
Figure 3: 2011 Mapped Site Features

Ten infestations of Canada thistle (*Cirsium arvense*) were mapped within the site boundaries in 2011 (Figure 3, Appendix A). The size of the infestations ranged from less than 0.1 acre to 1.0 acre with cover classes ranging from trace (less than 1.0 percent cover) to high (25.0 percent to 100.0 percent cover). The percent cover of Canada thistle increased site wide from 2010 to 2011. The site was not sprayed in 2011.

Ten infestations of Canada thistle (*Cirsium arvense*) were mapped within the site boundaries in 2011 (Figure 3, Appendix A). The size of the infestations ranged from less than 0.1 acre to 1.0 acre with cover classes ranging from trace (less than 1.0 percent cover) to high (25.0 percent to 100.0 percent cover). The percent cover of Canada thistle increased site wide from 2010 to 2011. The site was not sprayed by MDT in 2011. Spraying is recommended in 2012.

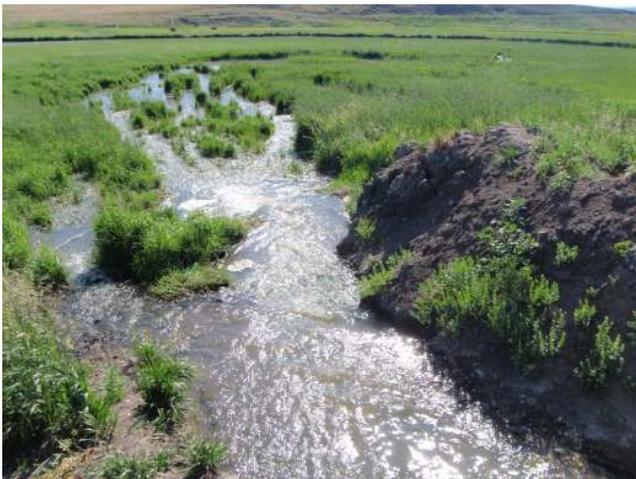
The irrigation return on the north edge of the site was breached between 2010 and 2011. The entire flow volume of the canal was diverted to the mitigation area and a majority of the west parcel was flooded in 2011. The area surrounding the breach is well vegetated and shows no signs of erosion. It is unclear if this is a maintenance need that needs to be addressed as the current condition of the canal does not adversely impact the existing wetlands and may eventually lead to the development of additional wetlands within the site.

Photo – Irrigation canal breach
Bearing: 250 Degrees
