# MONTANA DEPARTMENT OF TRANSPORTATION WETLAND MITIGATION MONITORING REPORT: YEAR 2012

*American Colloid Mitigation Site  
Alzada, Carter County, Montana*

Initial Construction:  
MDT Project Number NH STPS BR 6(10)  
Control Number 1396

Watershed 16 Repair:  
MDT Project Number STPX 6(15)  
Control Number 6714

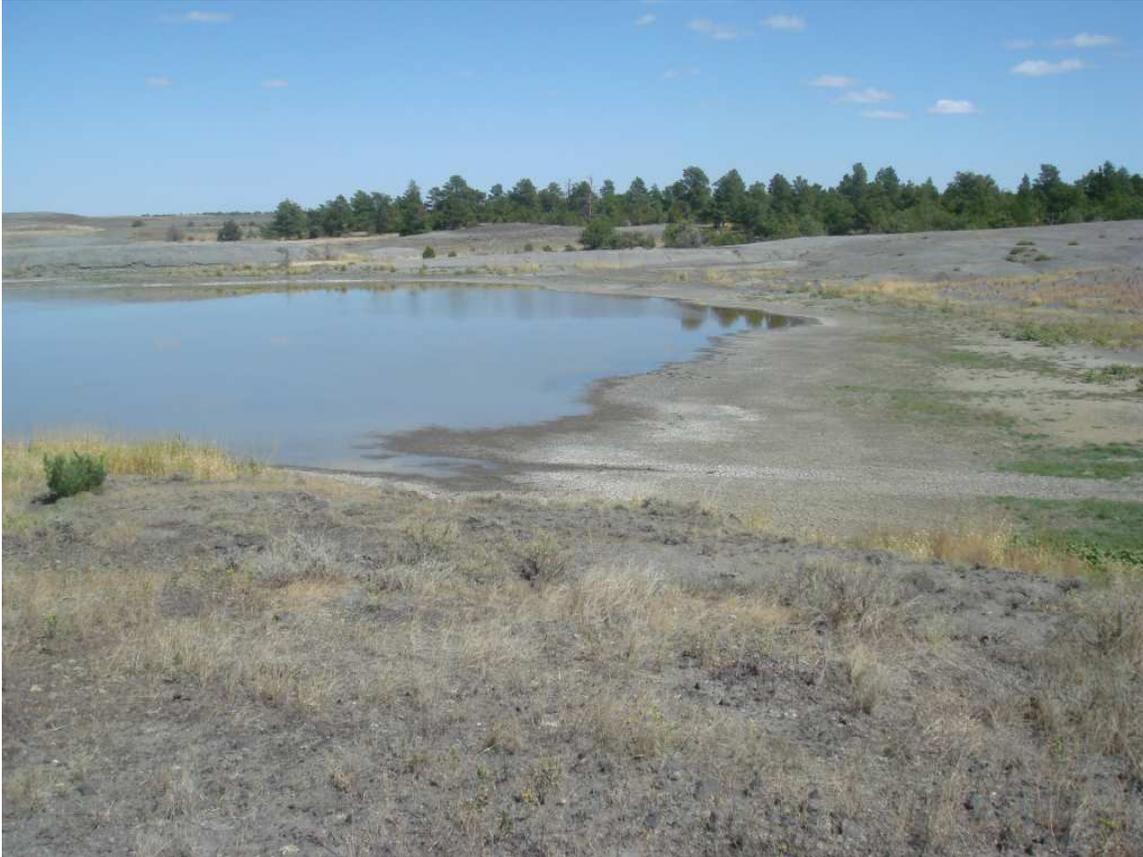
Cover: View from NE corner of AC wetland looking west near constructed berm.

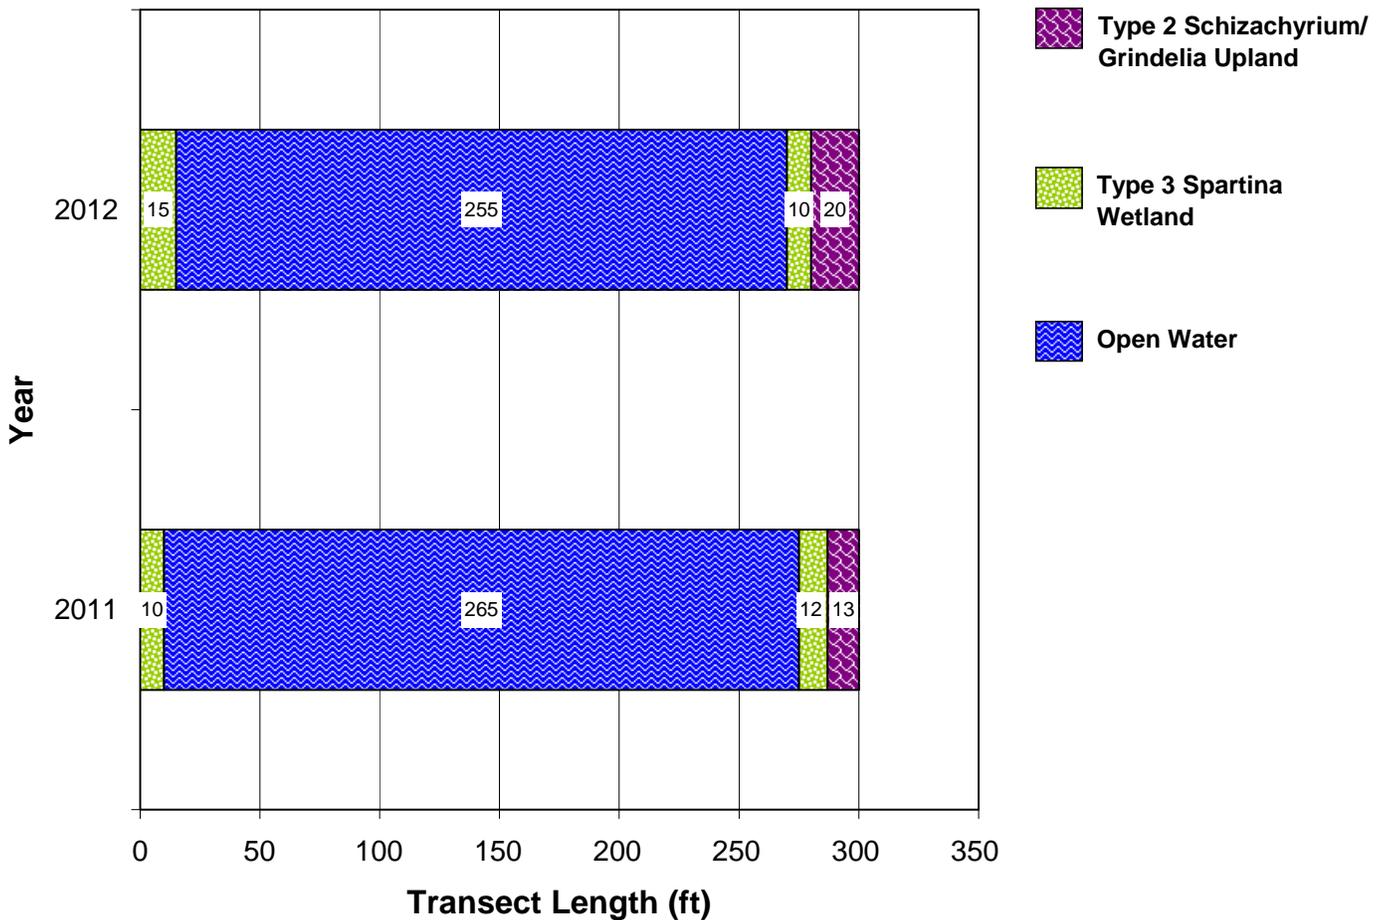
**Chart 1. Transect map showing community types on Transect 1 in 2011 and 2012 from start (0 feet) to finish (300 feet) at the American Colloid Wetland Mitigation Site.**

Monitoring Year	2011	2012
Transect Length (feet)	300	300
Vegetation Community Transitions along Transect	3	3
Vegetation Communities along Transect	2	2
Hydrophytic Vegetation Communities along Transect	1	1
Total Vegetative Species	7	12
Total Hydrophytic Species	4	5
Total Upland Species	3	7
Estimated % Total Vegetative Cover	12	15
% Transect Length Comprising Hydrophytic Vegetation Communities	7.3	8.3
% Transect Length Comprising Upland Vegetation Communities	4.3	6.7
% Transect Length Comprising Unvegetated Open Water	88.3	85.0
% Transect Length Comprising Bare Substrate	0.0	0.0

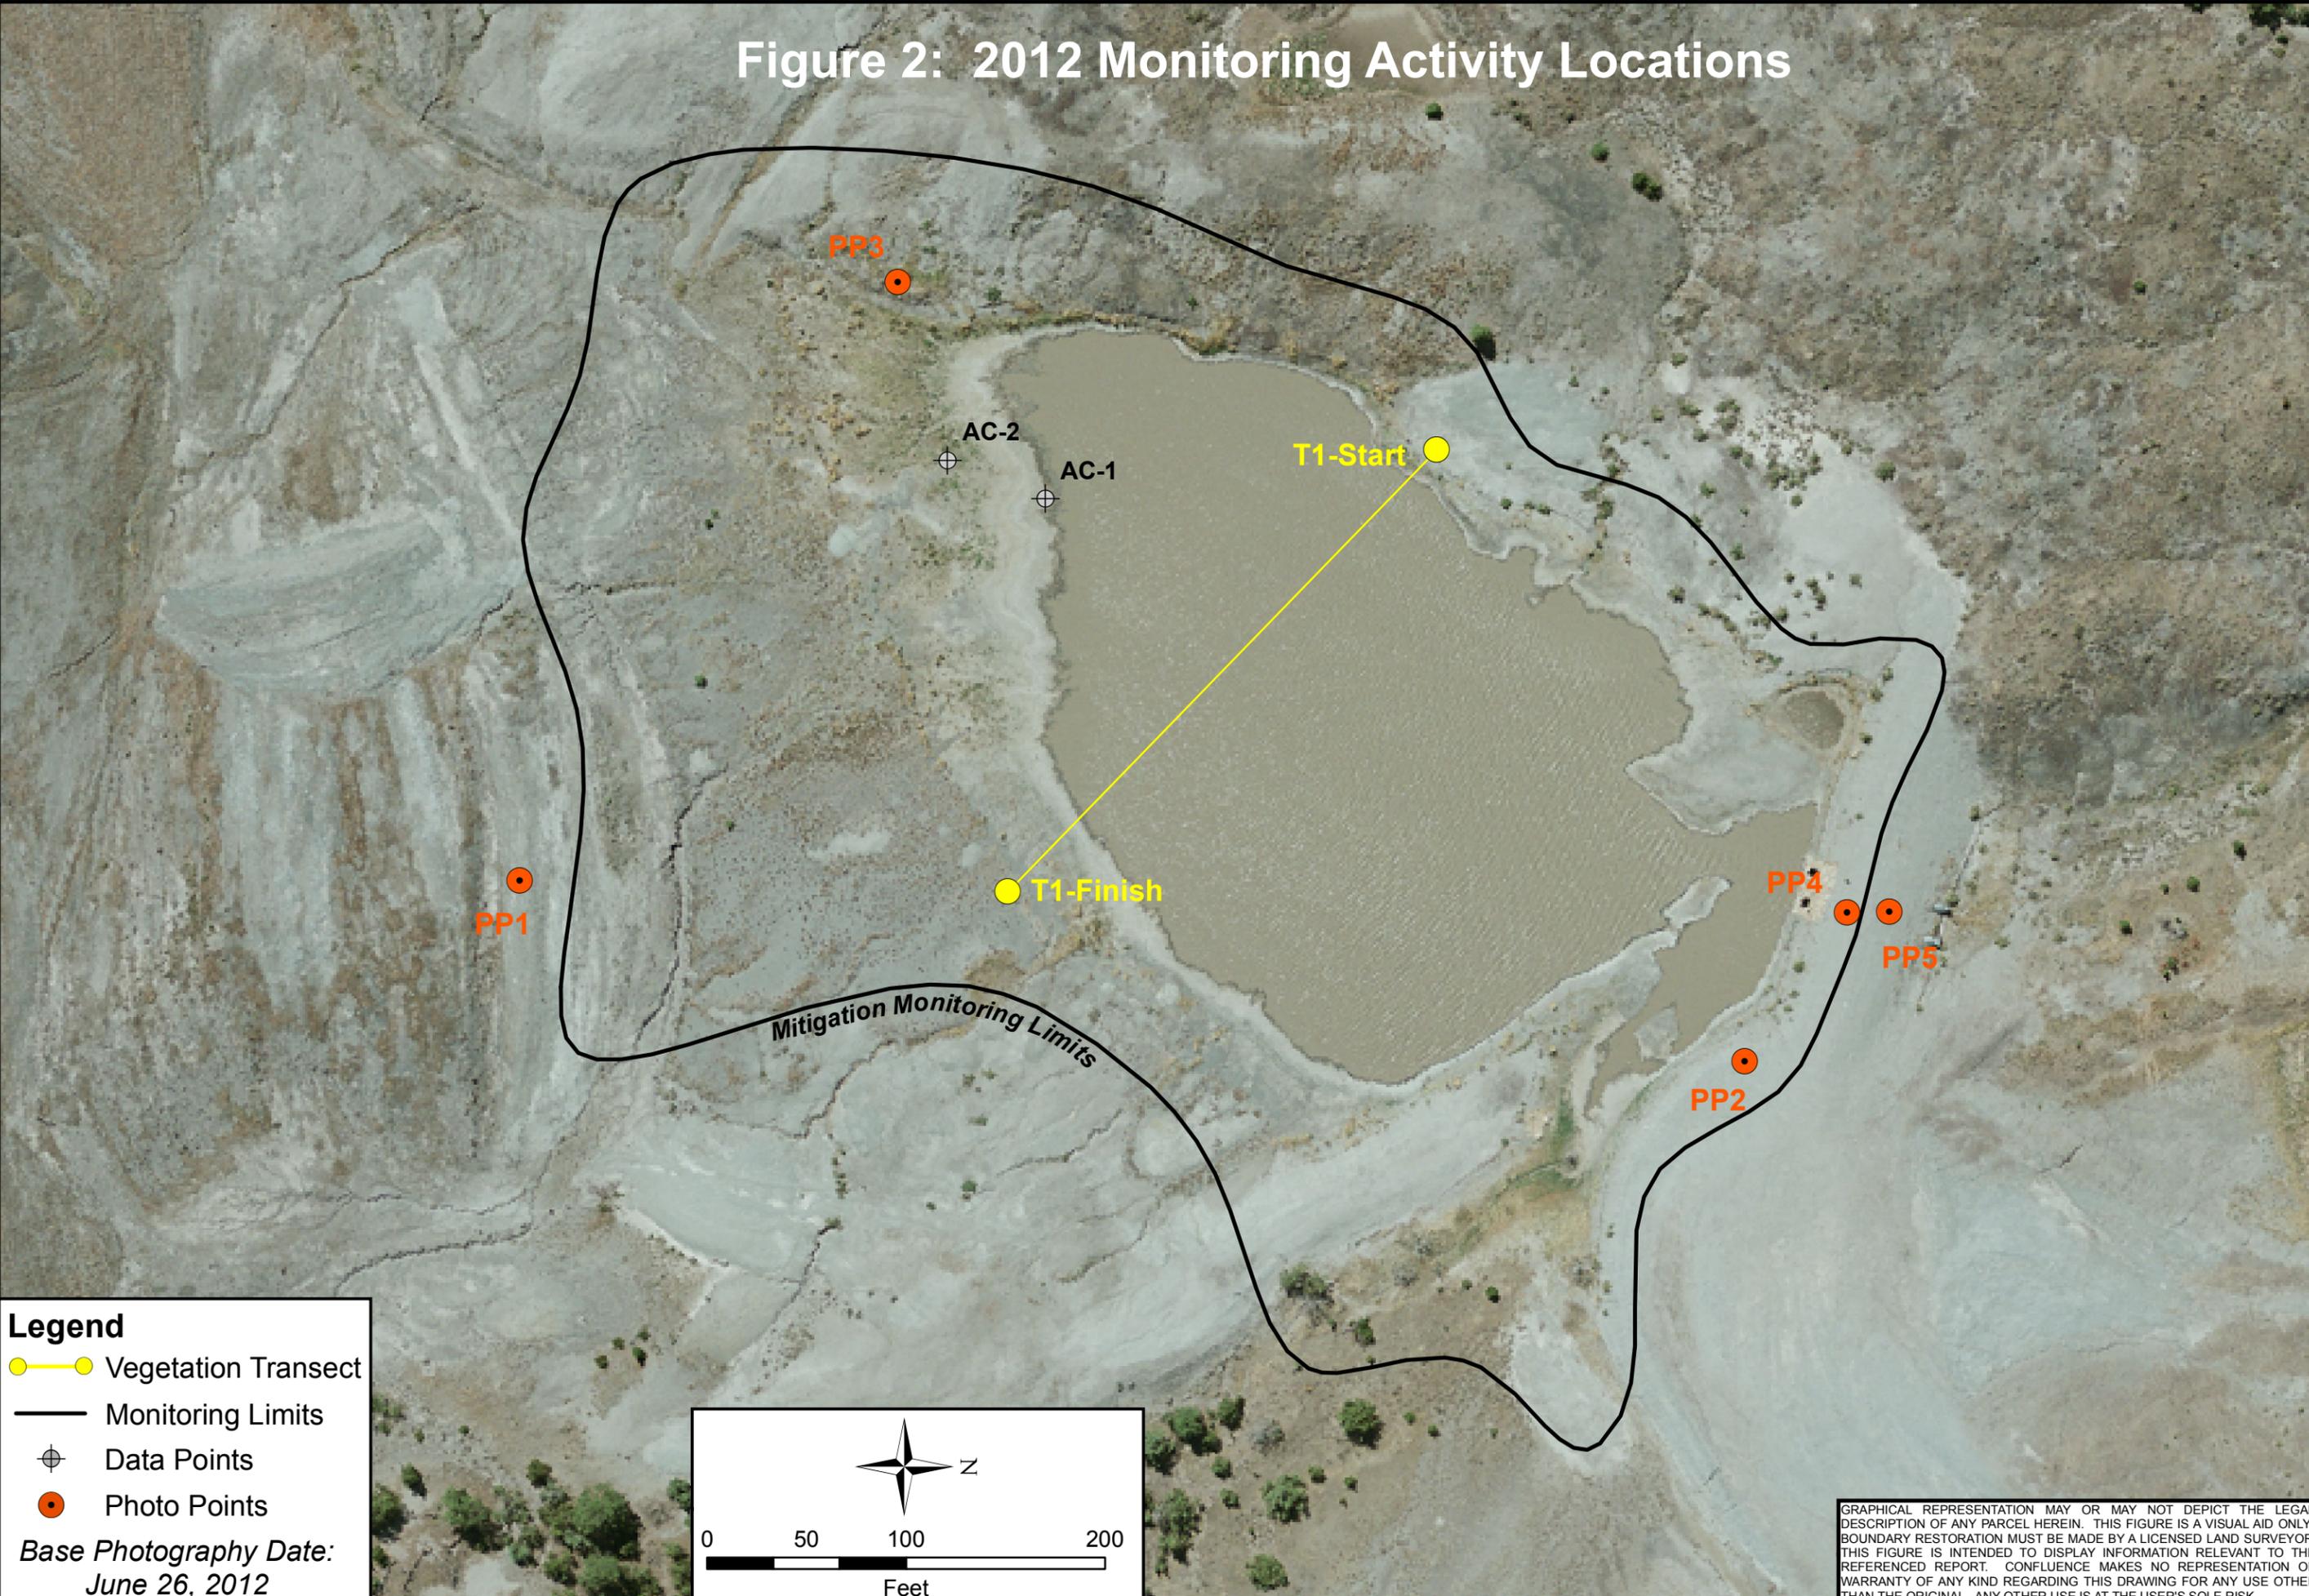
# Figure 2: 2012 Monitoring Activity Locations

Monitoring at photo points provided supplemental information documenting wetland, upland, and transect conditions; site trends; and current land uses surrounding the site. Photographs were taken at established photo points throughout the mitigation site during the site visit (Appendix C). Photo point locations were recorded with a resource grade GPS unit (Figure 2, Appendix A).

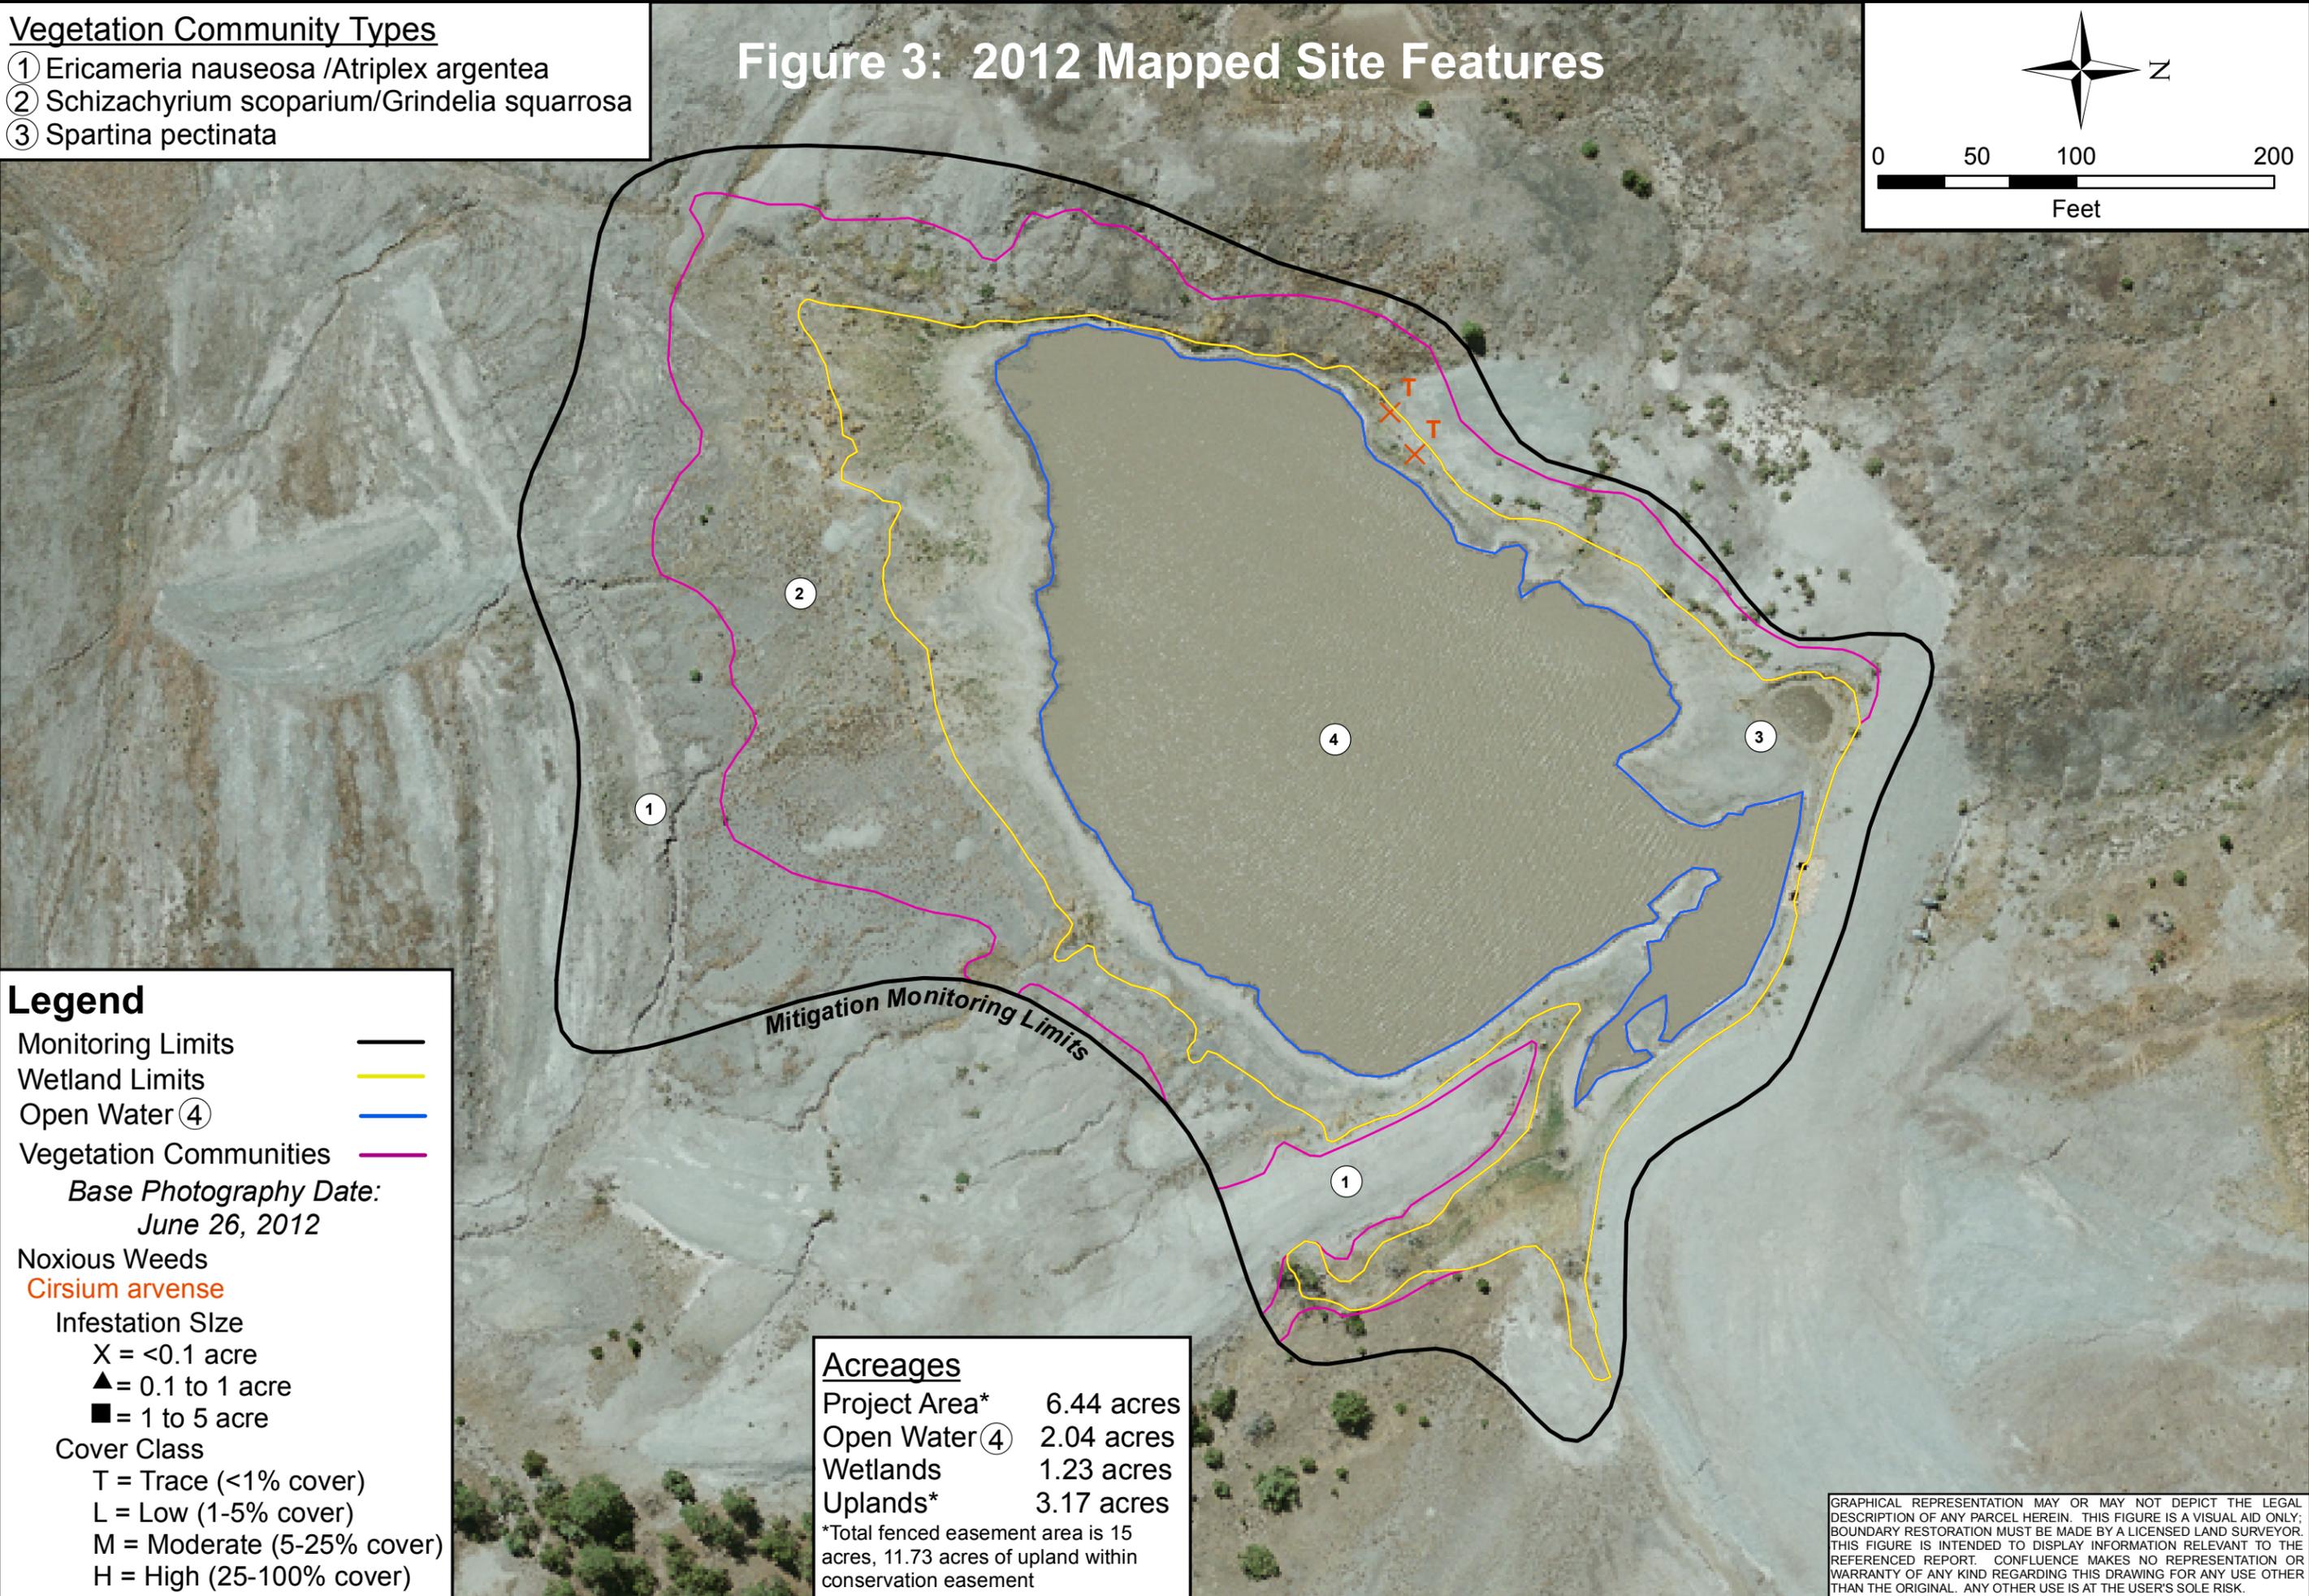
**Figure 3: 2012 Mapped Site Features**

Approximately 2.04 acres of open water (Polygon 4) covered a majority of the area within the constructed wetland cell. The open water contained less than five percent cover of saltmarsh club-rush, freshwater cord grass, and corn spurry (*Spergula arvensis*). The wetland cell has been flooded only since the dike repair in 2010. Productivity levels in the open water are likely limited by the short time frame for growth and by the presence of suspended clay particles. The level of turbidity restricts photosynthesis through the water column.

Less than 0.1 acre of Canadian thistle, a Priority 2B weed, was noted near the northwest mitigation boundary. The cover was less than 1 percent. The MDT has an ongoing weed control program that annually manages State noxious weed infestations on each mitigation site.

Project Area*	6.44 acres
Open Water ④	2.04 acres
Wetlands	1.23 acres
Uplands*	3.17 acres

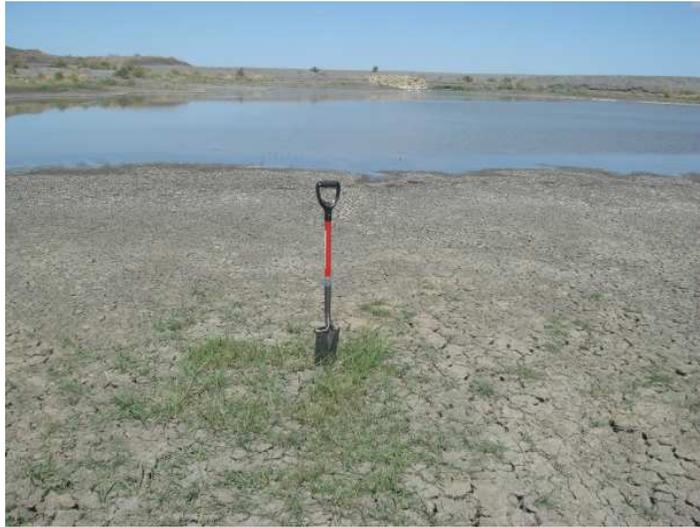
**Data Point – AC-1**  
**Bearing:** 340 Degrees

No groundwater monitoring wells were installed within this site. Hydrological data were collected at two data points, AC-1 and AC-2. Data point AC-1 located on the water margin exhibited saturation at six inches below the ground surface (bgs), an algal mat, inundation visible on aerial imagery, a dry-season water table, and surface soil cracks. Data point AC-2 located upslope of AC-1 documented an algal mat and surface soil cracks. Both data points exhibited positive signs of wetland hydrology.

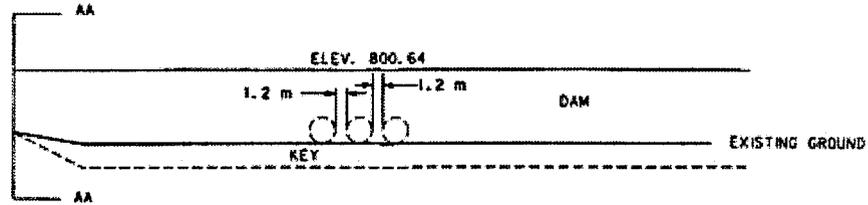
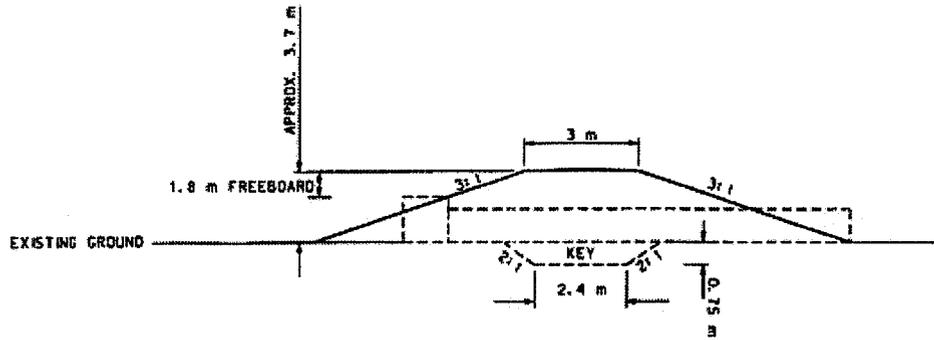
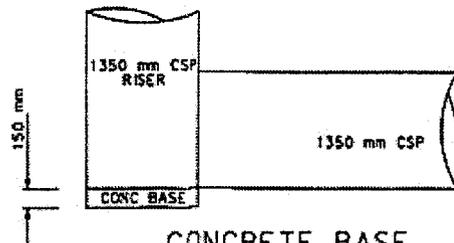
# DETAILS

SIDE VIEW DAM  
NOT TO SCALE

END VIEW DAM  
NOT TO SCALE  
SECTION AA

CONCRETE BASE  
NOT TO SCALE
