**Montana US Highway 93 South Wildlife Crossings Research
MDT # HWY – 308445-RP**

2010 Annual Progress Report

Prepared for the Montana Department of Transportation
January 31, 2011

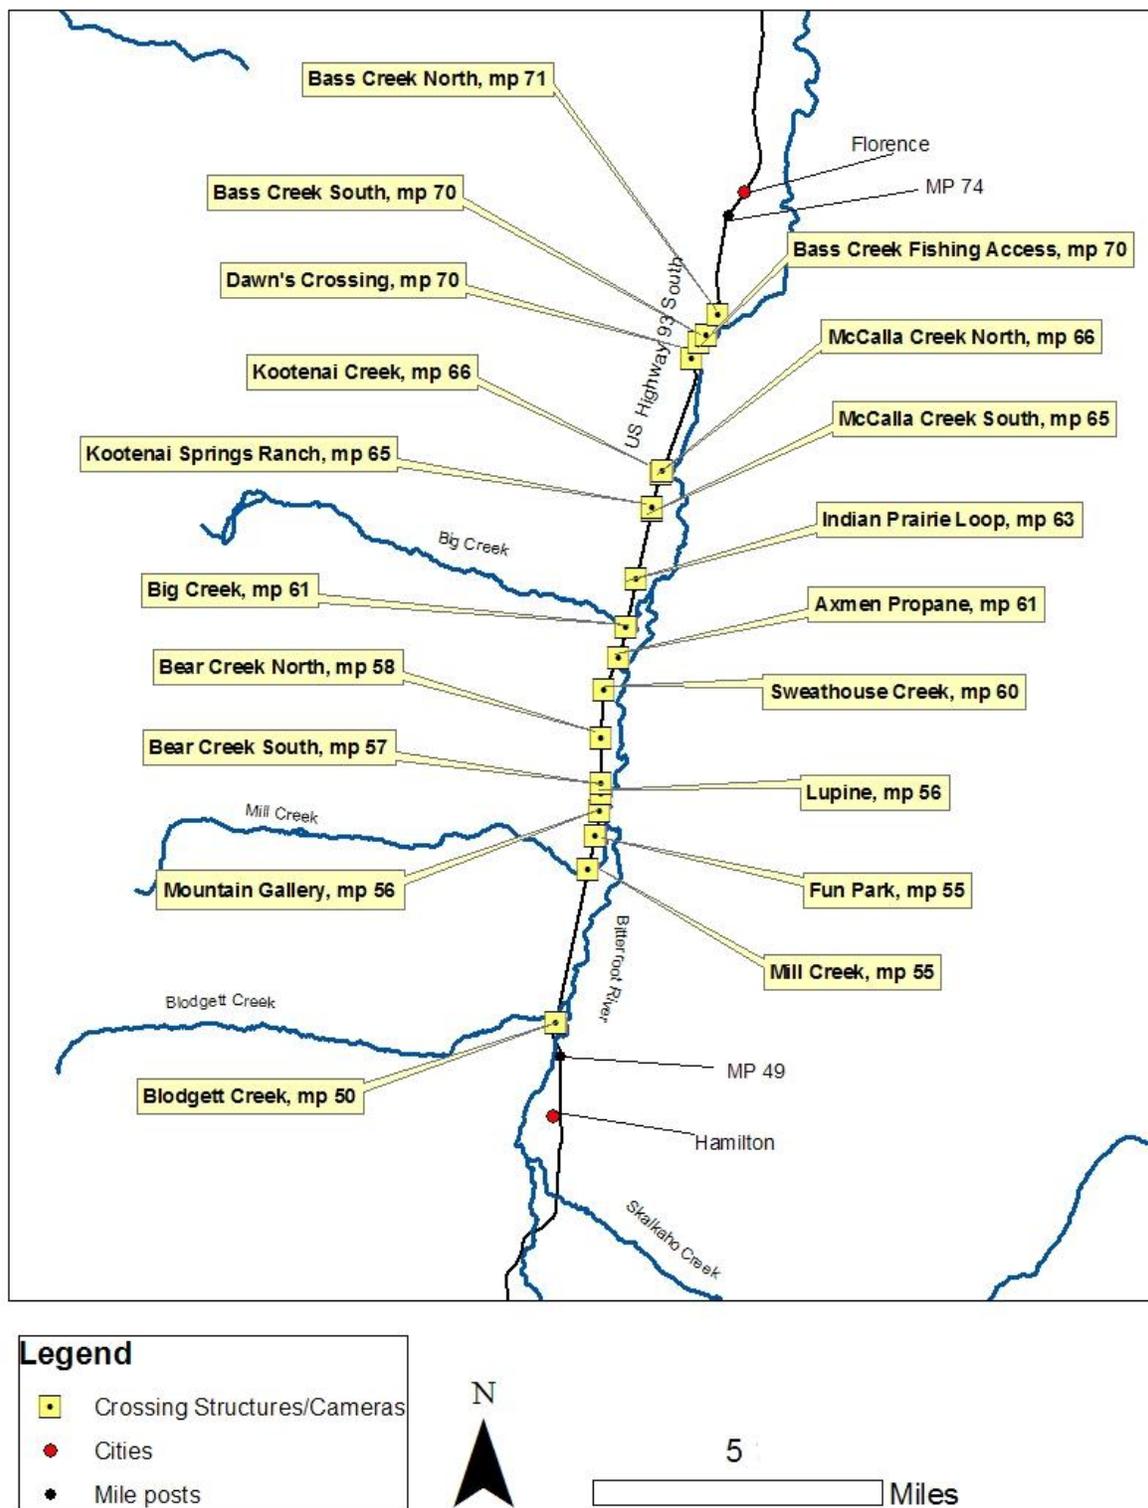
Figure 1. Map of US Highway 93 South Study Area and Locations of Existing and Future Wildlife Crossing Structures, Montana.

The Montana Department of Transportation (MDT) installed 11 large wildlife crossing structures along US Highway 93 South between Florence and Hamilton from 2004 to 2010. Eight additional wildlife crossing structures will be installed over the coming years. Details of the 11 existing wildlife crossing structures and eight future wildlife crossing structure sites are presented in Table 1. A map of the study area showing the locations of existing wildlife crossing structures and future wildlife crossing structure sites is presented in Figure 1.

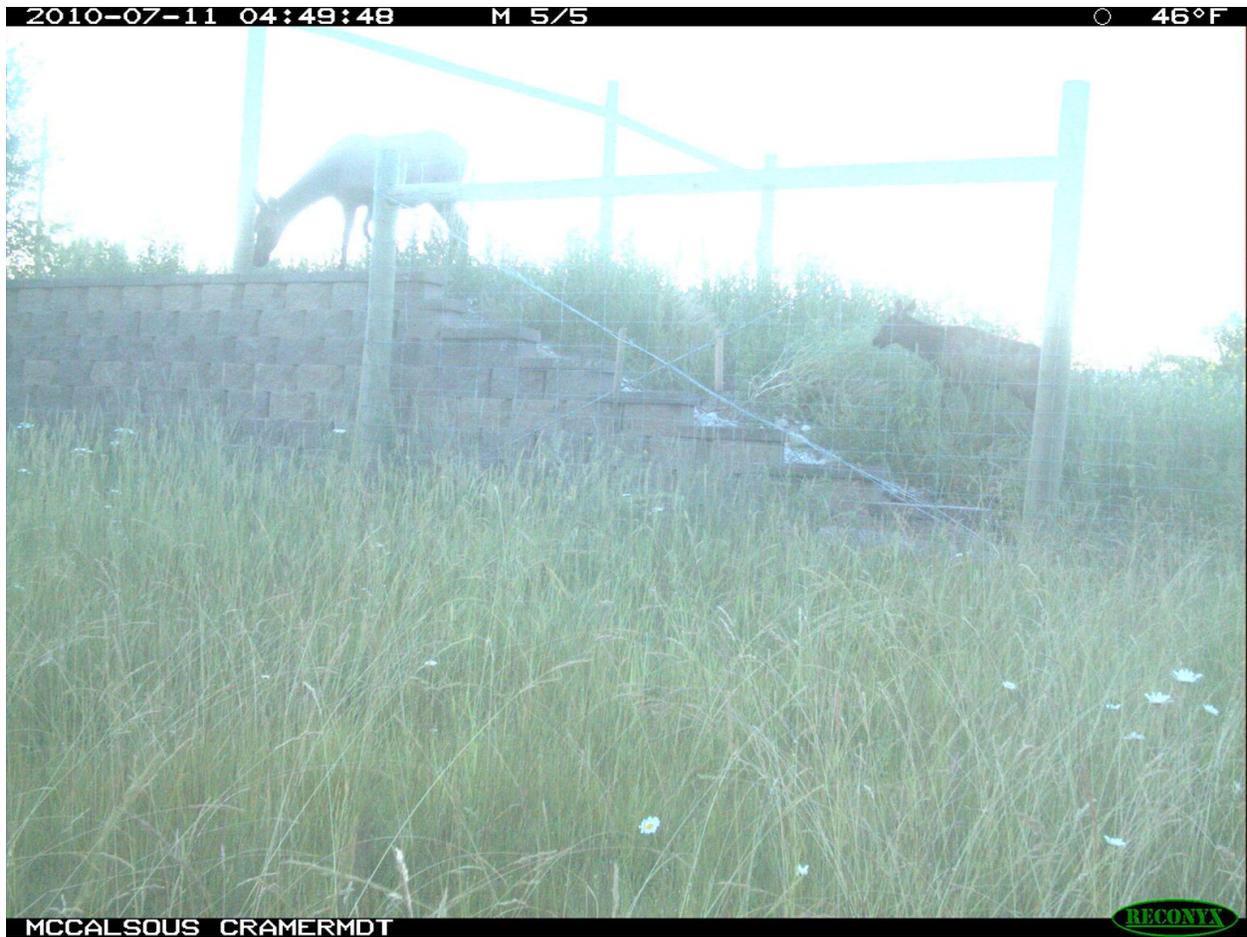
Figure 2. Elk Cow and Calves Using Jump-off Ramp at McCalla Creek South.

The wildlife crossing structures and jump-off ramps at McCalla Creek South and Kootenai Springs Ranch were designed to be utilized by white-tailed deer. Elk (*Cervus elaphus*) were not known to be present during the design of these structures. However, five cameras at McCalla Creek South and Kootenai Springs Ranch have recorded 170 elk observations during this research. Twenty of these observations were elk using jump-off ramps to leave the road (Figure 2.). Preliminary results of elk observations and use at Kootenai Springs Ranch pre-construction and post-construction are detailed in Table 7. In Figure 3, an elk calf successfully moves through the Kootenai Springs Ranch wildlife crossing structure.

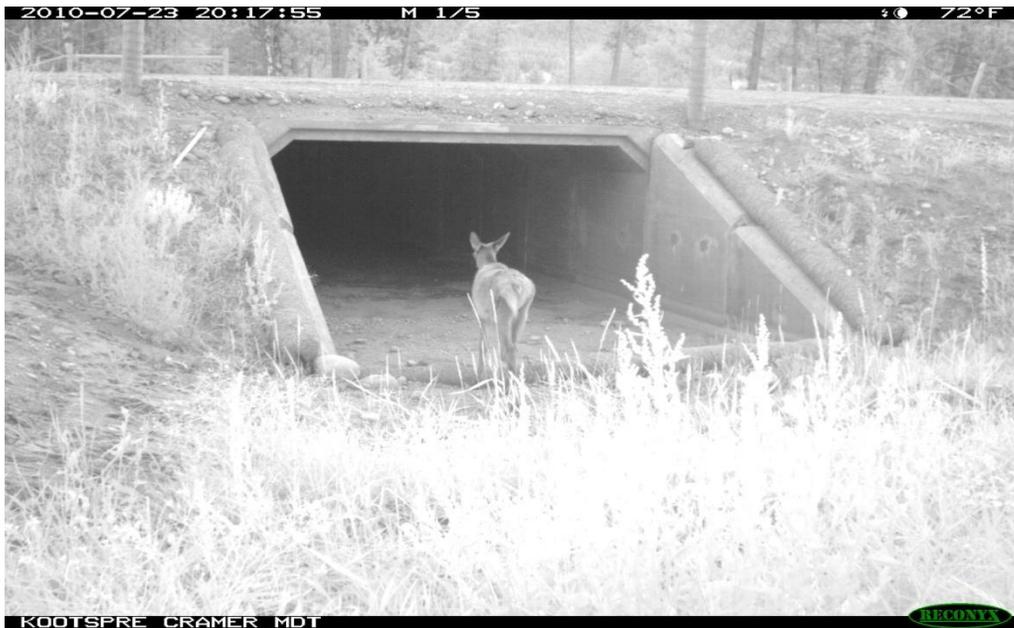
Figure 3. Elk Calf Using the Kootenai Springs Ranch Wildlife Crossing Structure.

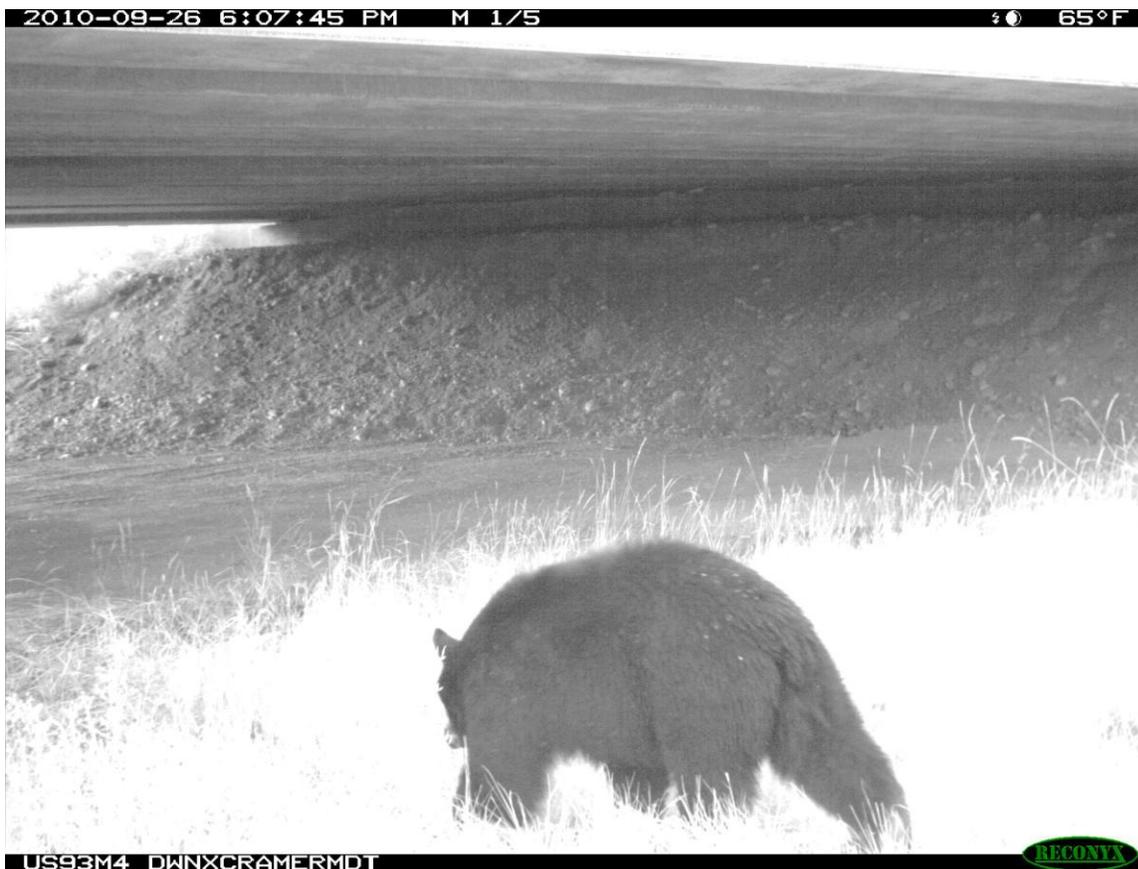
Figure 4. Black Bear Using Dawn's Crossing.

During this reporting period, black bear (*Ursus americanus*) were recorded on six occasions successfully using the structures at Bass Creek Fishing Access (mp 70), Dawn's Crossing (Figure 4, mp 70), Bear Creek South (mp 57), and Blodgett Creek (mp 50). On October 6, 2010, a black bear was repelled from the east side of the Kootenai Springs Ranch (mp 65) wildlife crossing structure. During the entire study, black bear have been photographed on 16 occasions.
