CORRIDOR PLANNING STUDY DOCUMENTATION

MT 1—ANACONDA TO GEORGETOWN LAKE

CORRIDOR PLANNING STUDY

MT-1—ANACONDA TO GEORGETOWN LAKE

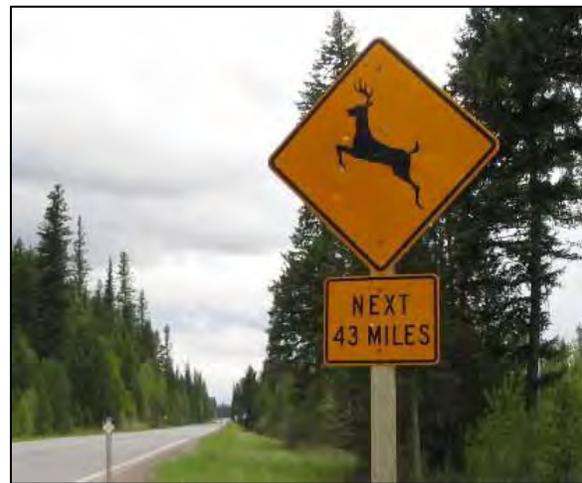
2(b). Animal Detection System

For cost estimating purposes it was assumed that approximately four miles of the study area would receive animal detection systems. An estimated cost of \$100,000 per mile for an animal detection system was used.

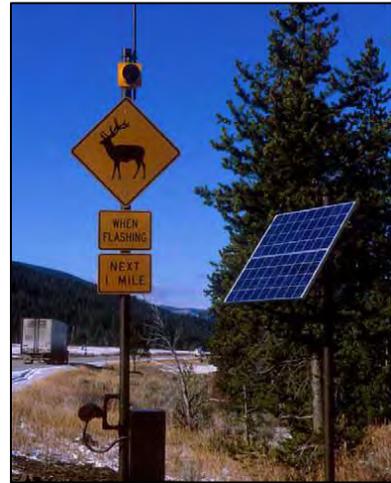
2(c). Wildlife Fencing

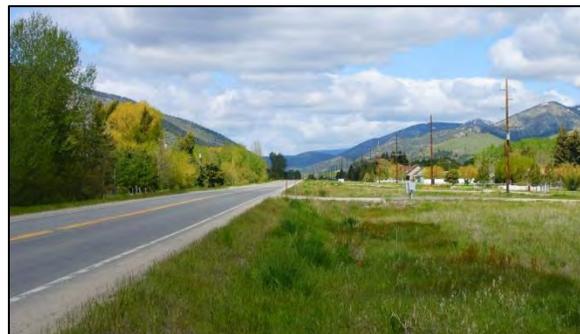
5. *Urban Interface (RP 10.06 to RP 13.8)*

This option is envisioned as a long-term improvement that will modify approximately the first four miles of the corridor (RP 10.06 to RP 13.8). The intent of long-term changes in this section of the corridor is to improve roadway geometrics, better manage access and to establish a speed limit that matches the roadside environment and driver expectations.

The 35 mph posted speed limit between RP 10.1 and RP 12.0 results in driver frustration. Safety data

shows that the crash rate and the severity rate along the corridor are both lower than the statewide average for roadways of similar type and function. Data collection shows that the 85th percentile speed for this section of road is 42.2 mph, which is 7.2 mph higher than the posted speed.

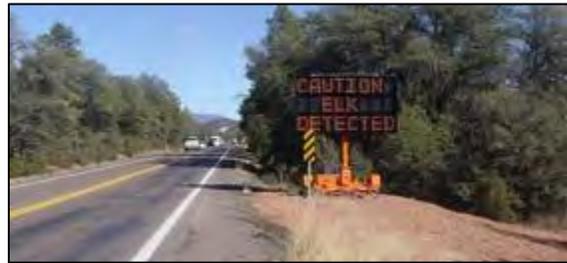
A high concentration of bighorn sheep collisions have occurred near RP 14.5. Temporary variable message signs have been used in the past to help warn drivers of potential bighorn sheep near the roadway. The temporary signs were used in conjunction with decreased speed limits and the removal of salt from roadway deicing in the area in response to the concentration of bighorn sheep collisions. Crash data analysis resulted in an identifiable trend with animal/vehicle collisions in this area.

It is recommended that permanent variable message signs be installed near RP 14.5.

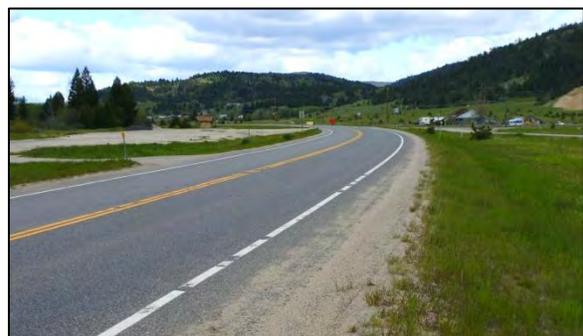
During the winter and spring of 2010 / 2011 a temporary speed zone of 45 mph was established between RP 14.3 and RP 15.3, in the 70 mph speed zone, to help address bighorn sheep conflicts in the area. The temporary speed zone was part of multiple measures aimed to decrease animal vehicle collisions. Crash data analysis resulted in an

identifiable trend with animal vehicle collisions in this area.

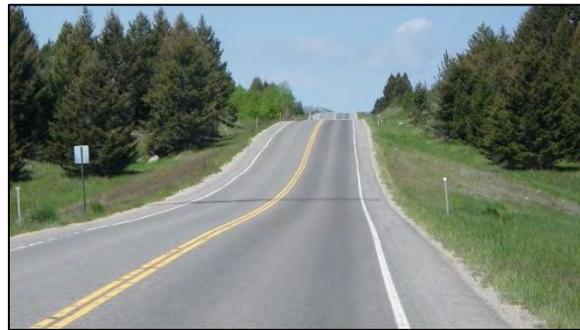
This improvement option has been identified between RP 15.3 and RP 15.8. This area, commonly referred to as the “camel humps”, has two vertical curves that do not meet current MDT design standards. A long-term improvement option is to flatten and/or lengthen the vertical curves to bring the geometrics up to current standards.

It is recommended that the vertical curves be modified to meet current MDT standards. According to carcass reports for the time period 1999 to 2010, this area exhibits a high occurrence of mule deer collisions. During project development activities, specific mitigation measures to reduce mule deer collision occurrence should be examined.

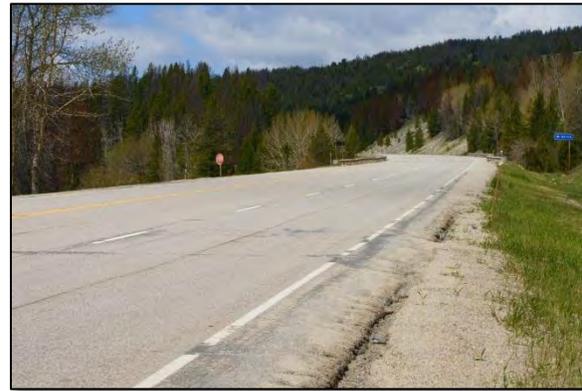
It is recommended that advance intersection warning signs be installed at the intersection of Spring Hill Road and MT-1.

- Increased driver awareness of the intersection.
- Improved safety.

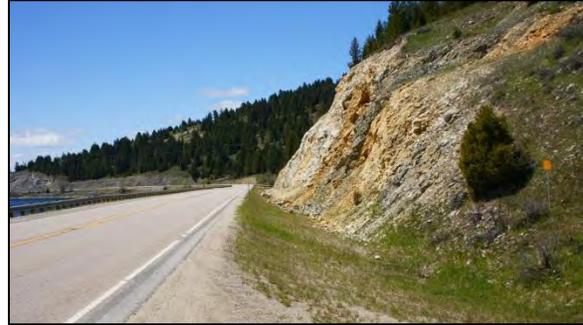
Multiple steep rock cut slopes exist within the MT-1 clear zone between RP 21.1 and RP 23.1. Multiple improvement options are identified to help mitigate fallen rocks and steep cut slopes in this area. During project development activities, the opportunity may exist to combine one or more of these recommended improvements.

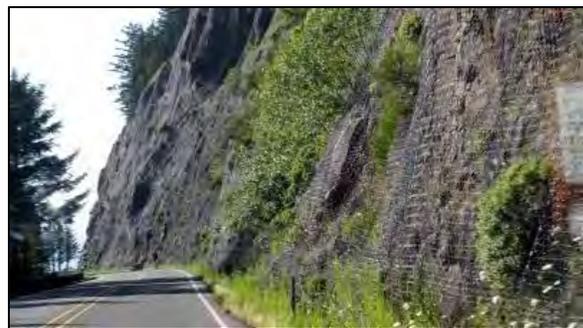
It is recommended that rock fall protection netting be installed along rock cut slopes between RP 21.1 and RP 23.1.

- Reduction in fallen rocks along the roadway and roadside ditches.
- Improved clear zones and safety.

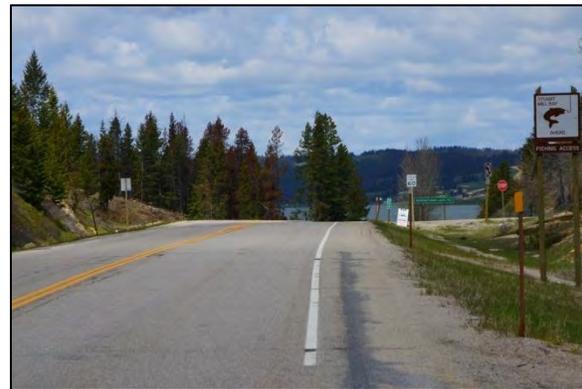
It is recommended that advance intersection warning signs be installed at the intersection of Denton Point Road and MT-1.

- Increased driver awareness of the intersection.
- Improved safety.

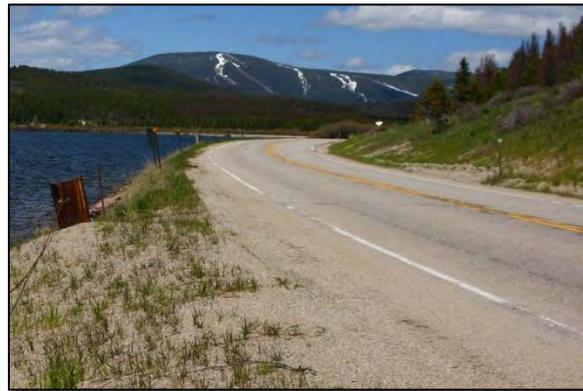
Photo 2.13: Steep fill slopes exist along Georgetown Lake.

Multiple areas with steep fill slopes within the roadway clear zones exist between RP 24.8 and RP 26.8. These areas are potential safety hazards due to the steep slopes. Across from Georgetown Lake is an existing water feature (pond) which may also be a candidate for protection with guardrail. The pond is important for fish rearing and presents a clear zone concern. Total reconstruction of the roadway in these areas is included under Improvement Option 13, however until which time this occurs a stand-alone option is to incorporate guardrail in this area.

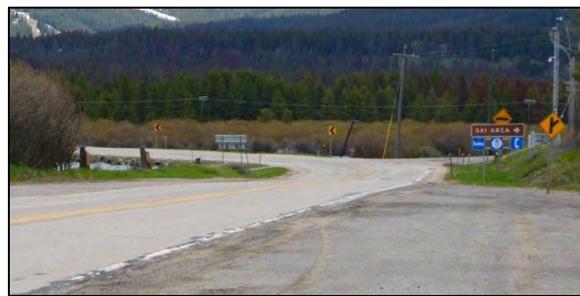
16. Discovery Road Intersection (RP 25.5)

The intersection of Discovery Road with MT-1, located at RP 25.5, causes operational concerns due to poor intersection definition. Discovery Road provides access to multiple recreation areas, including Discovery Ski Area, as well as the Georgetown residential area. The speed limit at this location is 60 mph. There are three recommended improvement options at this intersection which represent a range of improvement types. During project development activities, the opportunity may exist to combine one or more of these recommended improvements.

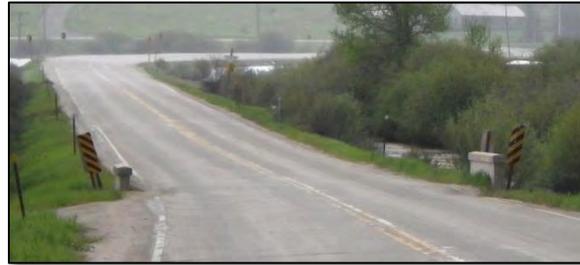
Photo 2.15: Concrete bridge ends near the edge of roadway present safety hazards.

An existing box culvert located at RP 25.9 has concrete bridge ends which are located close to the edge of roadway. No protection currently exists around the concrete ends which are within the roadway clear zone and are potential safety hazards. Total reconstruction of the roadway in this area is included under Improvement Option 13, however until which time this occurs a stand-alone option is to incorporate guardrail around the concrete bridge ends.

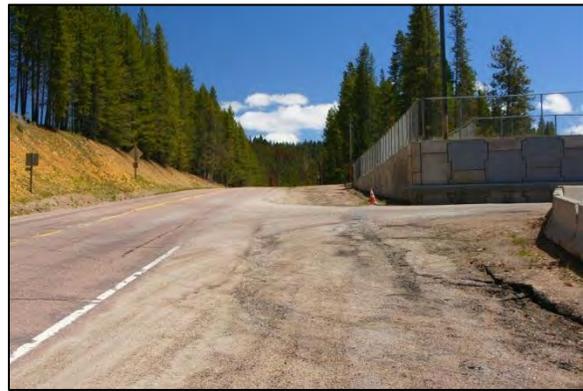
Photo 2.16: Georgetown Lake Road intersection has limited sight distances and geometric concerns south of the intersection.

The intersection of Georgetown Lake Road with MT-1, located at RP 27.35, causes operational concerns due to roadway geometrics and limited sight distances. Georgetown Lake Road provides access to the west side of Georgetown Lake. Multiple recreation and residential areas are accessed from Georgetown Lake Road. There are three recommended improvement options at this intersection which represent a range of improvement types. During project development activities, the opportunity may exist to combine one or more of these recommended improvements. These improvement options could be combined with Improvement Option 13 which recommends full reconstruction between RP 24.2 and RP 27.35.

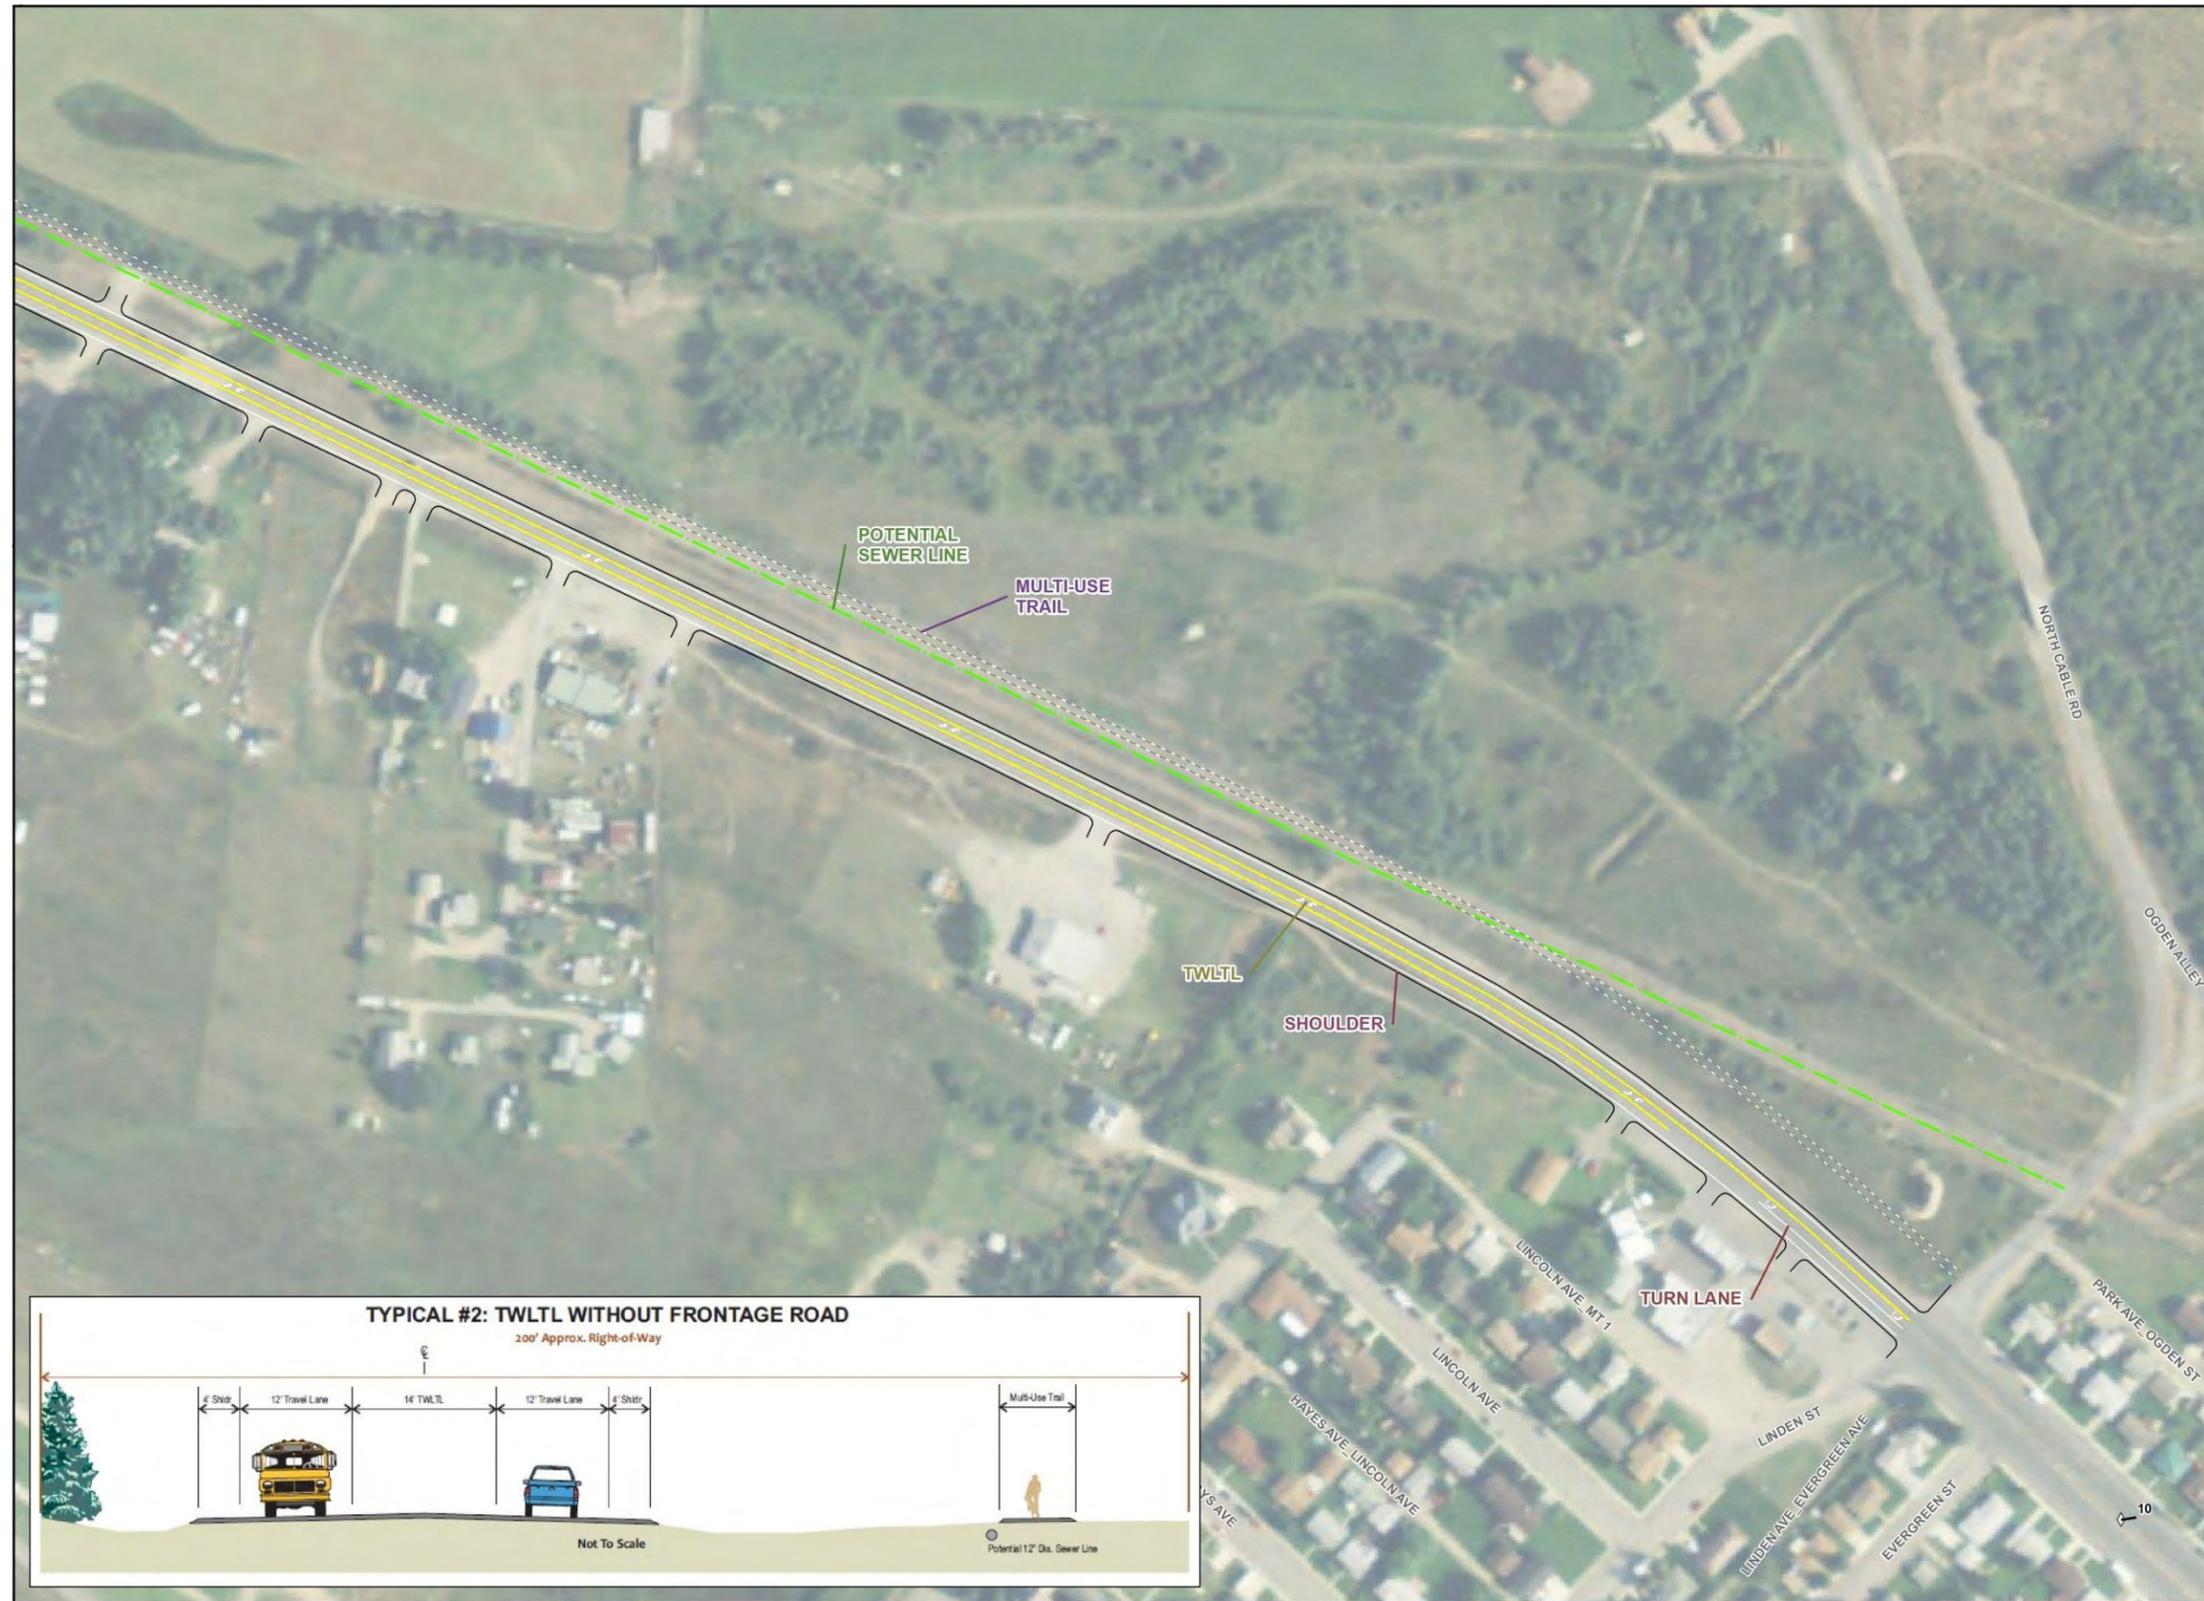
Figure B.1

TYPICAL #2 TWLTL WITHOUT FRONTAGE
