# Improvement Options

## MT-1—ANACONDA TO GEORGETOWN LAKE

### CORRIDOR PLANNING STUDY

September 2011

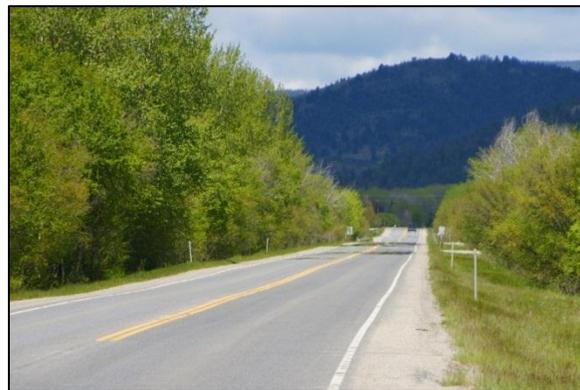
Photo 2.3: Dense roadside vegetation near RP 14.0

Areas with dense vegetation were identified as areas of concern due to decreased sight distances and clear zones. The area of the corridor between RP 12.4 and RP 14.2, for example, includes willow stands and high grass clusters in the roadside ditches, which presents driver sight distance concerns. Additionally, whitetail deer and moose movements are frequently observed along the road within these heavy vegetative areas.

It is recommended that a *Vegetation Management Plan* be developed for the corridor.

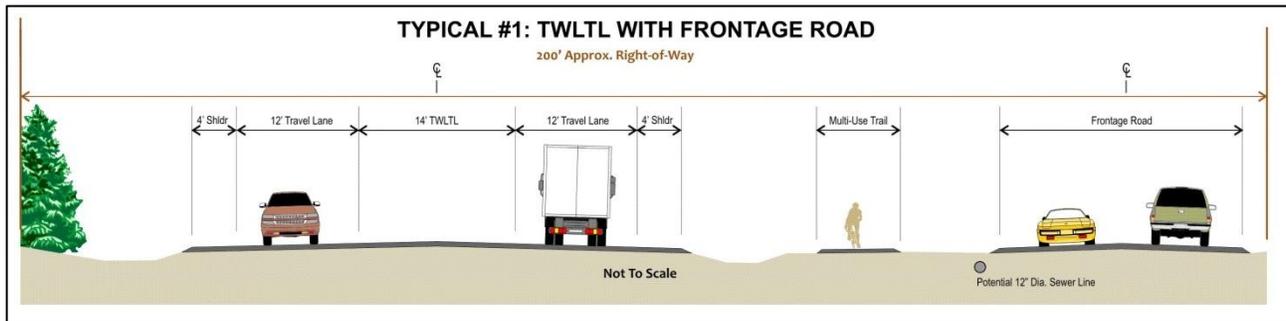
**Figure 2.1: Typical Section #1 – TWLTL with Frontage Road**

Two typical sections have been developed for this section of the corridor. Typical Section #1 utilizes a two-way left-turn lane (TWLTL) with a frontage road on the north side of MT-1 (see **Figure 2.1**). Typical Section #2 utilizes a TWLTL without a frontage road on the north side of the roadway (see **Figure 2.2**). **Appendix A and B** of this memorandum contain conceptual plans for Typical Sections #1 and #2, respectively, for the first 2,500 feet of the corridor.

It is recommended that the roadway between RP 10.06 and RP 13.8 be modified to incorporate Typical Section #1 – TWLTL with Frontage Road. This typical section will provide a center TWLTL to accommodate westbound and eastbound left turning traffic from MT-1. The development of a frontage road on the north side of MT-1 will allow the consolidation and/or closure of numerous private approaches. The typical section can accommodate local infrastructure plans for wastewater facility extension and a multi-use trail. Although the exact location of the multi-use trail cannot be identified, it is recommended that it be placed between the edge of MT-1 and the proposed frontage road. The potential also exists for adding right-turn lanes at appropriate major access points on the north side of MT-1. The need and location of right-turn lanes would be explored during project development activities. Pedestrian signage should be incorporated into future project implementation as appropriate.

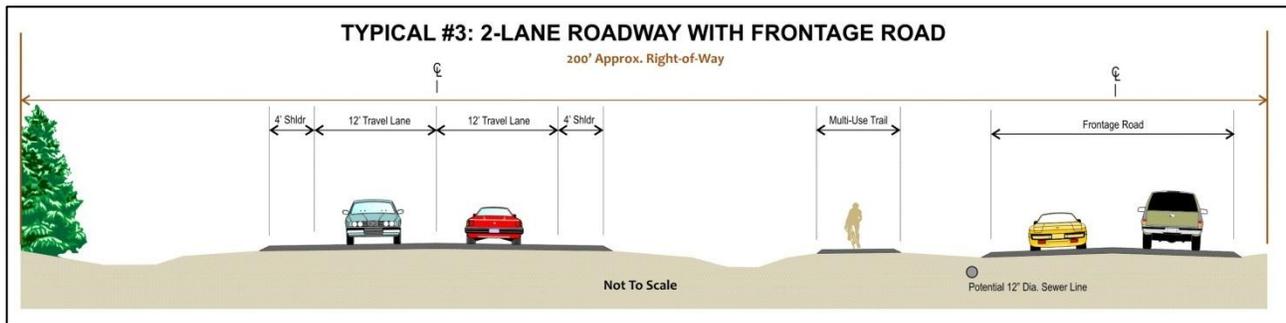
Figure 2.3: Typical Section #3 – 2-Lane Roadway with Frontage Road

Additional typical sections were considered for the first four miles and are shown as **Figure 2.3** and **Figure 2.4**. These typical sections do not utilize a TWLTL. The Planning Team removed these typical sections from further consideration, as they do not improve turning movement operations on the south side of the roadway. The Planning Team determined that any long-term reconfiguration of the roadway

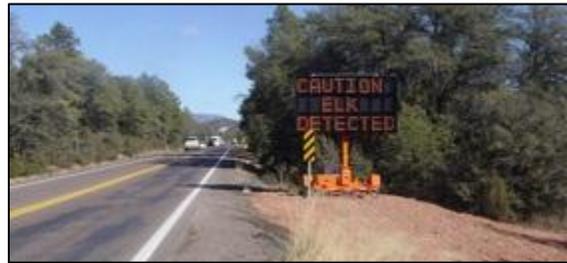
A high concentration of bighorn sheep collisions have occurred near RP 14.5. Temporary variable message signs have been used in the past to help warn drivers of potential bighorn sheep near the roadway. The temporary signs were used in conjunction with decreased speed limits and the removal of salt from roadway deicing in the area in response to the concentration of bighorn sheep collisions. Crash data analysis resulted in an identifiable trend with animal/vehicle collisions in this area.

It is recommended that permanent variable message signs be installed near RP 14.5.

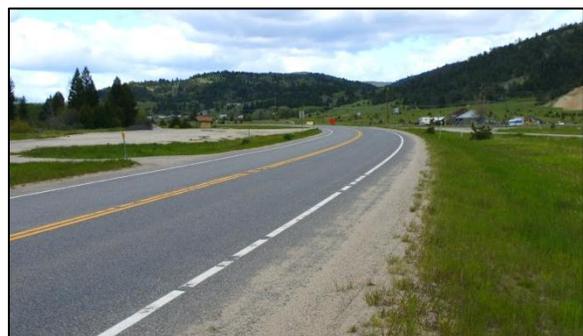
During the winter and spring of 2010 / 2011 a temporary speed zone of 45 mph was established between RP 14.3 and RP 15.3, in the 70 mph speed zone, to help address bighorn sheep conflicts in the area. The temporary speed zone was part of multiple measures aimed to decrease animal vehicle collisions. Crash data analysis resulted in an

identifiable trend with animal vehicle collisions in this area.

It is recommended that the 45 mph seasonal speed zone be continued between RP 14.3 and RP 15.3 during winter and spring time periods when bighorn sheep are in the area. MFWP biologists have expressed that this mitigation measure has had positive results. Long term monitoring should be performed to evaluate this strategies continued effectiveness. This strategy can be enhanced by using the permanent variable message signs described in Improvement Option 6(a).

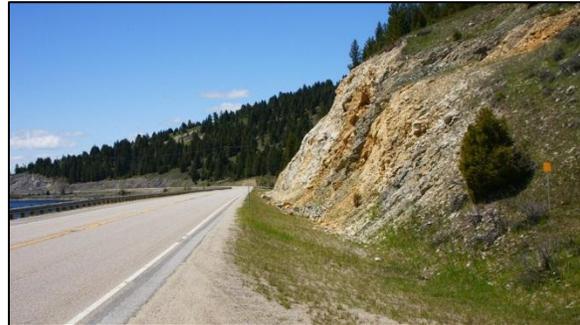
Multiple steep rock cut slopes exist within the MT-1 clear zone between RP 21.1 and RP 23.1. Multiple improvement options are identified to help mitigate fallen rocks and steep cut slopes in this area. During project development activities, the opportunity may exist to combine one or more of these recommended improvements.

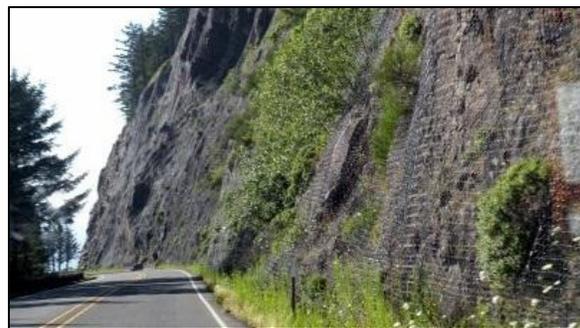
It is recommended that rock fall protection netting be installed along rock cut slopes between RP 21.1 and RP 23.1.

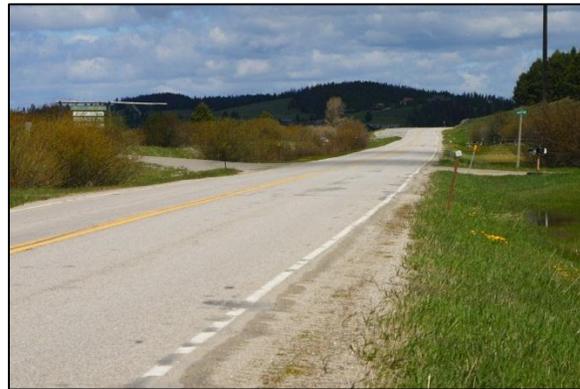
Photo 2.12: Narrow roadway with deteriorating surfacing near RP 24.5.

MT-1 between RP 24.2 and RP 27.35 is only 24 feet wide between edges of pavement and has deteriorating surfacing. Current MDT standards call for a minimum roadway width of 28 feet for a rural Minor Arterial roadway.

An improvement option was looked at to simply construct 4-foot shoulders along the existing edge of roadway. However, due to the poor existing surfacing condition, as well as the potential impacts to the adjacent area, it was assumed that the entire roadway section would be reconstructed.

It is recommended that MT-1 be reconstructed to a minimum width of 32 feet between RP 24.2 and RP 27.35.

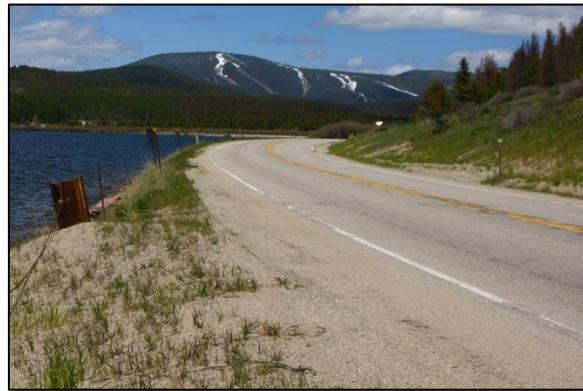
Photo 2.13: Steep fill slopes exist along Georgetown Lake.

Multiple areas with steep fill slopes within the roadway clear zones exist between RP 24.8 and RP 26.8. These areas are potential safety hazards due to the steep slopes. Across from Georgetown Lake is an existing water feature (pond) which may also be a candidate for protection with guardrail. The pond is important for fish rearing and presents a clear zone concern. Total reconstruction of the roadway in these areas is included under Improvement Option 13, however until which time this occurs a stand-alone option is to incorporate guardrail in this area.

It is recommended the guardrail be installed along areas with steep fill slopes between RP 24.8 and RP 26.8.

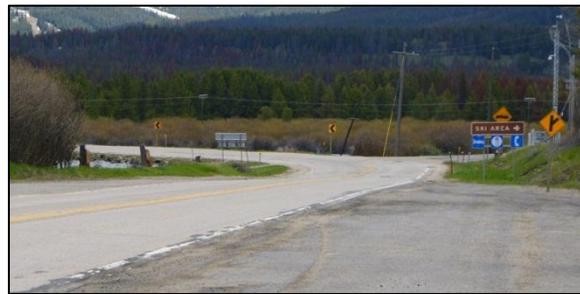
The intersection of Discovery Road with MT-1, located at RP 25.5, causes operational concerns due to poor intersection definition. Discovery Road provides access to multiple recreation areas, including Discovery Ski Area, as well as the Georgetown residential area. The speed limit at this location is 60 mph. There are three recommended improvement options at this intersection which represent a range of improvement types. During project development activities, the opportunity may exist to combine one or more of these recommended improvements.

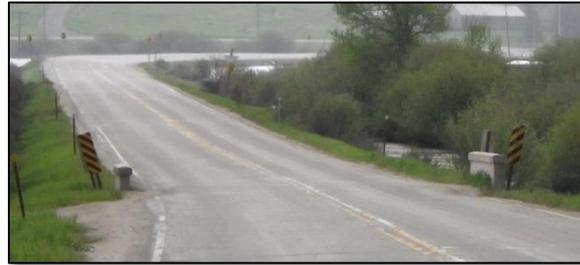
Photo 2.15: Concrete bridge ends near the edge of roadway present safety hazards.

An existing box culvert located at RP 25.9 has concrete bridge ends which are located close to the edge of roadway. No protection currently exists around the concrete ends which are within the roadway clear zone and are potential safety hazards. Total reconstruction of the roadway in this area is included under Improvement Option 13, however until which time this occurs a stand-alone option is to incorporate guardrail around the concrete bridge ends.

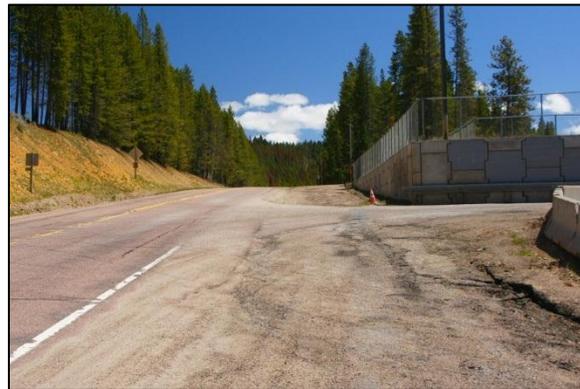
**Photo 2.16:** Georgetown Lake Road intersection has limited sight distances and geometric concerns south of the intersection.

The intersection of Georgetown Lake Road with MT-1, located at RP 27.35, causes operational concerns due to roadway geometrics and limited sight distances. Georgetown Lake Road provides access to the west side of Georgetown Lake. Multiple recreation and residential areas are accessed from Georgetown Lake Road. There are three recommended improvement options at this intersection which represent a range of improvement types. During project development activities, the opportunity may exist to combine one or more of these recommended improvements. These improvement options could be combined with Improvement Option 13 which recommends full reconstruction between RP 24.2 and RP 27.35.

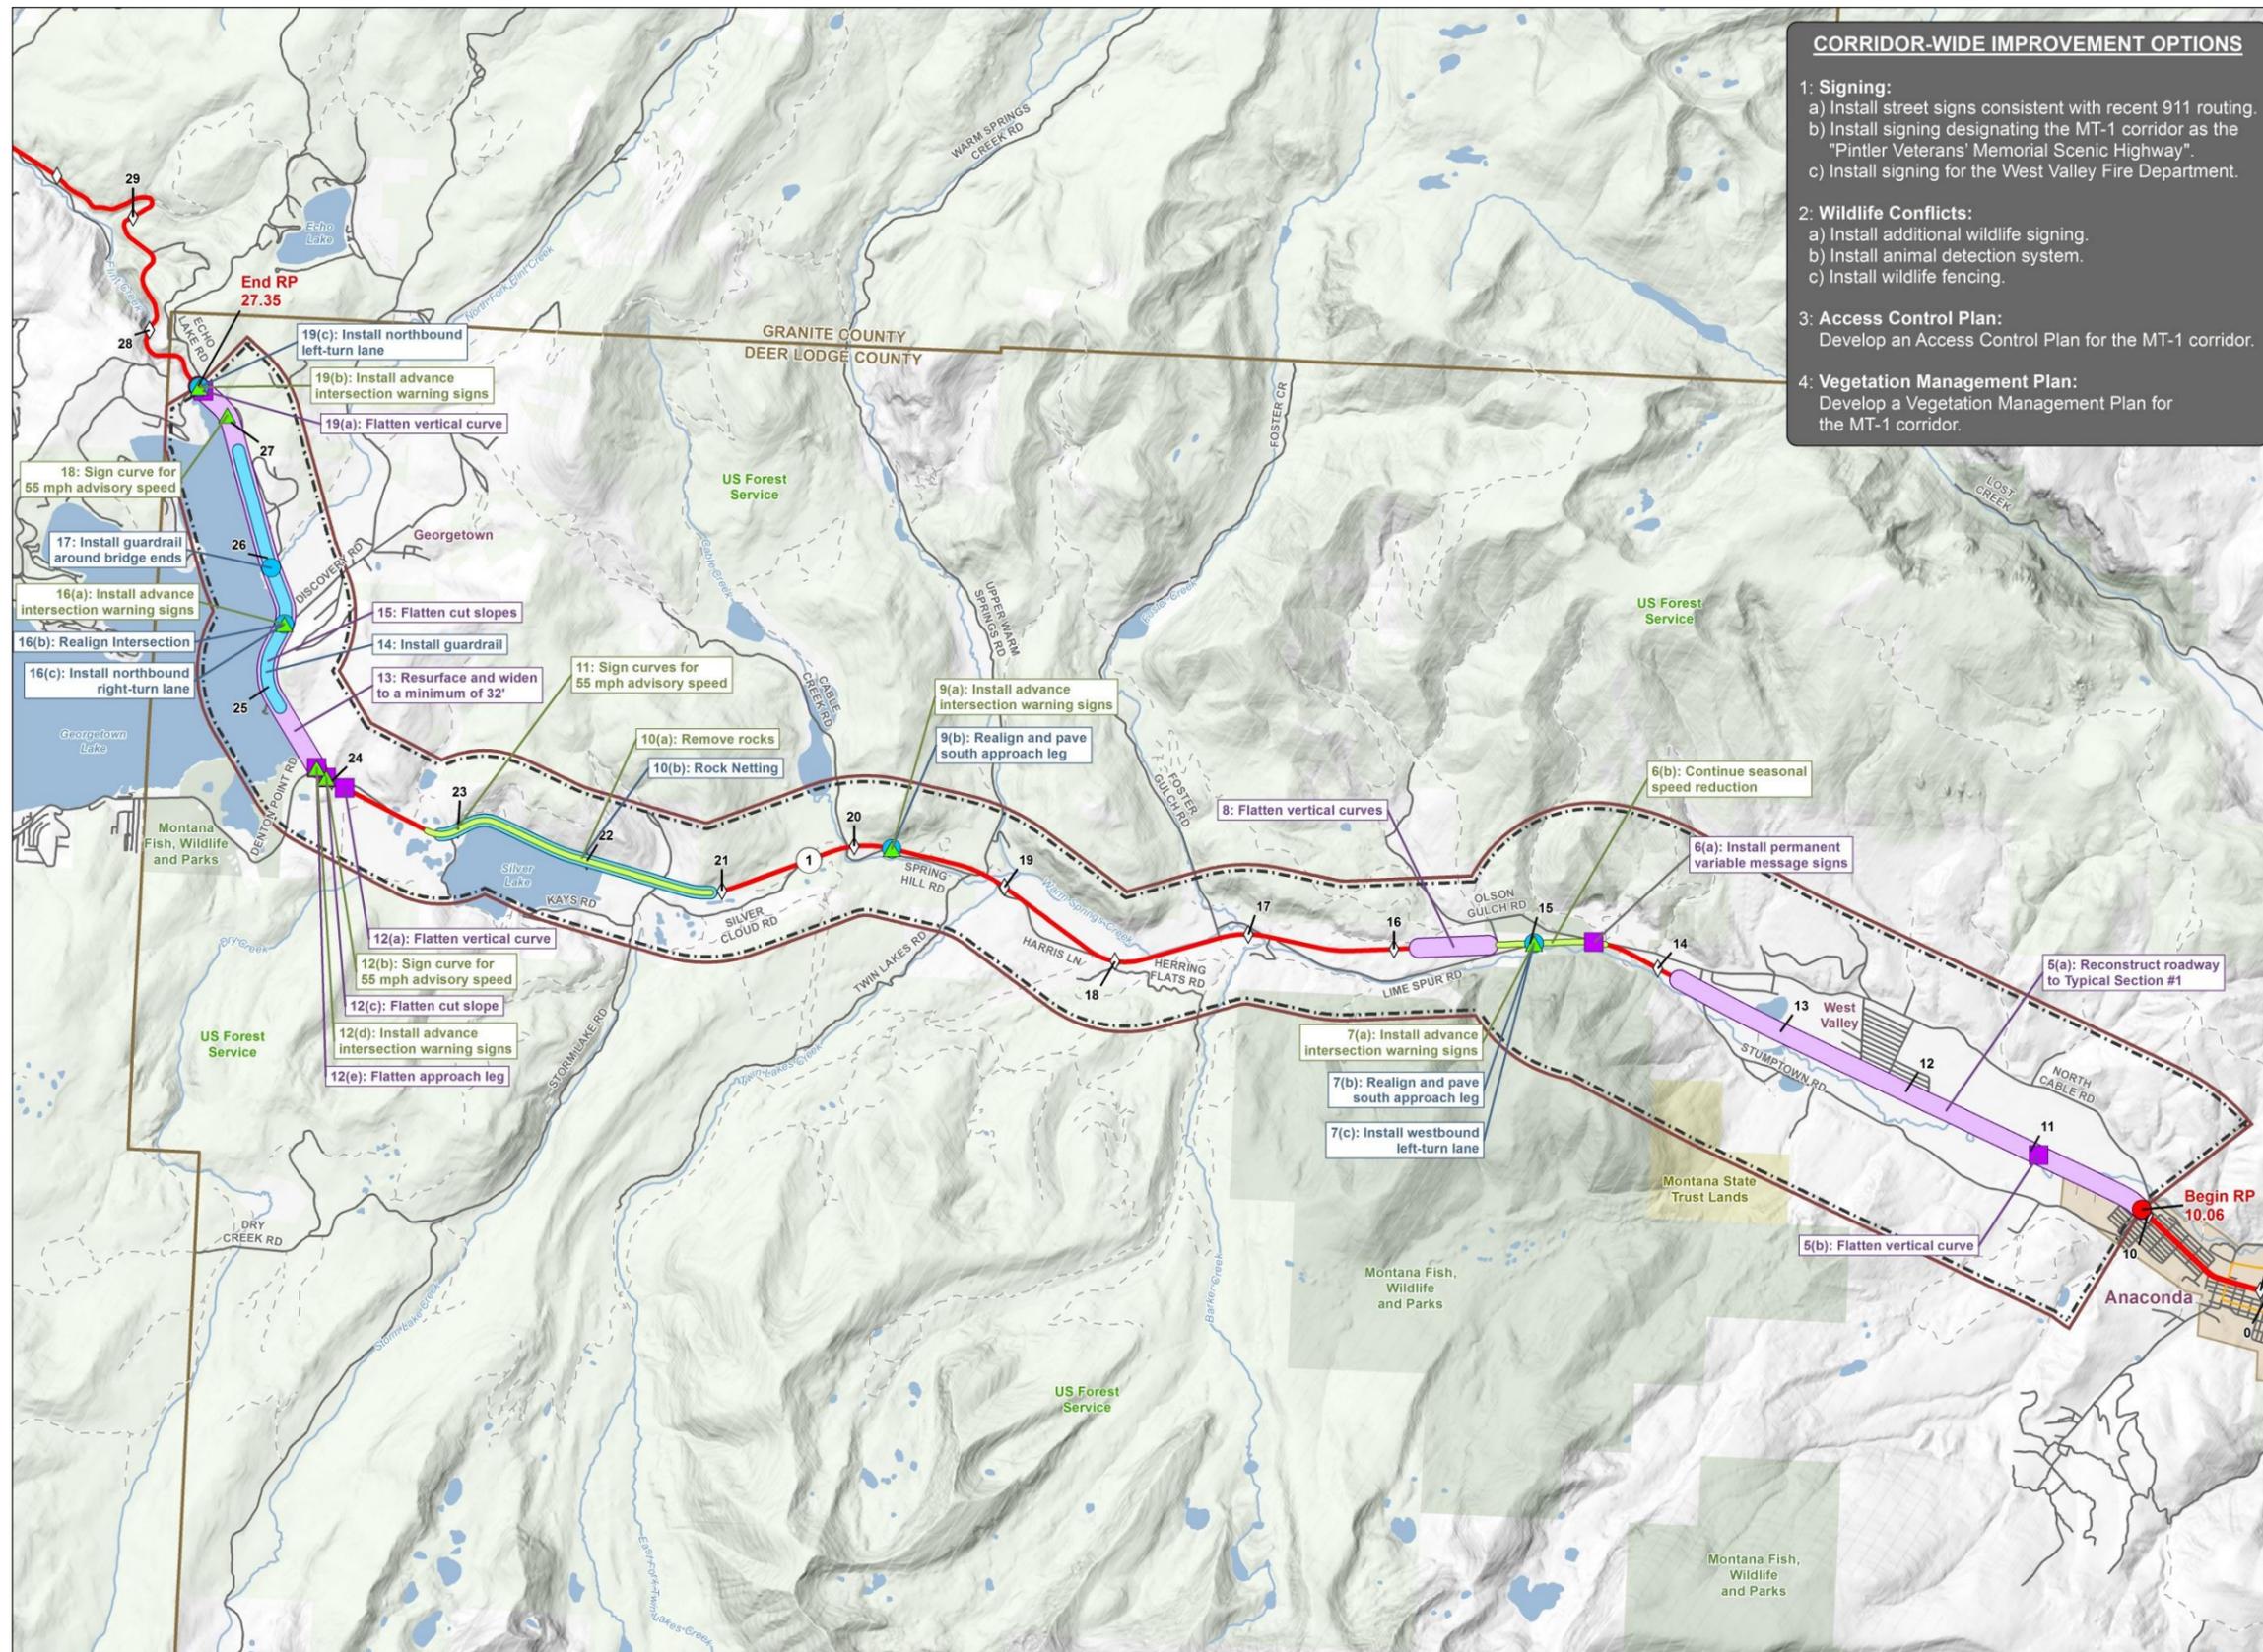
Figure 3.1

- CORRIDOR-WIDE IMPROVEMENT OPTIONS**
- 1: Signing:**
    - a) Install street signs consistent with recent 911 routing.
    - b) Install signing designating the MT-1 corridor as the "Pintler Veterans' Memorial Scenic Highway".
    - c) Install signing for the West Valley Fire Department.
  - 2: Wildlife Conflicts:**
    - a) Install additional wildlife signing.
    - b) Install animal detection system.
    - c) Install wildlife fencing.
  - 3: Access Control Plan:**

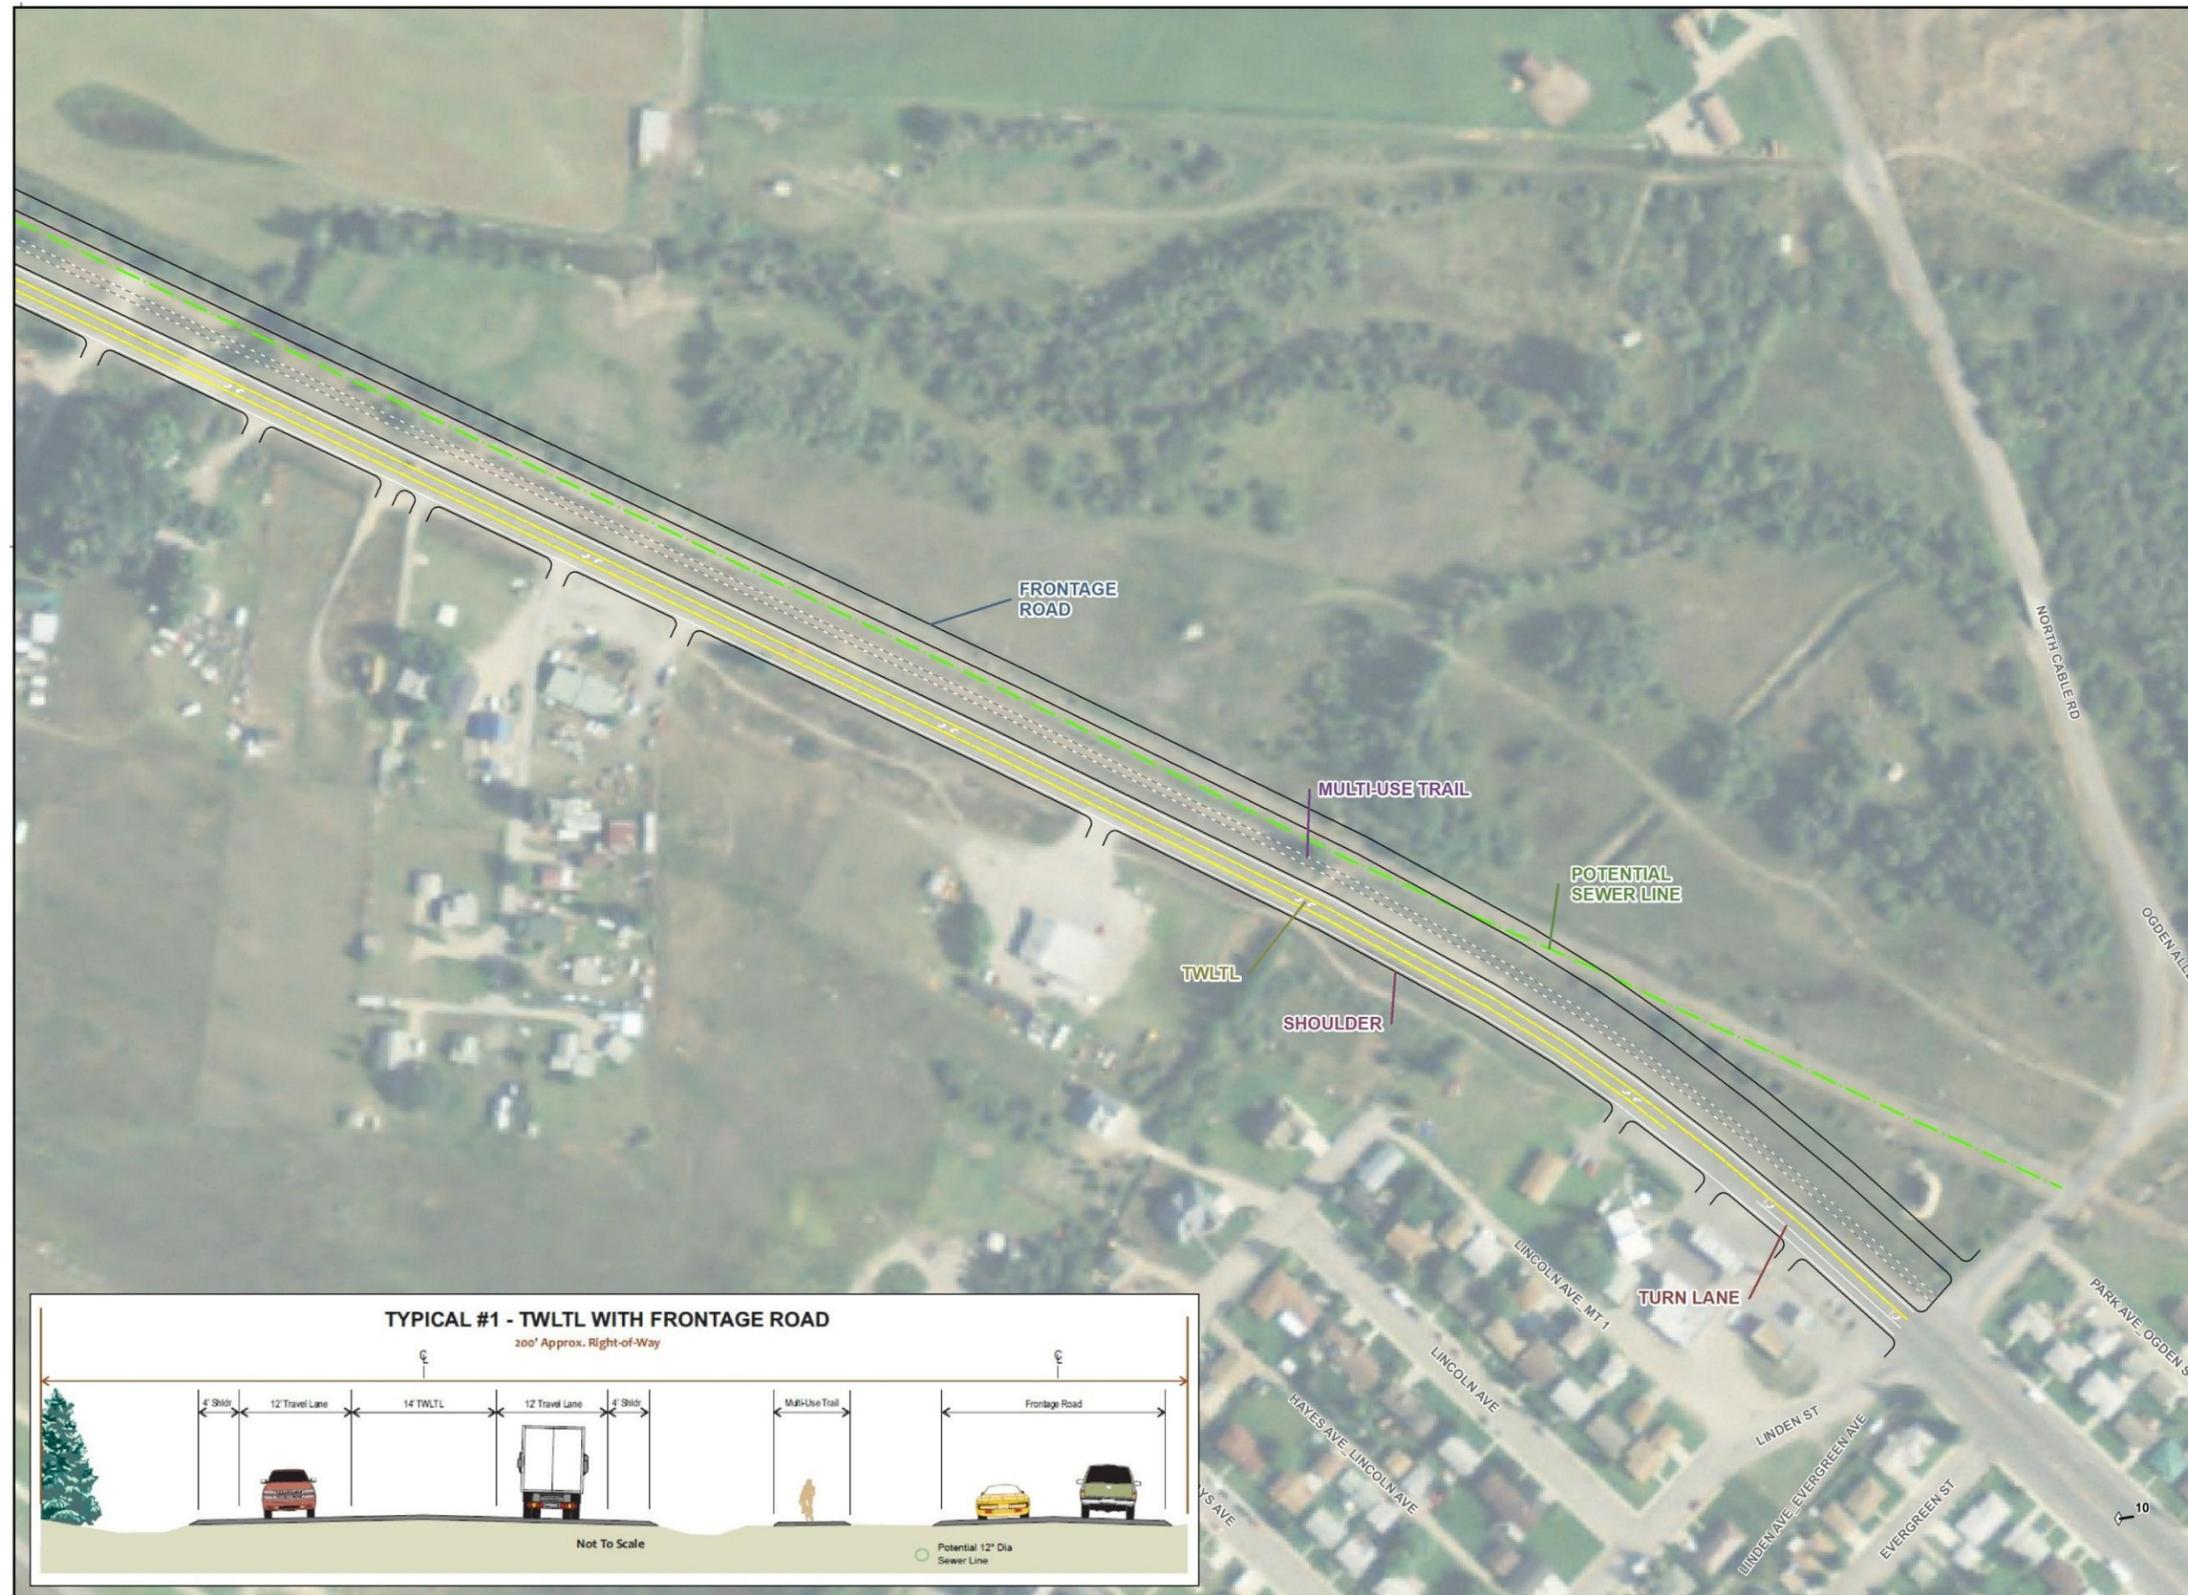
**Figure A.1**

### TYPICAL #1 TWLTL WITH FRONTAGE

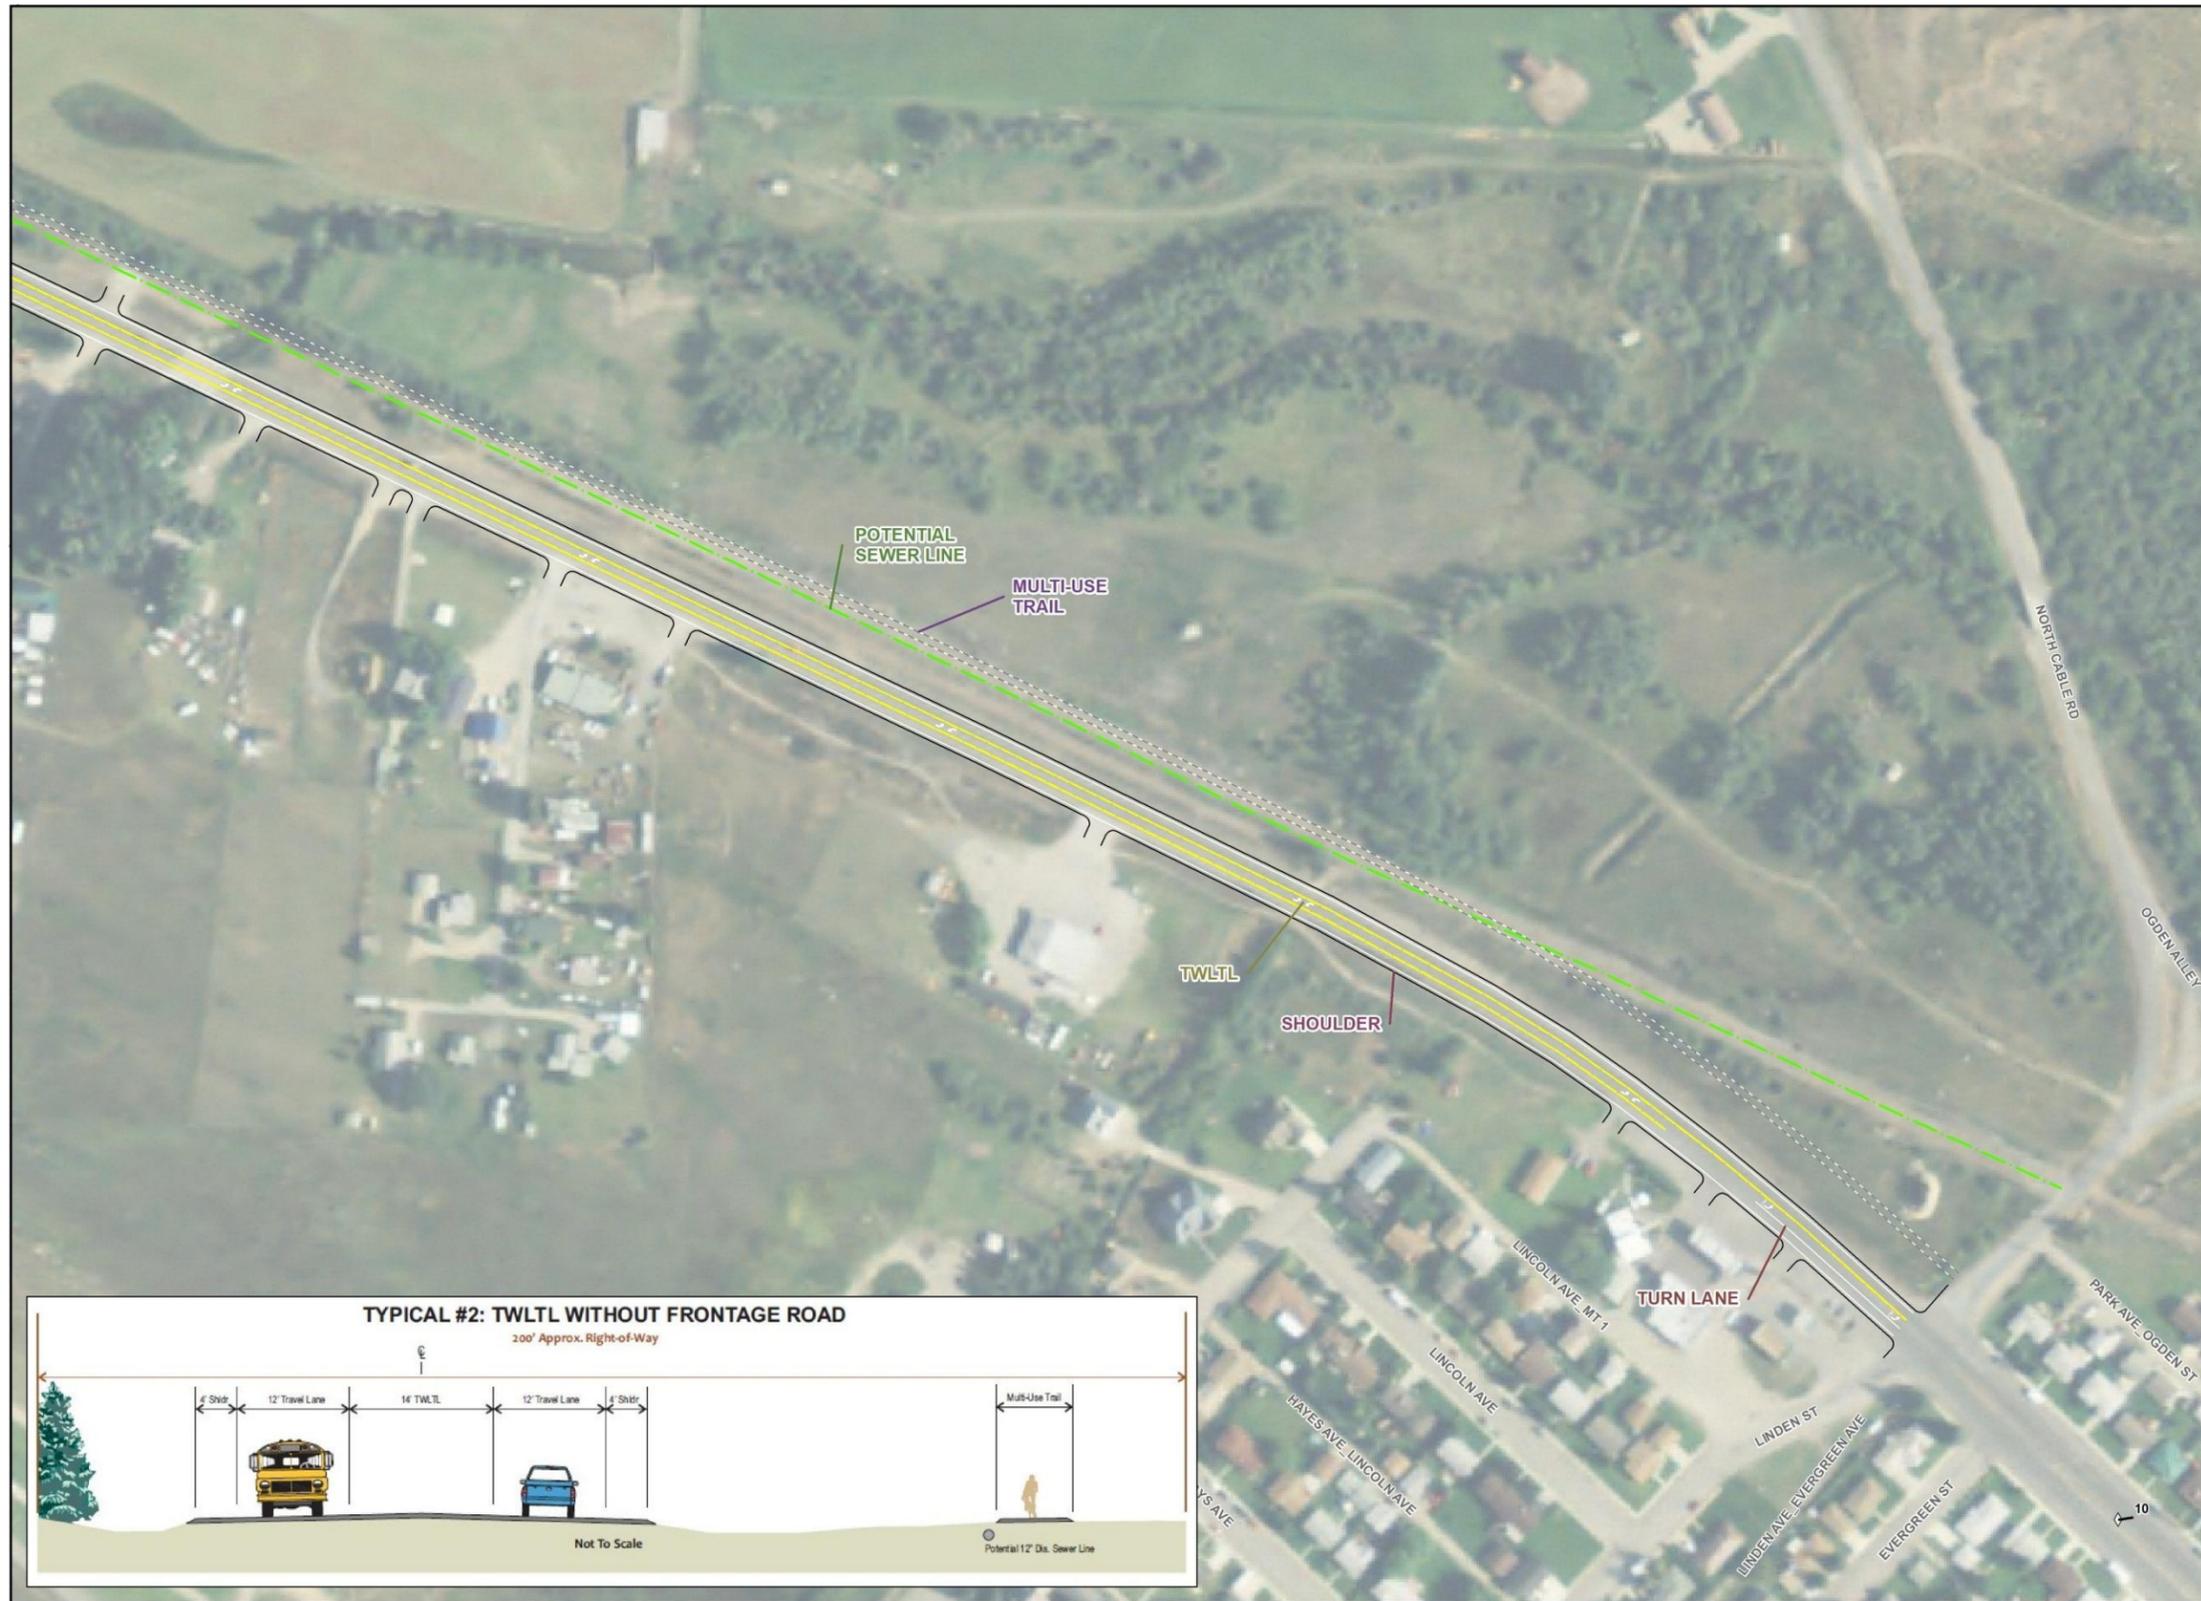
### TYPICAL #2 TWLTL WITHOUT FRONTAGE
